Joint Report for Tsunami Field Survey for the Solomon Islands Earthquake of April 1, 2007

PARI Tsunami Survey Team

International Tsunami Survey Team

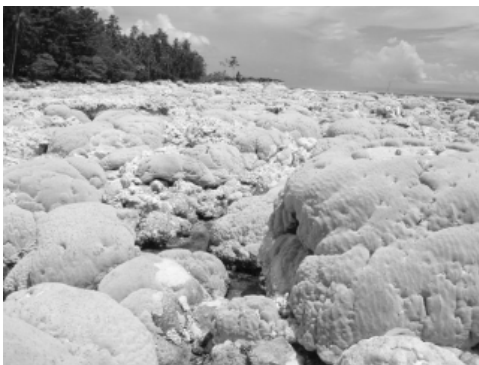
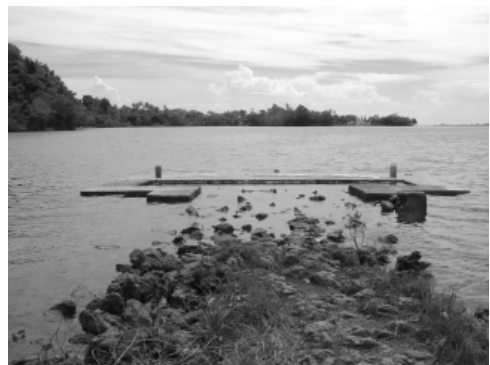
lages, Lengana and Riguru. For example, a pier at Lengana was submerged after the earthquake (Fig. 2.4b). Those clearly indicate that a pattern of the vertical coseismic crustal deformation was changed between two Islands, Simbo and Ranon-

(a) Uplifted corals around Ranongga Is. (b) A subsided pier at Lengana Simbo Is.

Fig. 2.4 Photos of crustal deformations.

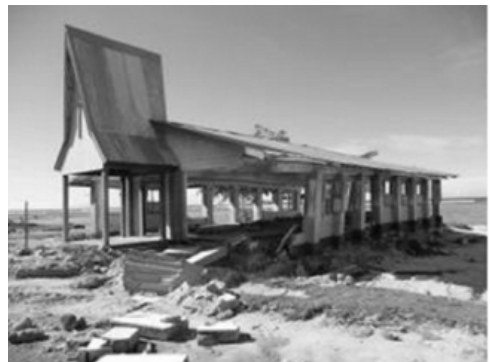
The tsunami caused severe damage in Titiana. As shown in Photo 3.1.2.2, most houses were swept and destroyed by the tsunami. A church was damaged but remained intact as shown in Photo 3.1.2.3. The front and back walls facing the tsunami flow direction were completely de-

Photo 3.1.2.3 Damaged church

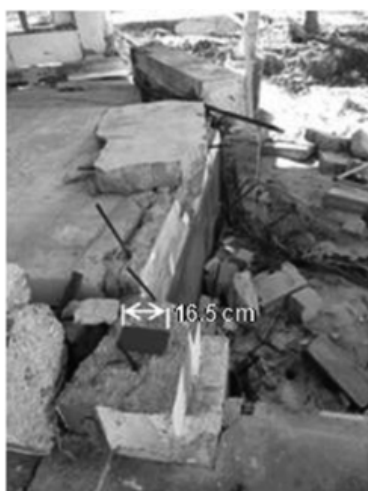
stroyed, but side walls had less damage. Photo 3.1.2.4 shows a broken section of the front wall, and a column more than 30 cm thick was broken.

Photo 3.1.2.4 Broken front section of the damaged church

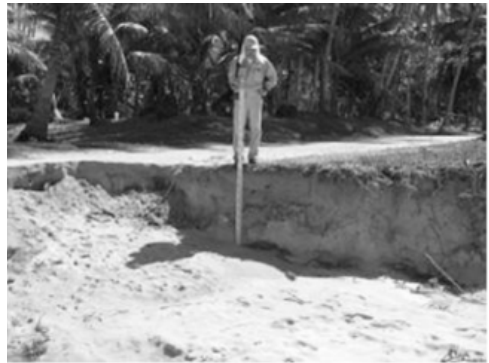
Photo 3.1.3.3 Beach erosion in New Manra

side of a bridge in Fig. 3.1.3.2 and the erosion reached near a main road, as shown in Photo 3.1.3.4. The depths of erosion were measured at two points in New Manra, and they were 0.70 m and 1.05 m. The foundation of a damaged church in Fig. 3.1.3.2 was also eroded as shown in Photo 3.1.3.4, resulting in structural destruction originated by erosion as well as tsunami wave pressure.

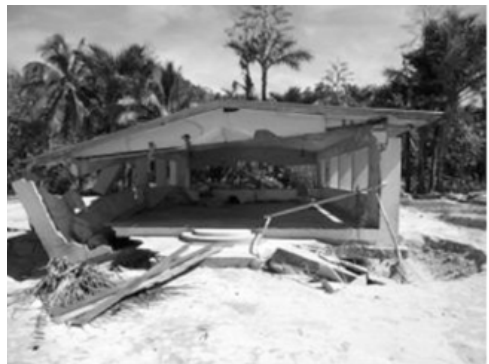
Photo 3.1.3.4 Erosion of foundation of structure in New Manra

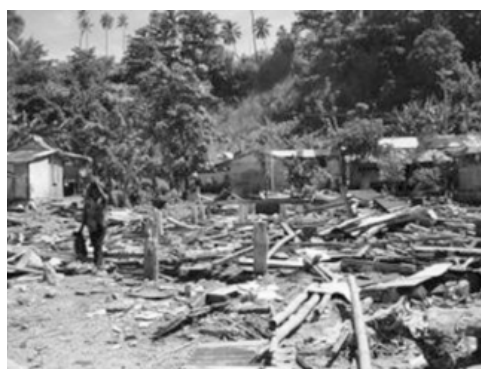
Photo 3.1.4.3 Situation of damaged areas in Marakerava 3

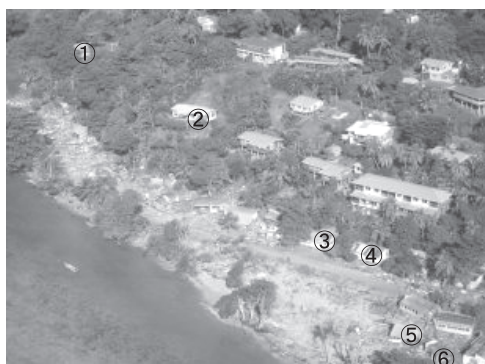
Photos 3.1.5.1 and 3.1.5.2 show the situation of the village after the tsunami (on April 12, 2007), and Photo 3.1.5.3 is an aerial photo before the tsunami. In order to compare these photos easily, houses are numbered in each photo, and the houses with the same number are the same. Comparing among three photos and analyzing results of the field survey, severe damage was caused in the dash-lined area in Photo 3.1.5.3. The reason why the area suffered severe damage, especially in Marakerava 1, is that the tsunami struck directly from the tsunami source, because the alongshore direction of the coastline of Marakerava 1 is east-west, and the coast faces the tsunami source. Moreover, no tsunami reduction by sand dunes, vegetation or structures occurred on this coastline.

Photo 3.1.5.1 Damaged area in the west of Marakerava 1

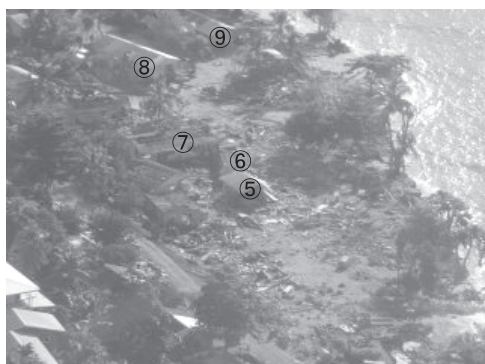
Photo 3.1.5.2 Damaged area in the east of Marakerava 1

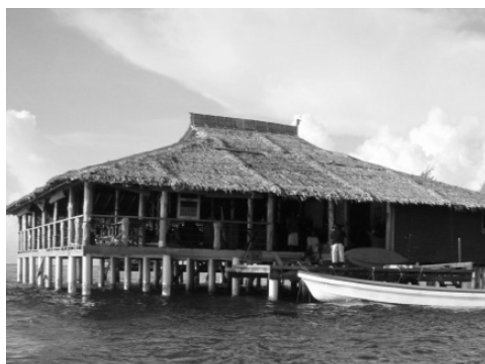
“Fatboys” is a restaurant and bungalows at Mbabanga Island, about 5 km east of Gizo Island (see Fig. 3.1.1.4). Some staffs were working in the restaurant at the time of the earthquake and tsunami. We interviewed them and got information in July 2007. The restaurant is situated 100 meters out of the island and built on the water (Fig. 3.1.16.1). The staffs felt strong shaking but it caused no significant damage on the structure. They said that the water (tsunami) came up to the floor level of the house and caught their feet, but tables and chairs were not moved by the water flow. So, we measured the floor level above the sea surface as the tsunami height. It was 1.24 m.

Fig. 3.1.16.1 Restaurant of “fatboys” at Mbabanga Island. Tsunami came up to the floor of the house

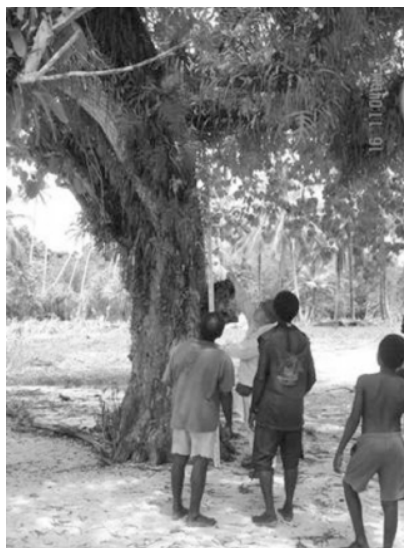
Photo 3.2.3.1 Tsunami inundation at the Mark 36 in Riguru, Simbo Is. We judged the tsunami inundation limit by eyewitnesses' account.

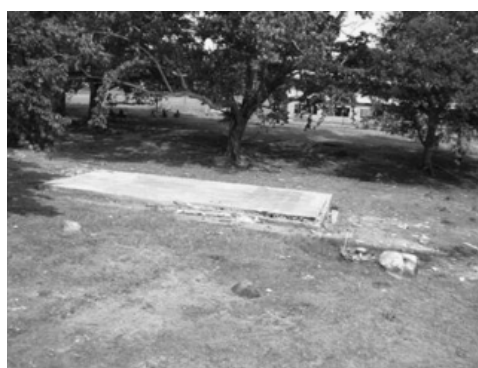
There was one handicapped person using a wheelchair, and his family tried to bring him to the hill. He wished to stay at his home, and did not evacuate. He survived. An old building of the school was completely swept away (Photo 3.2.6.1). The new school building, funded by JICA, was under construction on a hill; the tsunami did not arrive at it. Because fishermen were not at sea when the tsunami arrived, many canoes were carried away, but some of them were available to use. The borderline between living and dead vegetation caused by the tsunami was clear. The buildings of the primary school were not damaged by the tsunami. The houses also survived because they were located far from the coastline. Some of the inhabitants lived in temporary houses in the bush, but the emergency supplies from NDC, World Vision, and Recovery Center were sufficient. Spring water was also sufficient and Save the Children estimated that the water was safe to drink. Fishermen did not return to fishing because they feared finding missing persons in the sea. Some inhabitants had video and DVD players, and they had watched an educational lecture before the tsunami's arrival.

Photo 3.2.6.1 Building foundation of the school at Lengana, Simbo Island.

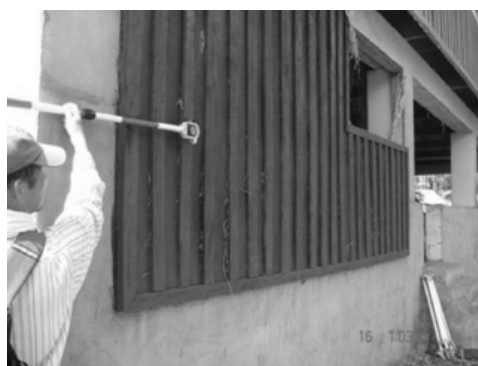
Photo 3.2.6.2 A line of water mark of scratches was traced on the wall of the centenary hall in Lengana.

3.2.6.2). We regarded the top of the scratch as the tsunami height, and the height was 4.9 m (after correction of the astronomical tide). At Mark 70, we found the clear border line between living and dead leaves. The line was the limit of runup. The height was measured as 4.1 m (after correction of the astronomical tide). We measured the other two heights in the same way.

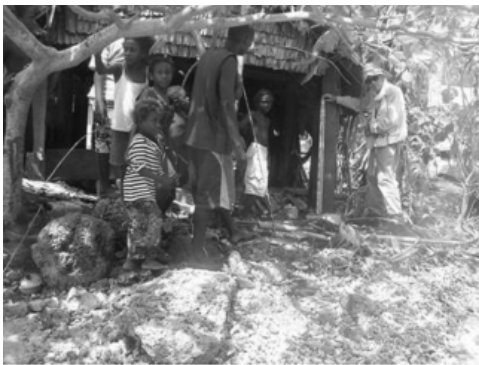
Photo 3.2.7.1 Measured run-up point in Ove, which was also corroborated by the inhabitants. The run-up height was 0.7 m.

bly not so much. Several cottages near the coast-line were damaged by the tsunami, although the tsunami trace height was not so high. The measured runup height was 0.7 m as shown in Figure 3.2.7.1. The runup mark was decided as the location of the debris on the ground, and this location was corroborated by the eyewitness account of an inhabitant (Photo 3.2.7.1).

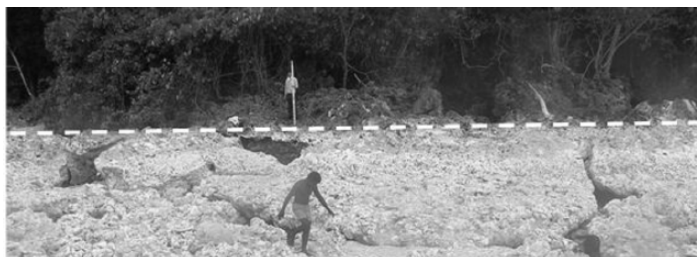
Photo 3.3.1.1 Bleaching coral reef uplifted more than 3 m at Lale village. The white broken line shows the possible low tide level before the earthquake.

Lale village is located on the west coast in the southern tip of the island. The height of ground upheaval was estimated to be more than 3 m. A bleaching coral reef uplifted by the earthquake is shown in Photo 3.3.1.1. Cracks in the ground were recognized in the residential area, as shown in Photo 3.3.2.1.

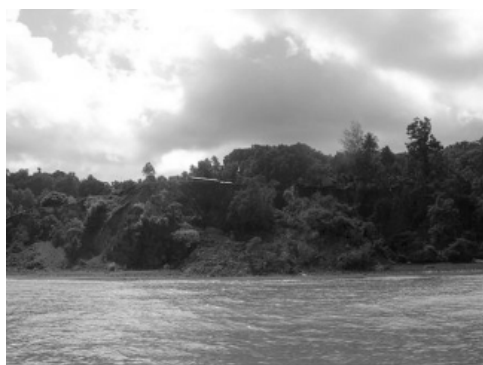
Photo 3.3.1.2 Small scale landslide at Mondo village on the west coast in the middle of Ranongga Island

Because the ground of the island was uplifted, the damage from the tsunami was light, considering the runup height of the tsunami. On the island, two persons were killed not by the tsunami, but rather by a landslide, which occurred almost everywhere on the west coast of the island. Photo 3.3.1.2 shows an example of the landslides at Mondo village where the two were killed. In the photo, a few houses can be seen at the edge of cliff.

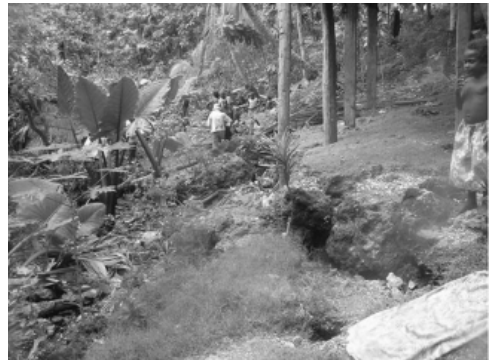
Photo 3.3.2.1 Cracks in the ground due to the earthquake in the residential area

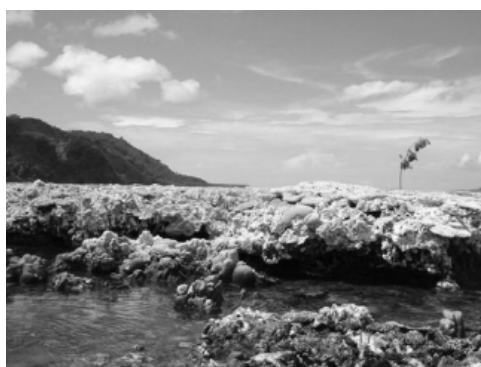
Photo 3.3.3.1 Bleaching coral reef uplifted by the earthquake in Keara

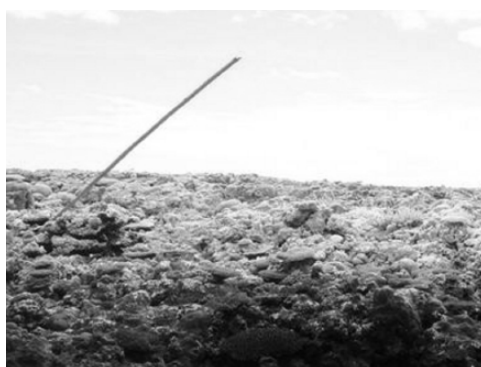
Photo 3.3.4.1 Bleaching coral reef uplifted by the earthquake in Keara

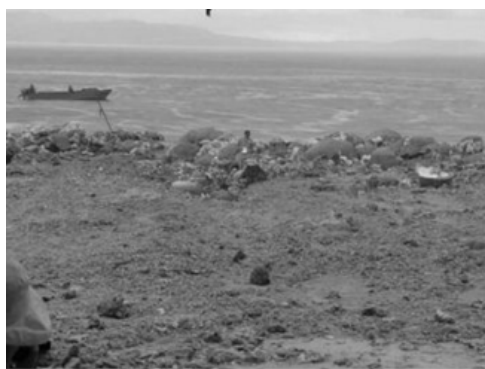
Pienuna village is located on the east coast in the middle of the island. No inundation and runup marks were found in the field survey, and residents noticed no tsunami. Coral reefs were exposed above the sea surface, and now sit 2.22 m above present sea level.

Photo 3.3.9.1 Coral reef uplifted 2.2 m at Pienuna village

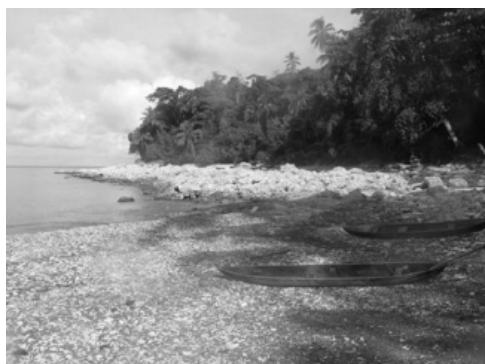
Photo 3.3.10.1 Bleaching coral reef uplifted more than 2.2 m at Suava village

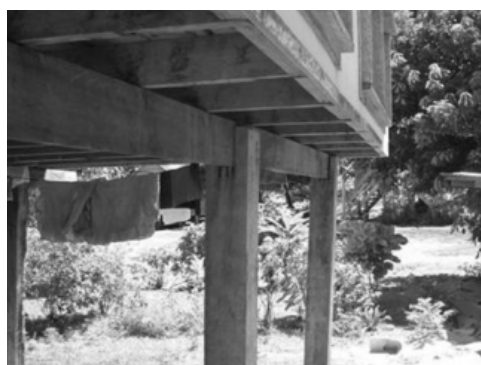
Photo 3.4.2.1 Connection between piers and floor in Sambora.

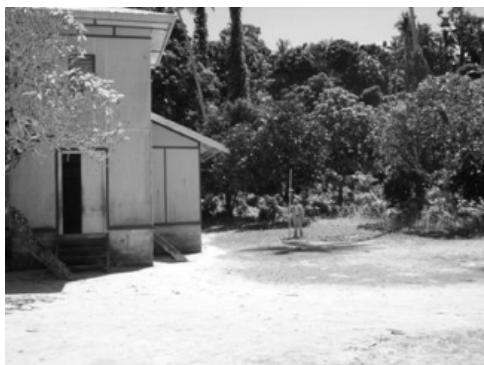
Photo 3.4.2.2 The tsunami runup limit in Sam-bora. The tsunami came up to the standing person in the photo.

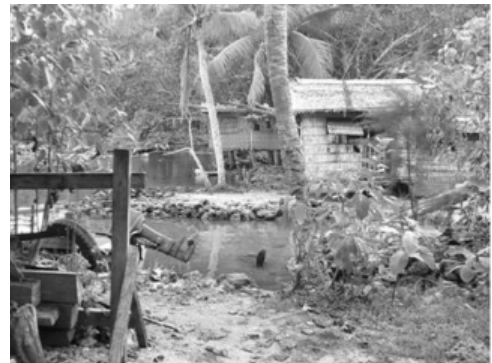
Photo 3.4.3.2 Light tsunami damage in Vonunu

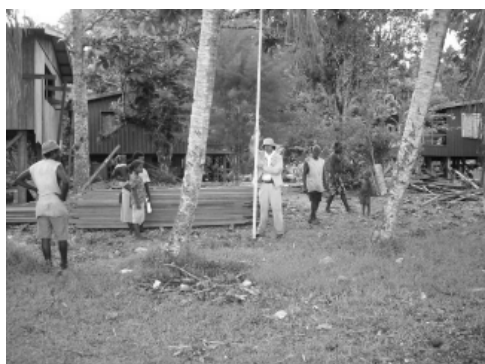
We measured the tsunami height at only Mark 85 in Maravari judged by the debris. At that point, tsunami ran up to the dead leaves line (Photo 3.4.4.1), which was also corroborated by the in-

Photo 3.4.4.1 Tsunami inundation at Mark 85 in Maravari, Vella Lavella Is.

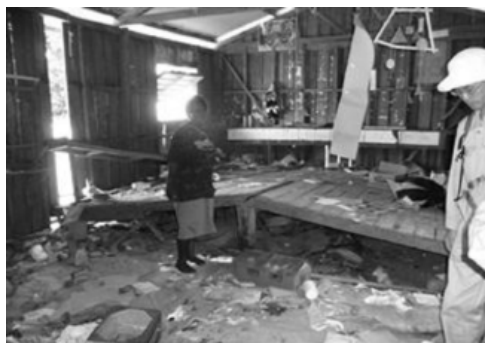
Photo 3.4.12.1 Damaged kindergarten in Pareamata

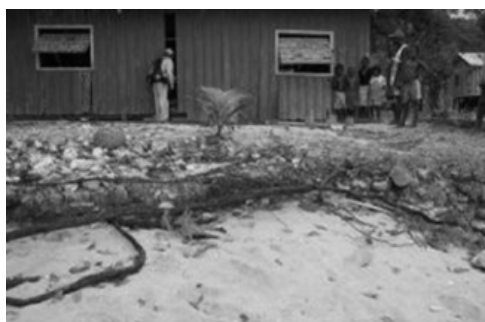
Photo 3.4.12.2 Beach erosion and roots of vegetation to prevent the erosion developing

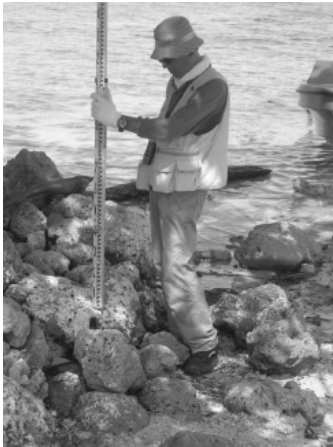
Photo 3.5.2.4 Uplift of ground at Rarumana
