Great Eastern Japan Earthquake 2011

Natori – Sendai Airport (24.03.2011)

Minami Sanriku (25.03.2011)

Onagawa (29.03.2011)

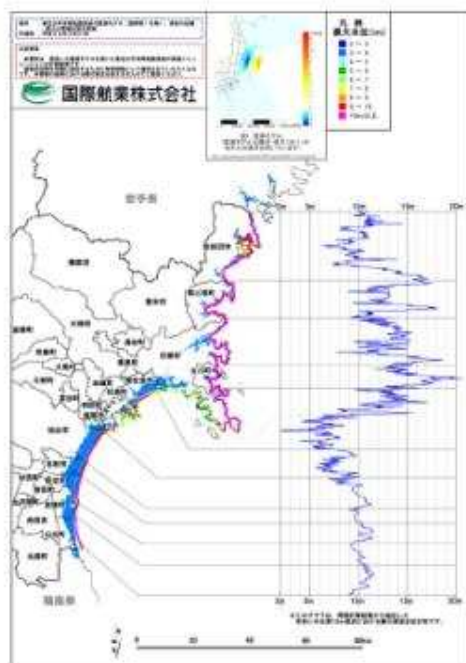
Figure 2.

Tsunami Height Distribution Map.

Natori (Sendai Airport): 10m;

Onagawa: more than 20m;

Minami Sanriku: 18m.

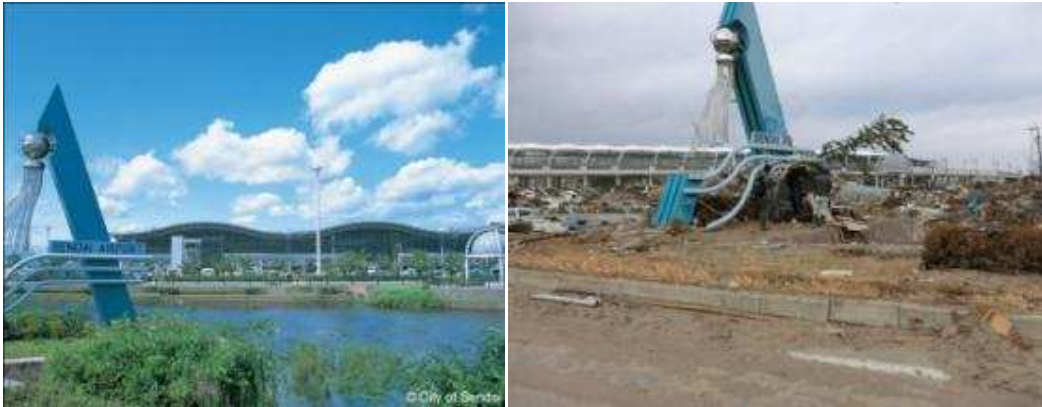
Figure 1. Damages to Sendai Airport (Left: before; Right: after)

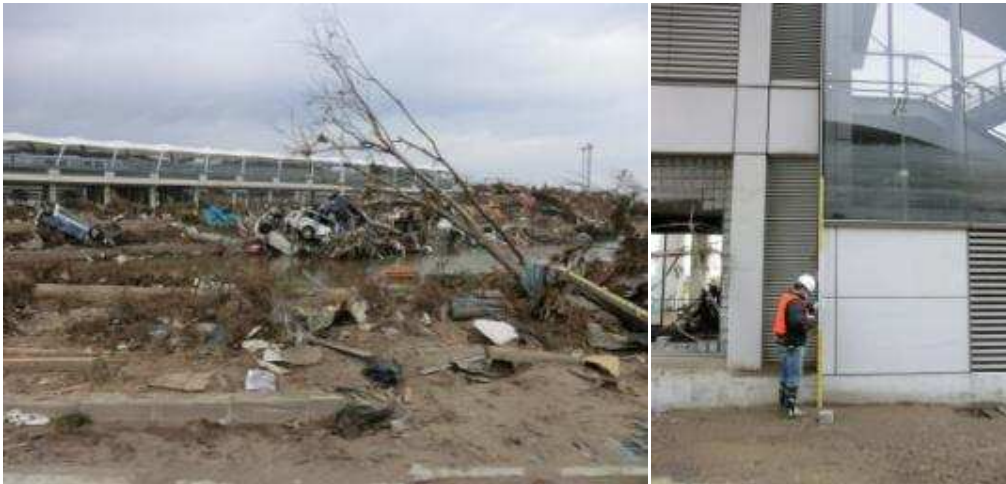
Figure 2. Left: Sendai Airport – International block, view from seaside

Right: Inundation at the back left picture, aprox. 3.5m

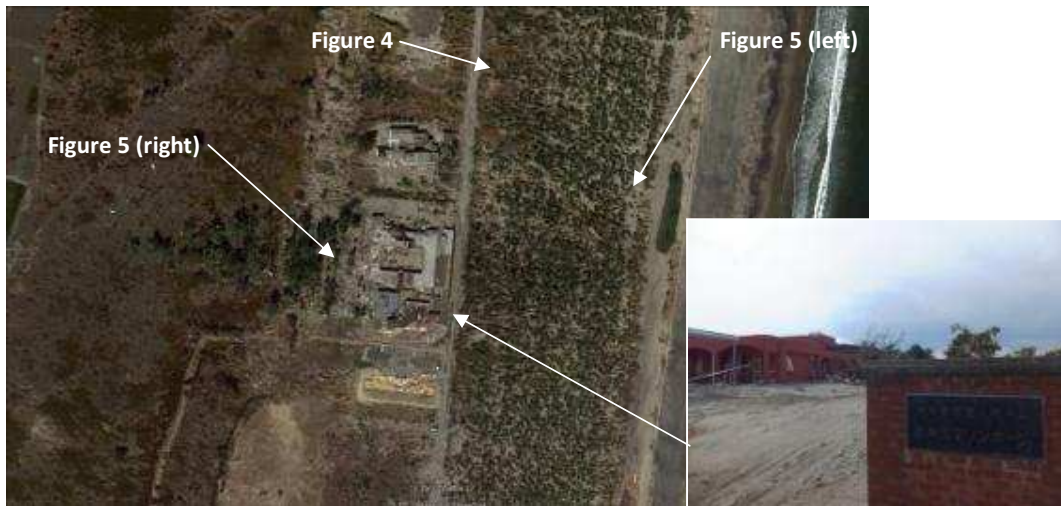
1. Tsunami height aprox. 10m.
2. Inundation limit 4km to 5km.
3. Greenbelt was not enough because some trees were young and not so big.
4. Trees were cracked from roots or at aprox. 40cm from ground on their main branch.

Figure 3. Image from Google Earth, south of Airport. Even the presence of Greenbelt could not stop tsunami damages and inundation into far inland.

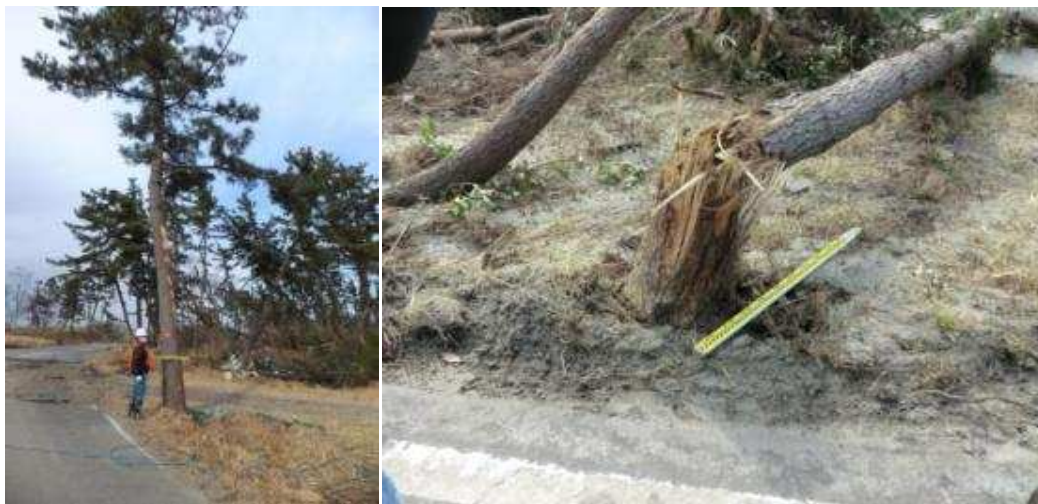
Figure 4. Trees dimensions were measured to assess a resistant threshold in the future.

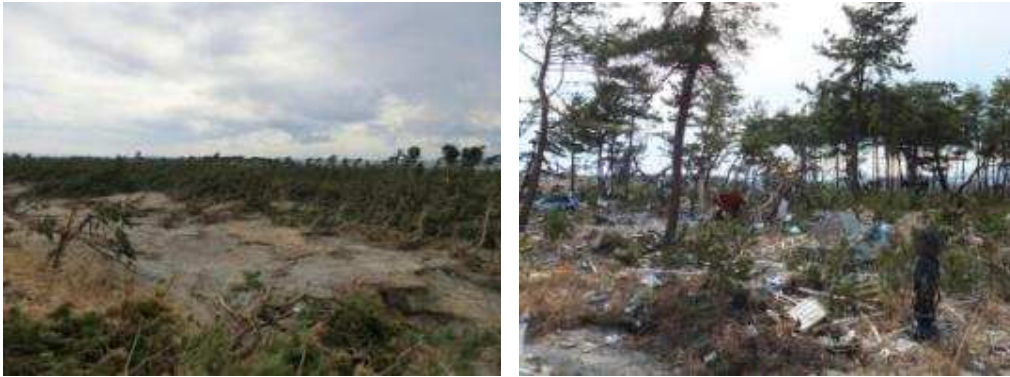
Figure 5. Front of greenbelt and trees at the back of buildings. (see Figure 3)

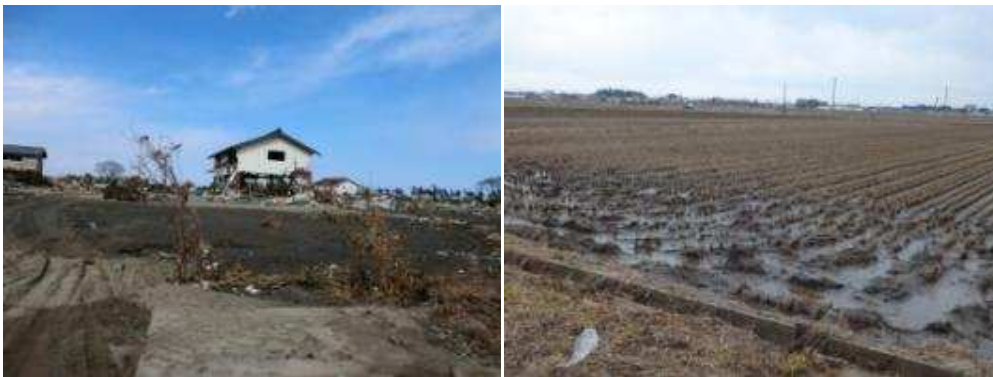
Figure 6. Inundation limits were over the 4km, tsunami traces and fishes were found on the way to confirm the observation.

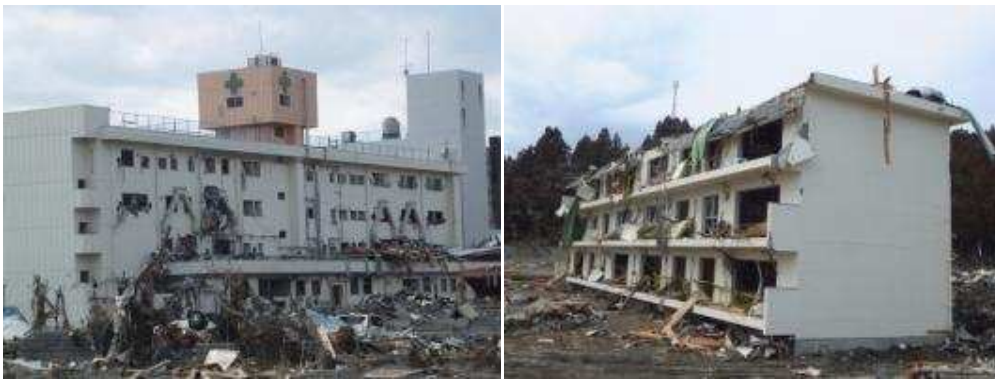
1. Tsunami height aprox. 18m
2. RC Evacuation Building remained after the EQ&T, however 22 persons died here because it was inundated.
3. A monument for past tsunamis of Chile, Showa and Meiji era were washed away, while a 2.6m tsunami monument from Chile T collapsed.
4. Even a school which was designated as evacuation shelter was washed away.
5. Around 10,000 people died and are missing.

Figure 1 Several RC buildings resist the tsunami impact, however almost all of them were inundated at all its floors.

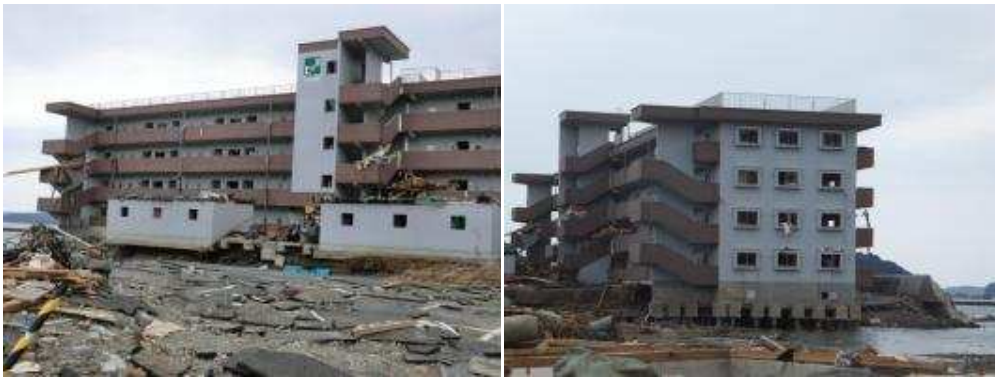
Figure 2. Tsunami Evacuation Buildings resist tsunami impact and saved lives, on the contrary other shelters like a school was washed away.

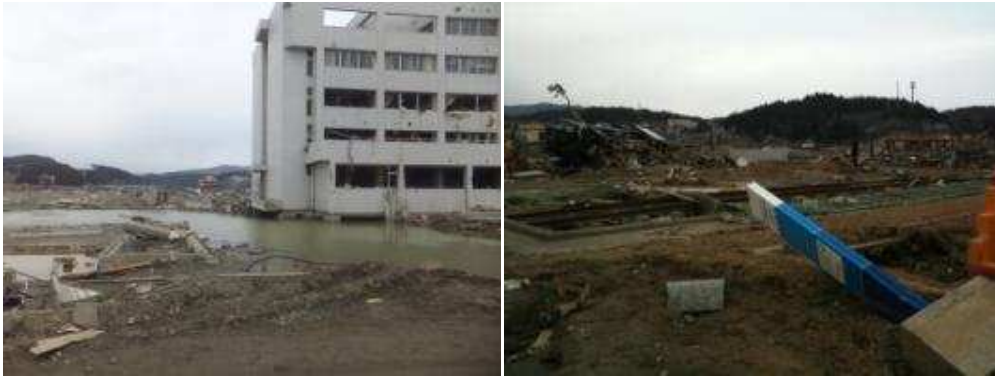
Figure 3 Scour on foundations and other structures like tsunami poles (monument in the right picture) resulted on structural damages.

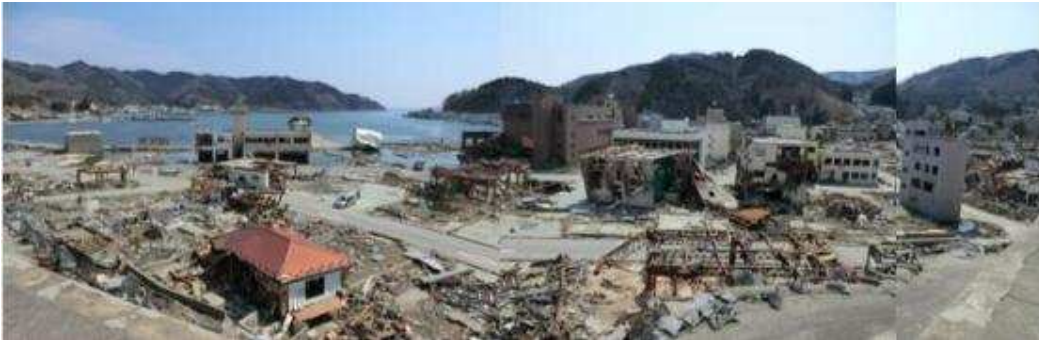
Figure 1. Almost entire city was washed away, only RC buildings stood still, however many of them failed from their pile foundations.

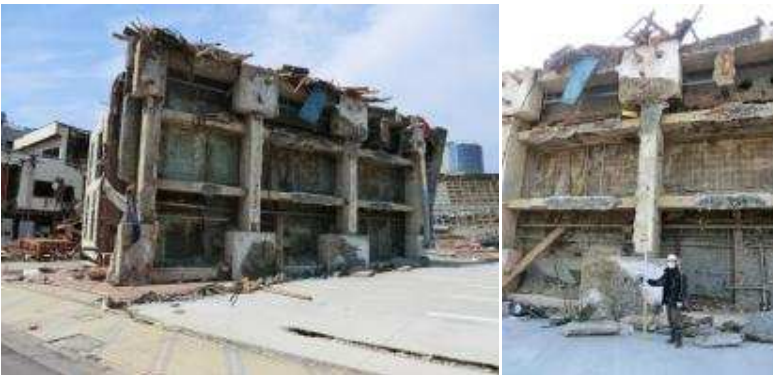
Figure 2. RC building fallen entirely, probably pile foundations failed and tsunami buoyancy force knocked the whole building down.

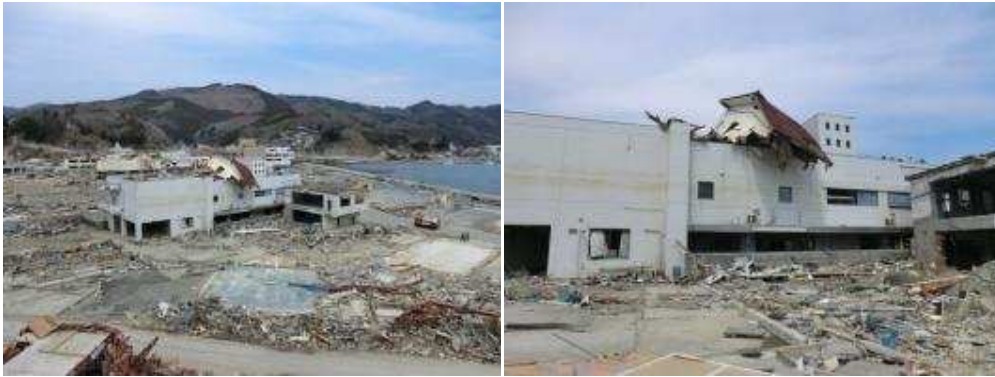
Figure 3. Tsunami inundation overtopped houses and buildings, wooden houses became floating debris.

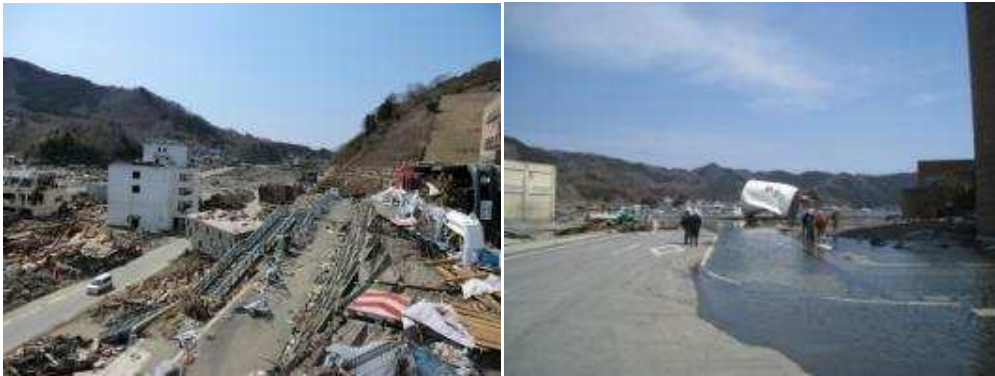
Figure 4. Inundation level went up to the hospital at the hill, even inundating the first floor. In the right picture sea level inland due to subsidence (aprox. 70cm)
