6/4/ 2011 (Wed)

Field survey in Shinchi town, Yamamoto town and Watari town

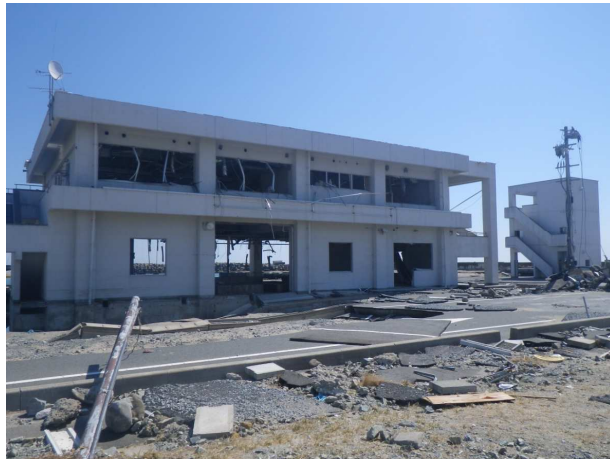
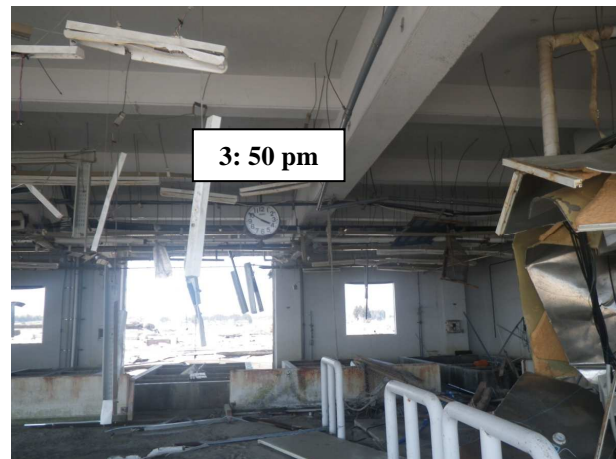
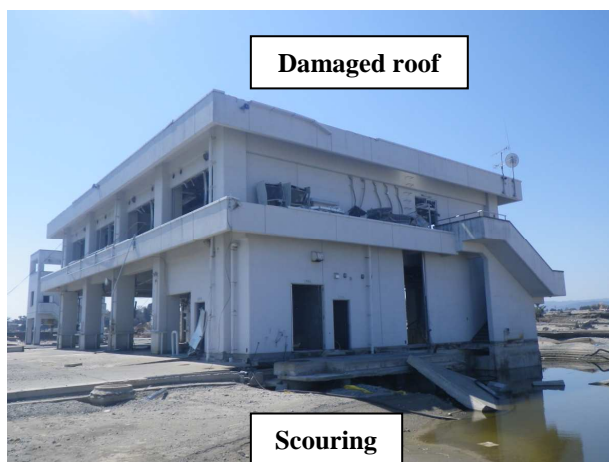
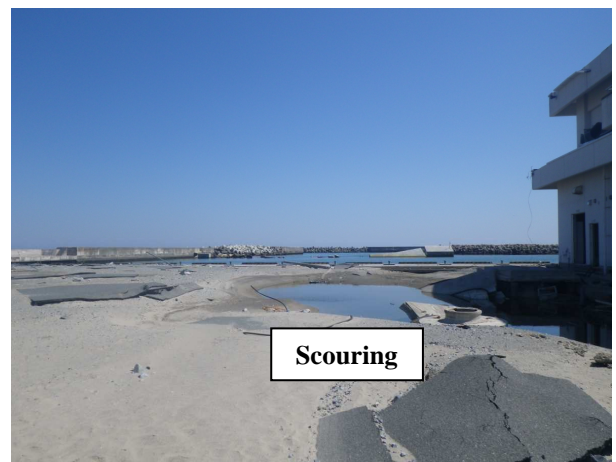
Type: two-story RC frame
 Function: Shinchi fishery cooperative
 Flow depth: higher than 11 m (overtopped)
 Damage: roof, punched wall and severe scouring at foundation
 Location: Latitude = 37.874722 and Longitude = 140.935670

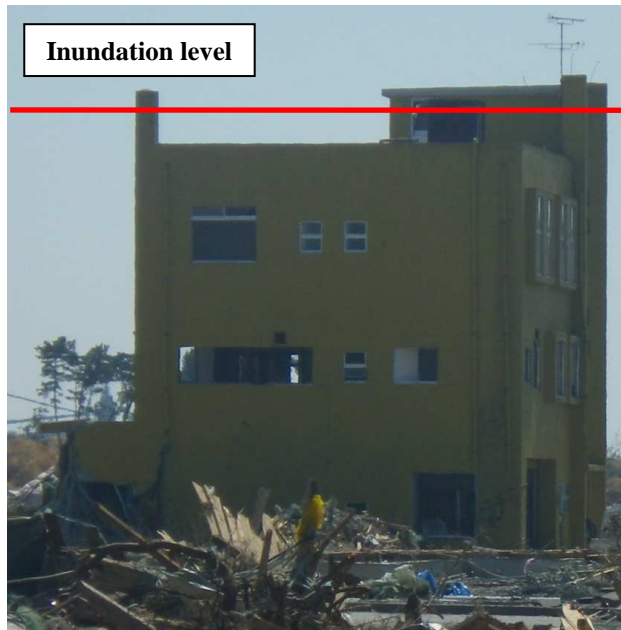
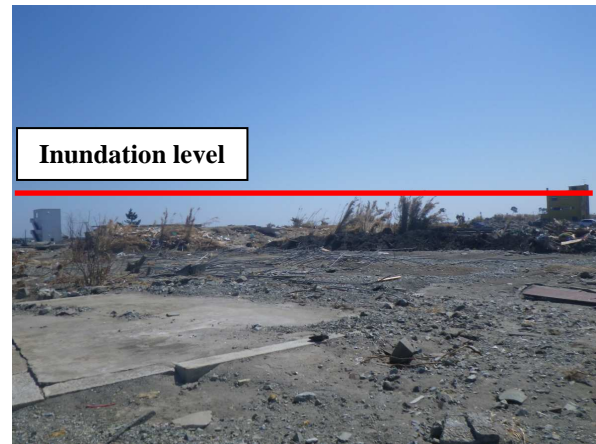
Type: four-story RC frame
 Function: unknown
 Flow depth: 15.42 m
 Damage: punched wall
 Location: Latitude = 37.872899 and Longitude = 140.935009

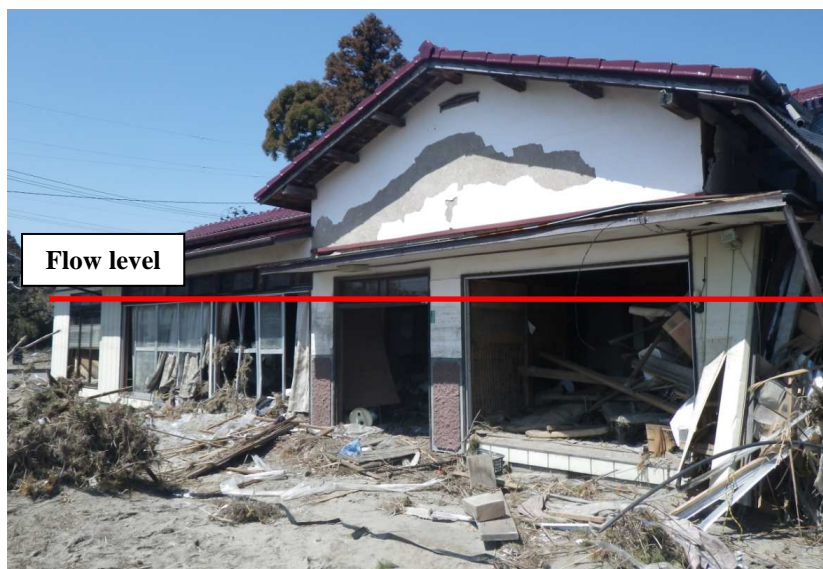
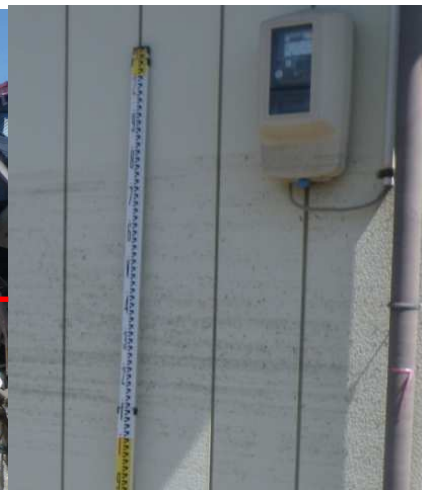
Type: one-story wood frame
 Function: residence house
 Flow depth: 1.77 m
 Damage: punched wall and damaged in some columns
 Location: Latitude = 37.984185 and Longitude = 140.893562

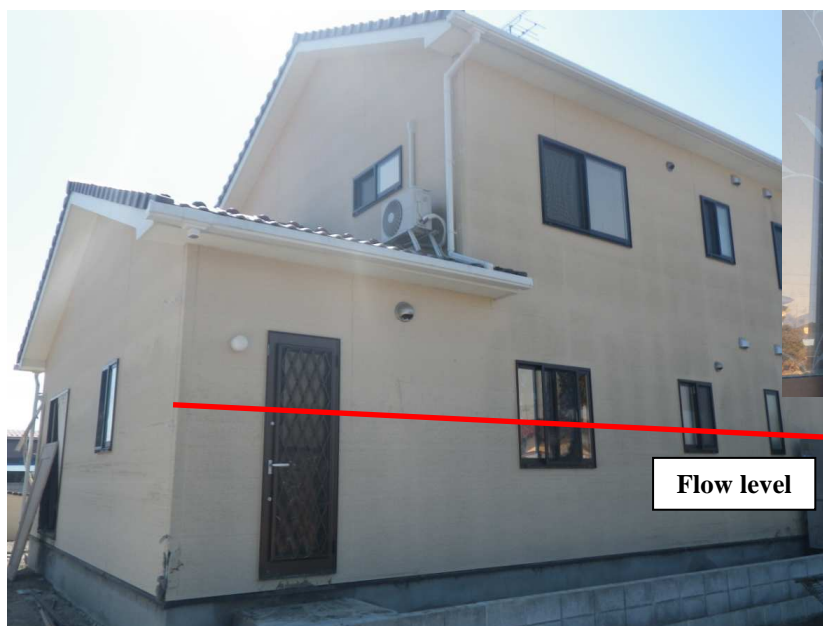
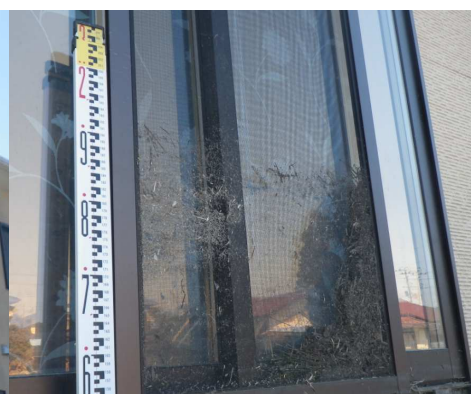
Type: two-story wood frame
 Function: residence house
 Flow depth: 1.94 m
 Damage: no structural damage
 Location: Latitude = 37.983961 and Longitude = 140.893869

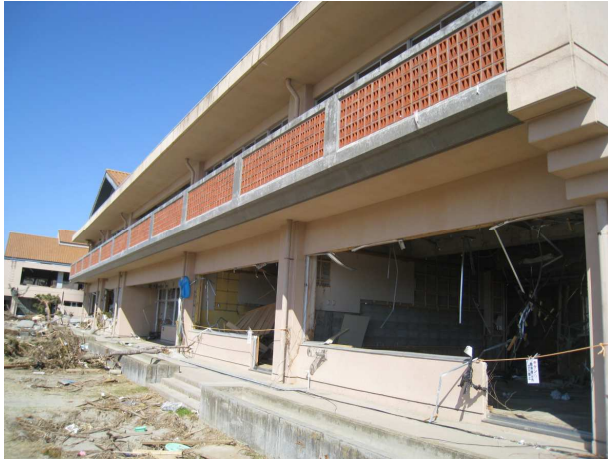
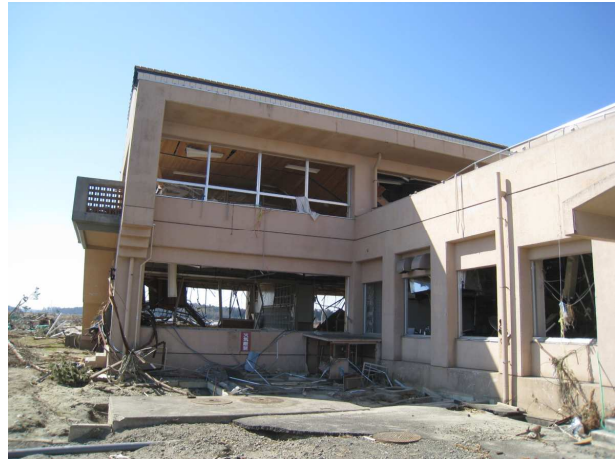
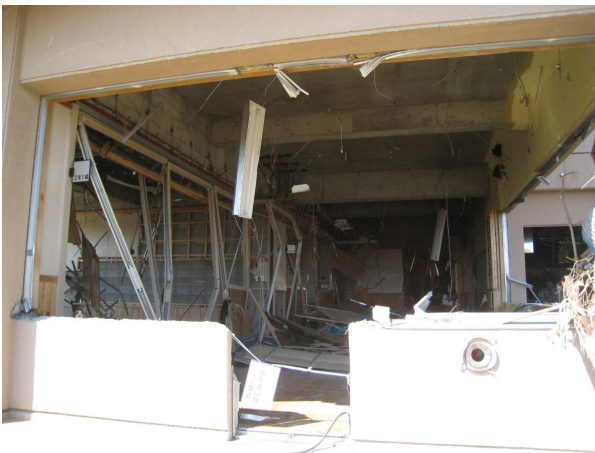
Damaged roof

Scouring

Type: two-story RC frame
 Function: Nakahama primary school
 Flow depth: higher than 10 m (overtopped)
 Damage: punched wall and scouring at foundation
 Location: Latitude = 37.916578 and Longitude = 140.917941

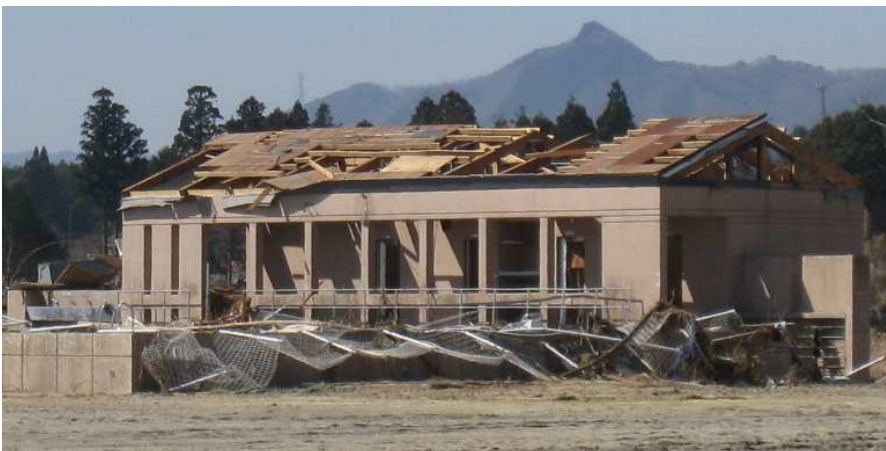
Type: one-story RC frame
 Function: unknown
 Flow depth: higher than (10 m)
 Damage: roof and punched wall
 Location: Latitude = 37.915652
 Longitude = 140.918064

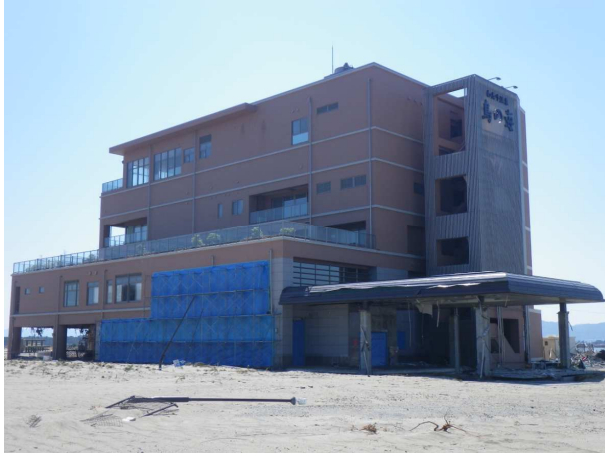
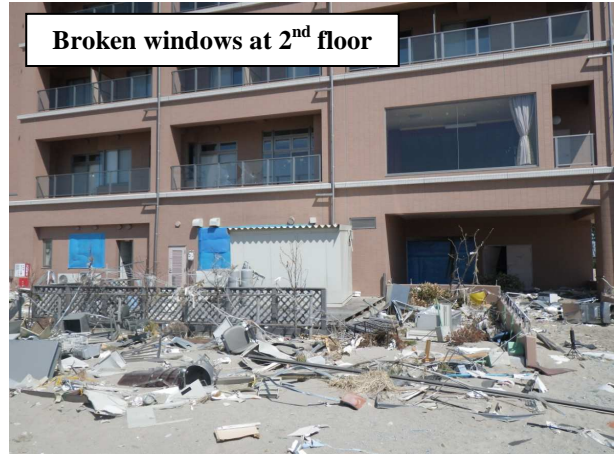
Type: six-story RC frame
 Function: Watari spa Tori no Umi hotel
 Flow depth: unknown (broken window glass until second floor)
 Damage: no structural damage
 Location: Latitude = 38.036667 and Longitude = 140.919089

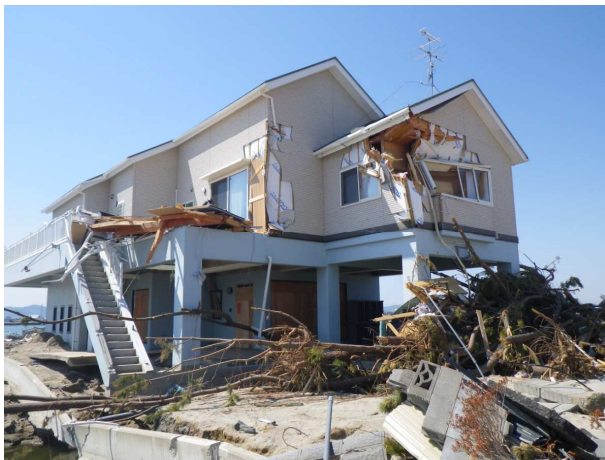
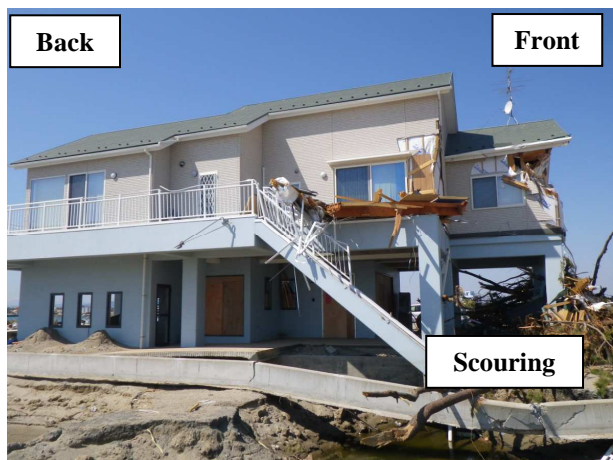
Type: two-story wood frame with RC column
 Function: Residence house
 Flow depth: 8.6 m
 Damage: wall due to tree debris and severe scouring at foundation
 Location: Latitude = 38.036968 and Longitude = 140.917572

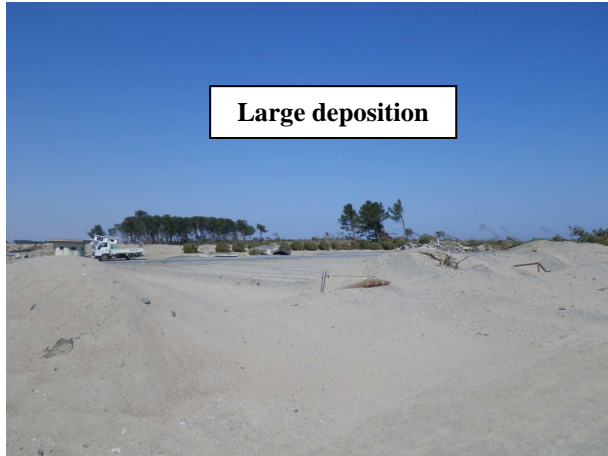
Large deposition

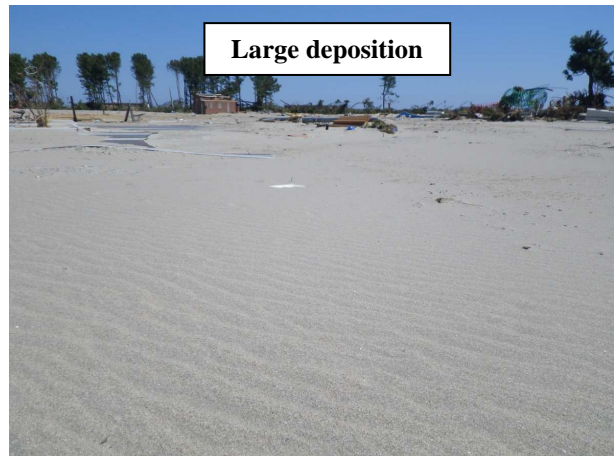
Large deposition

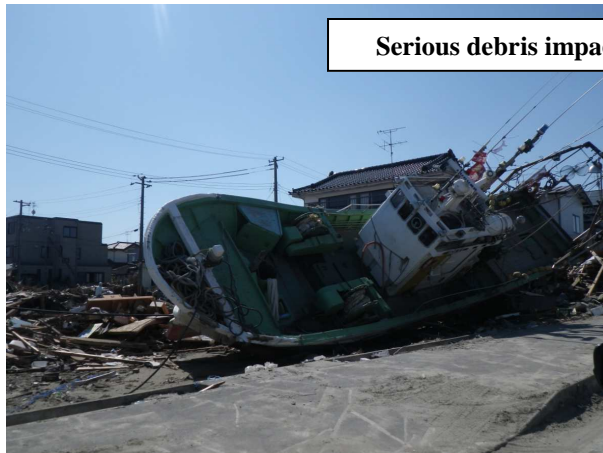
Serious debris impact especially fishing boats
