Damage characteristic of the 2011 Great East Japan tsunami in Miyagi prefecture

SUPPASRI ANAWAT¹, KOSHIMURA SHUNICHI¹, IMAMURA FUMIHIKO¹

¹ Disaster Control Research Center, Tohoku University, Japan

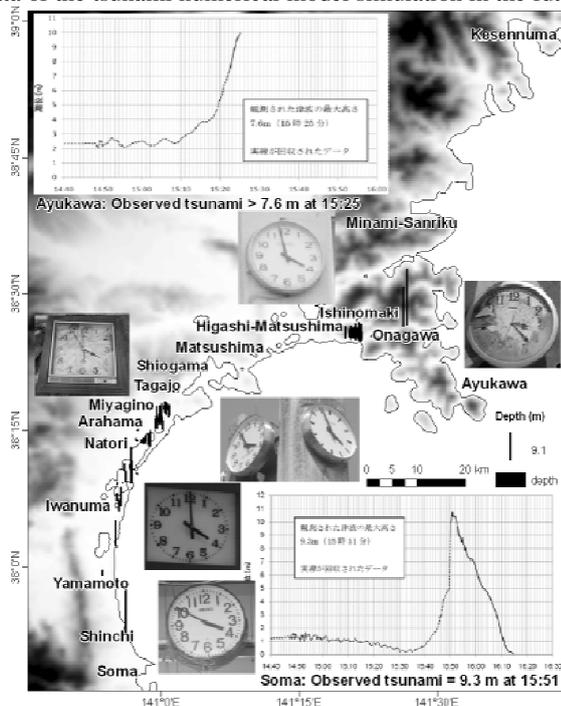
2. Tsunami damage field survey: A tsunami field survey was conducted to investigate the tsunami damage along the coastal areas in the Miyagi prefecture (Fig. 1). Nineteen one-day trips over four months from March to July 2011 were made to complete the general damage survey, structural damage inspection and inundation depth measurements (TTJT, 2011). The purpose of the damage survey was to investigate the impact of the tsunami on coastal structures such as breakwaters, seawalls, control forests, housing and buildings. The damage mechanism for each feature is discussed based on scientific background and compared with the findings of the survey. This investigation will be helpful for future coastal zone development. Tsunami inundation depths were measured as an important feature for developing a damage function and verification data of the tsunami numerical model simulation in the future.

Fig. 1 Measured tsunami inundation depth and arrival time of tsunami arrival from stopped clocks

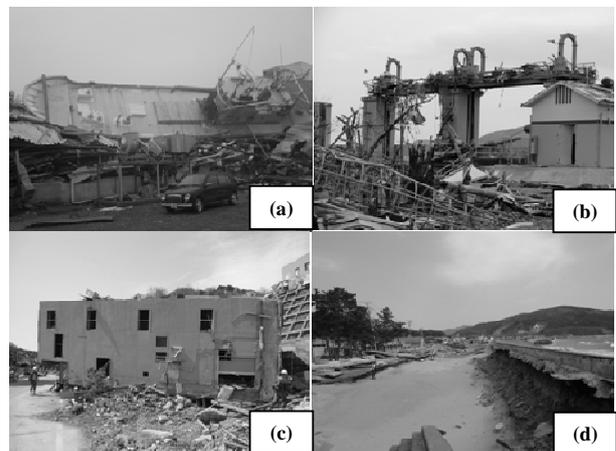
3.1 Sanriku coast areas: Because of the large number of fishing boats near the port, many boats were found stranded among the tsunami debris in Kesennuma city (Fig. 2a). These boats increased the impact load of the tsunami to coastal structures. Around the fishery port, damage to the oil tanks was also observed, in some cases causing fire and burning for four days. A tide station was also found damaged during the survey. Minami-Sanriku town had constructed a tsunami gate, which worked against the 1960 Chile tsunami. However, the 8 m-high tsunami gate was overtopped by 15 m height tsunami and completely destroyed (Fig. 2b). The memorial park for the historical tsunami and high-rise evacuation building is located near the tsunami gate were also destroyed. In Onagawa town, the town hospital, which is located on a hill of 15 m height, was inundated on the first floor with a maximum observed tsunami height larger than 18 m. The most remarkable feature in this area is that six reinforced concrete (RC) buildings were overturned by the tsunami (Fig. 2c). All of them were 2-4 stories high and possessed shallow or pile foundations. The populated area in Ishinomaki city located in a plain-shallow water area and not in the head-on direction of the tsunami propagation experienced a lower tsunami velocity. The city was also protected by breakwaters, seawalls and control forests. Although damage to the breakwaters was not large, the seawalls were seriously damaged by erosion on their back side (Fig. 2d). However, these structures were able to protect the forests behind them.

Fig. 2 (a) Debris impact in Kesennuma, (b) Damaged tsunami gate in Minami-Sanriku, (c) Overturned building in Onagawa and (d) Damaged seawall foundation in Ishinomaki

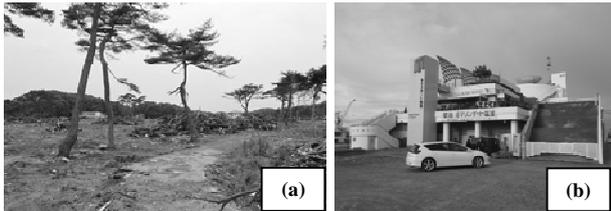
3.2 Matsushima Bay areas: Some locations in Higashi-Matsushima city, the tsunami overtopped and destroyed a seawall because the tsunami came from inland and attacked the backside of the seawall; during a design of the seawall, testing from this direction was not expected because tsunamis are commonly expected to arrive from the sea. The control forest was severely damaged as a large number of trees were uprooted (Fig. 3a). JR train and JR Nobiru station were also damaged. Matsushima town and Shioyama city

are located inside a bay. Approximately 260 tiny islands are located off of Matsushima town that make the town famous for one of the three best coastal views in Japan. Because of the large number of small islands and the shallow area inside the bay, Matsushima town was highly protected by this natural barrier. A low inundation depth and weak current acted resulted in flooding, causing small damage to these areas (Fig. 3b). The average inundation depth was only approximately 2 m. Unlike Matsushima town and Shiogama city, Shichigahama is located next to the Pacific coast and the town was hit by a tsunami height of nearly 10 m. The tsunami caused damage to the breakwaters, seawalls and roads as well as strong erosion.

Fig. 3 (a) Damaged control forest in Higashi-Matsushima and (b) Survived evacuation building in Shiogama

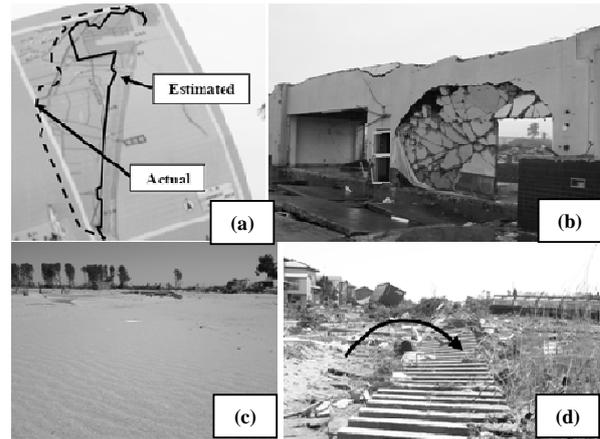
3.3 Sendai Plain areas: Most of the residential areas in Tagajo city are located behind the factory areas of Sendai port and the inundation depths in these areas were not as high. Therefore, a small number of washed-away houses were found. Many factories were damaged by the tsunami. The elevated park located at the center also survived the tsunami. Sand deposits were also found in a river near the JR Tagajo station. The land near a manhole receded by 40 cm. Most houses were washed away in Arahama village. The plain area underwent the maximum inundation distance of 5 km. In fact, the tsunami was accidentally blocked by the highway linking the Tohoku areas to Tokyo. Without this highway, the tsunami might have inundated further inland and caused more impact. The only high-rise building for vertical evacuation to survive the tsunami was the Arahama primary school, which was inundated up to the second floor. Tsunami hazard map (Fig. 4a) information based on the simulation of the Miyagi oki earthquake (M7.5-8.0) and tsunami estimated only 500 m inundation. Tsunami overturned most trees in Yuriage village. Some people evacuated to a shrine on an elevated hill and lost their lives because the tsunami also overtopped the shrine. Fish market was completely destroyed. Damage to an RC wall on the right side represents a common punching failure of an RC structure (Fig. 4b), whereas the non-RC wall on the left side was easier to damage and allowed water to pass through while maintaining the main structure. The Sendai airport stopped its service due to damage on the first floor caused by the 3.5 m of tsunami. Near hot spa in Watari town, the tsunami carried a large amount of sand, which was deposited around the hotel area (Fig. 4c). Fishery boats acted as debris impact and destroyed many houses, similar to events that occurred in Kesennuma city. In Yamamoto town, railway's sleepers made of wood were more heavily damaged (Fig. 4d) and overturned by the force of the tsunami while wooden sleepers with additional concrete sleepers in Higashi-Matsushima survived even the tsunami was higher. In the southern part of the town, most of the houses were washed away.

Fig. 4 (a) Tsunami hazard map in Arahama village, (b) Damaged RC wall in Yuriage village, (c) Large sand deposit in Watari town and (d) Damaged wooden railways in Yamamoto town
