PRELIMINARY REPORT ON THE TSUNAMI CAUSED BY SISSANO THE  
EARTHQUAKE AT, WEST SEPIK, PNG ON 17 JULY 1998

Yoshiaki Kawata\* · Yoshinobu Tsuji\*\* ·  
Hideo Matsutomi\*\*\* · Koji Fujima\*\*\*\* ·  
Fumihiko Imamura\*\*\*\*\* · Masashi Matsuyama\*\*\*\*\* ·  
Tomoyuki Takahashi\*\*\*\*\*

The first investigation on the tsunami caused by the earthquake offshore north-western coast of the Papua New Guinea (PNG) was carried by the Tsunami Survey Team (ITST) during the period of 31 July to 7 August 1998. The survey to the aged area confirmed the 7-10 m wave reported and found the place where the waves were larger-up to 15 m and extreme overland flow velocities of 10 to 15 m/s. The severe damage and extreme wave heights were confined to a relatively short (30 km) stretch of coast between Aitape and Sissano Villages and specially large along the sandbar the outer margin of Sissano Lagoon.

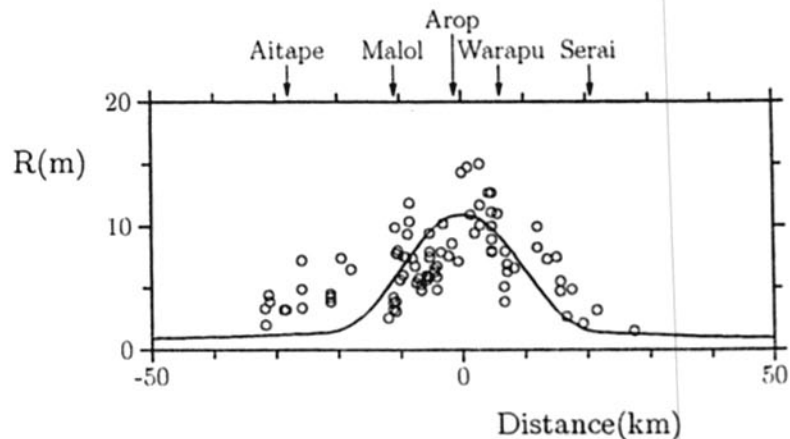
Figure 3 Comparison between theoretical and measured tsunami heights

fundamental study. At the present, about 30 cases of initial tsunami profiles were examined through Fujima's theory by varying several parameters. As a result, it becomes clear that the initial tsunami profile as shown in Fig.2 reproduces the observed distribution of tsunami height well. Length and width of tsunami source area are 40 km and 20 km, respectively. Maximum deviation of water surface from mean sea level is -2.5 m. A minus sign indicates the depression of water surface. And location of maximum deviation point is 20 km off the Sissano Lagoon. Estimated tsunami height distribution is shown in Fig.3

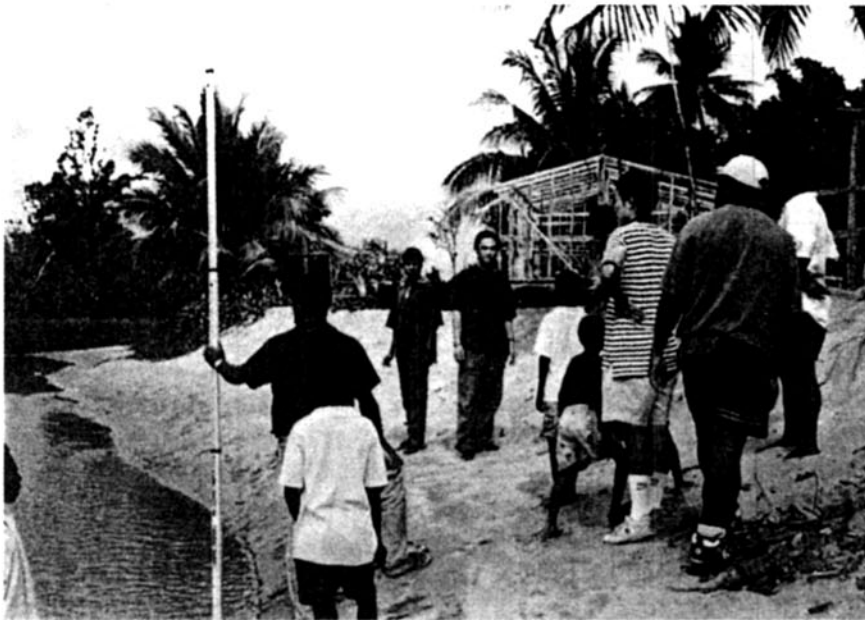
Photo 1 Survey team on the coast measuring tsunami heights after interview and checking marks

Sissano lagoon is fronted on the ocean side by a sand bar with a fairly narrow mouth. The lagoon is almost semicircular with its back side distant about 4 km from the mouth; as seen in figure 1 and photograph 1. At its eastern end there is the village of Arop with the village of Sissano about 1 km west from the lagoon entrance. There was no evidence of any of houses or their remains anywhere along the bar, other than bent 2×2 stilts which were used in their foundations and which were normally vertical. Many of the remaining coconut trees which had not been swept away far into the lagoon were bent close to the roots or had been uprooted. (Photographs 2 and 3.) The average flow depth over the sandbar near the lagoon mouth was 10 m, while near Arop it reached 15 m. Note that it was not possible to determine maximum runup, since the most land ward penetration point was over 4 km away in a swamp where crocodiles had been reported. The team inferred that the

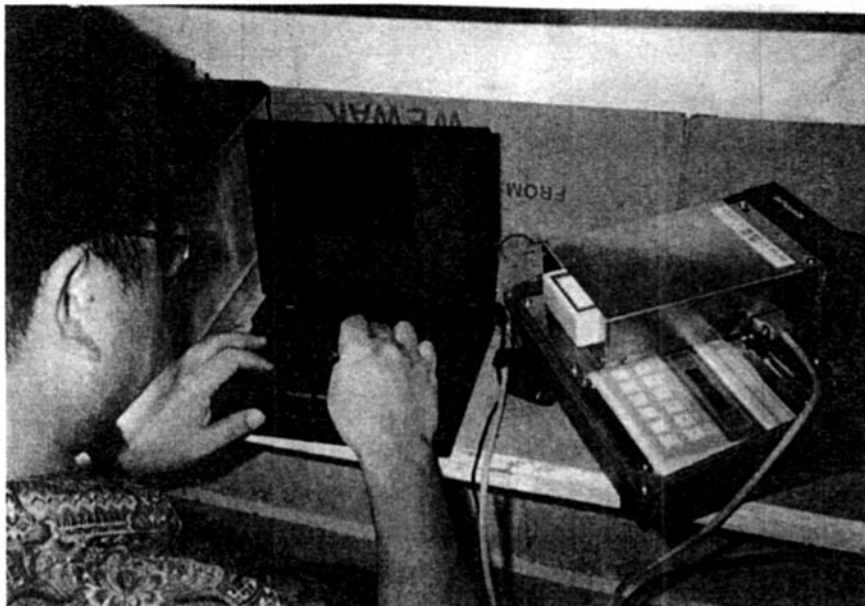
Photo 2 Installing the seismic records with ground acceralation sensors in three components

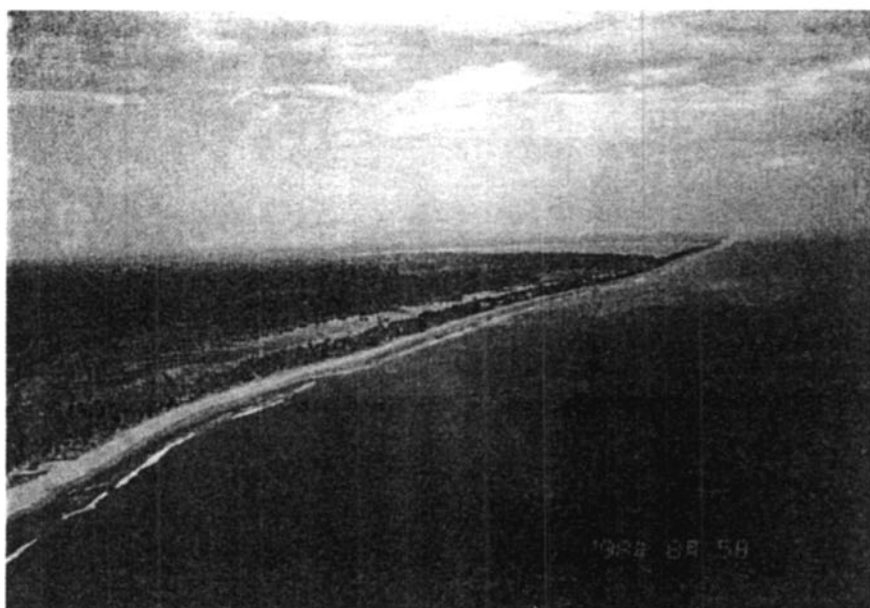
Photo 3 Coastal line nearby the Sissano lagoon taken from the aircraft. In the left of the photo, the water pool is created after the tsunami from Malol to Arop

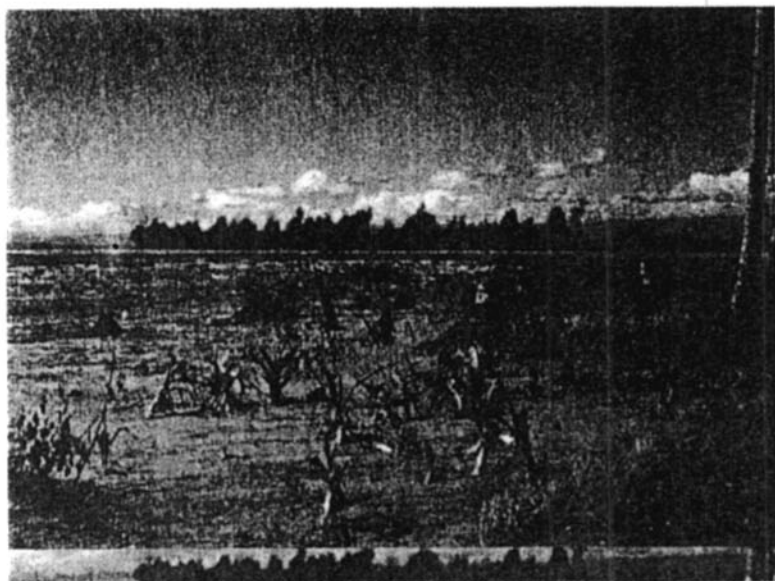
Photo 5 Scene of the damage by the tsunami at Arop village ; nothing are left and bending trees and glasses

However, the wave height varies at different points long the sandbar and was as high as 15 m above the sea level at the former site of the Arop village. In this 1.2 km long sector of the sandbar long sector of the sandbar nothing was left standing now. There was a complete stripping of structures and trees.

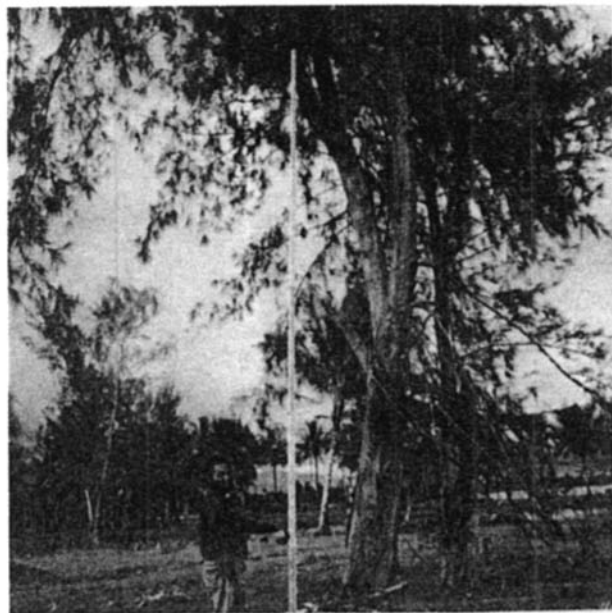
Photo 6 A typical tsunami marks on trees which is a change color of leaves

The average maximum heights of the tsunami waves they crossed the Sissano sandbar was about 10 meters. The wave heights were determined by the team, using tsunami traces and marks such as damaged to the front of coconut plams.

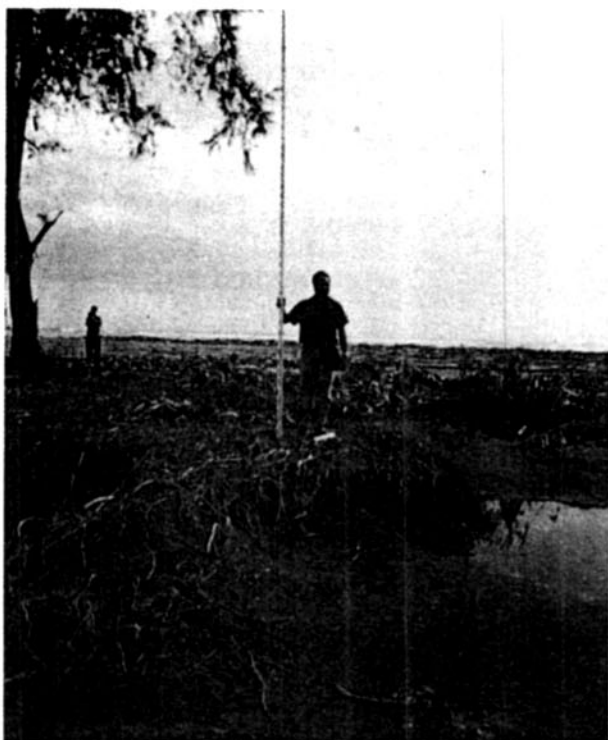
Photo 7 Erosion of sand at the back side of sand bar, due to a strong current

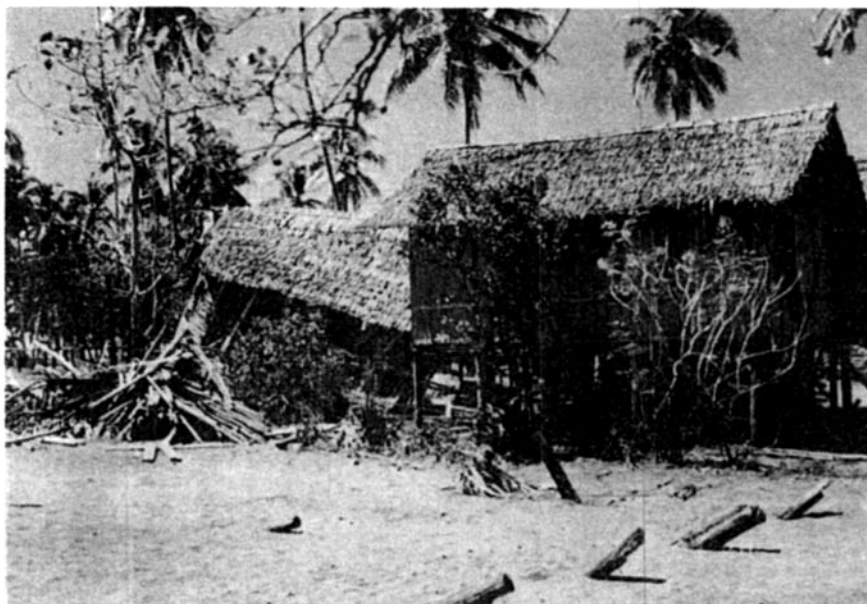
Photo 8 Damaged houses in the left. A house with low floor was swept away. A sheltered house (right) with high floor remains without severe damage

the inundation depth and the degree of damage to houses. Even if the inundation depth is the same, fluid force on houses depends on the Froude number (see Eq. (4b)) and places where the seawater is prone to remain or not. When the degree of damage to houses is discussed by the inundation depth, at least, it is necessary to distinguish between the places. Besides, the degree of damage to houses depends on types of houses. Discussion of it must be done for each type of houses. In the survey, only data of wood house (church) built on flat land at Malol was collected. Figure 5 shows the relation between the inundation depth and the degree of damage to houses. The front depth is adopted as the inundation depth. The degree of damage to houses is classified into three categories:

Destroyed (D.): walls are damaged and most of pillars are damaged. Restoration is not possible.

Partially Damaged (P.D.): pillars withstand, but a part of walls are damaged. Restoration is possible.

Withstood (W.): windows are broken, but pillars and walls withstand. It is possible to reuse with a slight repair.
