The June 23, 2001 Peruvian Earthquake Tsunami :
A Report from the International Tsunami Survey Team 2001 and Numerical Modeling

Shunichi KOSHIMURA*

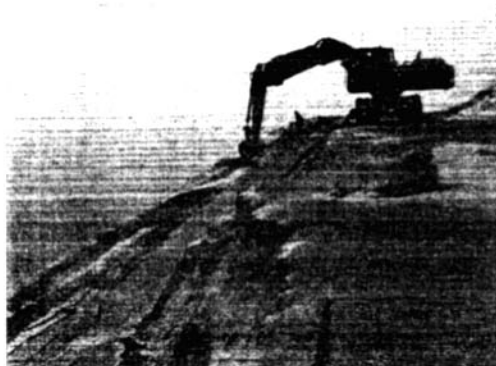
Ocona is a town which locates very close to the earthquake epicenter. The measured tsunami run-up height was less than 3 m at the mouth of Ocona River. The Pan American Highway between Atico and Ocona was significantly damaged by the main shock and the aftershocks (see Figure 3).

Figure 3 Damaged Pan American Highway near Ocona.

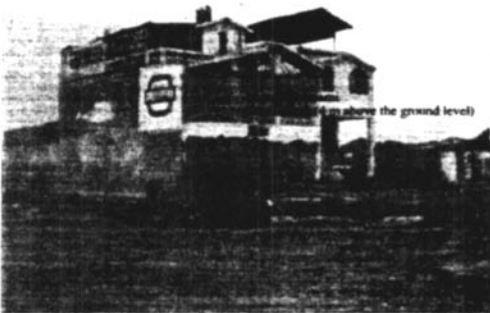
erosion. The maximum measured run-up height at La Punta was more than 7.25 m. Figure 6 is the photo of the hotel building where the maximum run-up in La Punta was measured. The building was standing at approximately 70 m inland from the shoreline. Fortunately, the building withstood the wave force, though it was likely to be struck directly. As well as the other destroyed houses, scouring was occurred in front of the building.

Figure 6 Hotel building struck by the tsunami at La Punta.

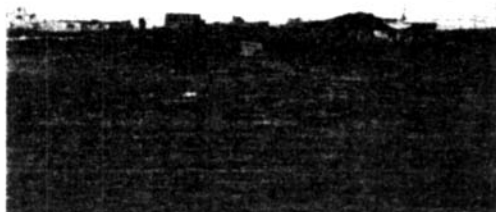
After the inspection at the site, it was found that construction method and quality would significantly affect the survival of the buildings. As shown in Figure 7, poorly built adobe and infilled wall structures were vulnerable for the impact of tsunami. The

structures that survived the tsunami penetration appeared to have deeper foundations and more reinforcing.

Figure 7 Completely destroyed houses at La Punta.

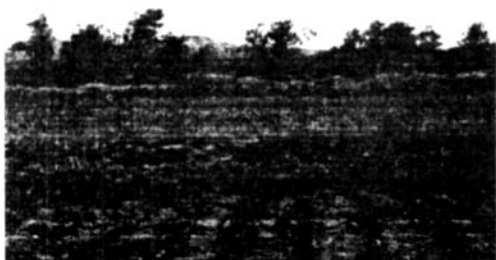
The western part of Camana district was mainly used as farmland, which was developed on the flat topography. At Playa Pucchun, the tsunami penetrated over the large area of the farmland as shown in Figure 8. The final tsunami trace (debris) was found at 1360 m inland from the shoreline. Further west of the developed farmland was the sandy beach. The maximum run-up in the entire region was measured as 8.8 m at Playa la Chira. As shown in Figure 9, the tsunami penetrated through the beach and ran up the steep slope.

Figure 8 Disturbed farmland at Playa Puchun, Camana.

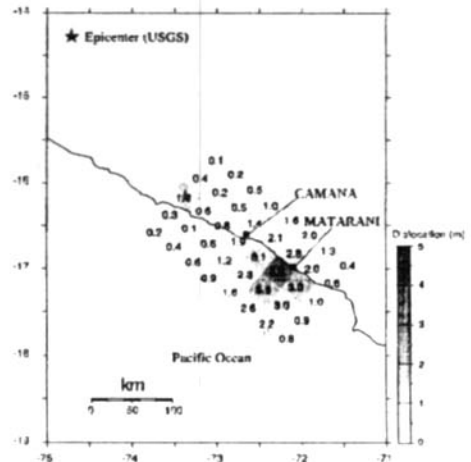
Also, they determined the moment release distribution in detail and slip angles on 40 fault segments within the rupture area of 150 km by 240 km. Figure 11 shows the fault slip distribution within the rupture area, obtained from the results of Kikuchi and Yamanaka (2001). Each fault segment indicates the area of 30 km by 30 km. Large asperity is concentrated at approximately 150 km south from the initial break point (epicenter). However, because their analysis is based on the teleseismic waves, the estimate of the location of epicenter should be flexible, considering the observation of the local seismic defor-

Figure 11 Fault slip distribution within the rupture area.
