A summary of the rapid response and analysis of tsunami on April 1st, 2014

Fumiyasu Makinoshima*, Masashi Watanabe*, Atsushi Tanobe*,
Suppasri Anawat**, Abdul Muhari**, Kentaro Imai**, and Fumihiko Imamura**

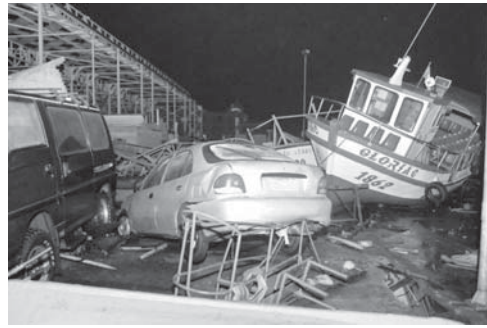
Fig. 3 Tsunami damages in Iquique, Chile (ABC News)

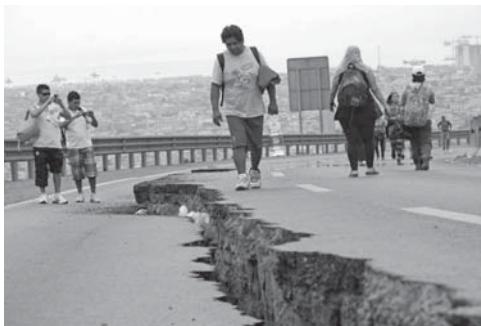
Fig. 4 Ruptured road in Iquique (ABC News)

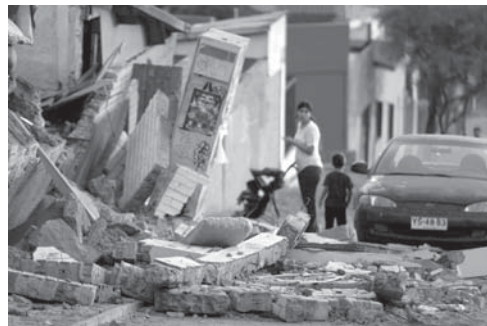
Fig. 5 Collapsed home in Iquique (ABC News)
