# Evaluation of Bathymetric Changes due to Tsunami at Kirinda Harbor, Sri Lanka

RANASINGHE PRASANATHI LANKA<sup>1</sup>, GOTO KAZUHISA<sup>1,2</sup>, IMAMURA FUMIHIKO<sup>1</sup>, TAKAHASHI JUN<sup>3</sup>

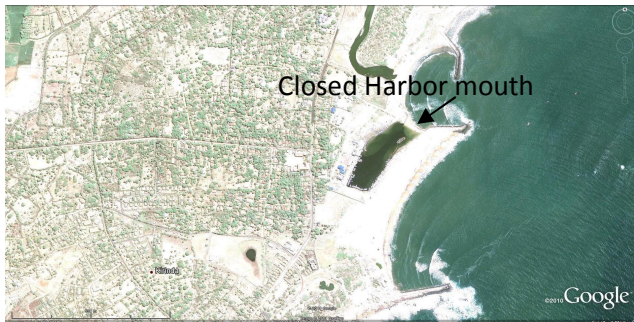
Figure 1: Kirinda fishery harbor-2009(Google Earth)

**Introduction:** Kirinda fisher harbor is located in southern coast of Sri Lanka. Since 1985 when it was constructed, it has the problem of keeping the harbor entrance open due to the unusual sediment transport pattern. Several studies were carried out to identify this scenario at Kirinda fishery harbor and some modifications also were introduced. Extending of the Main Break Water (BW), introducing secondary BW at the north side and a groyne at southern side were the major modifications which had done to reduce the sand intrusion into the harbor. Unfortunately these solutions were also not enough to solve this sedimentation problem. Up to 2004 tsunami event, the siltation problem at the mouth was remained same. Once tsunami waves hit the Kirinda coast, there was a remarkable bathymetric change in the harbor area including the washout of sediment at the harbor entrance. However, the currently siltation problem at the harbor mouth is back to the same situation as before the tsunami (Figure 1).

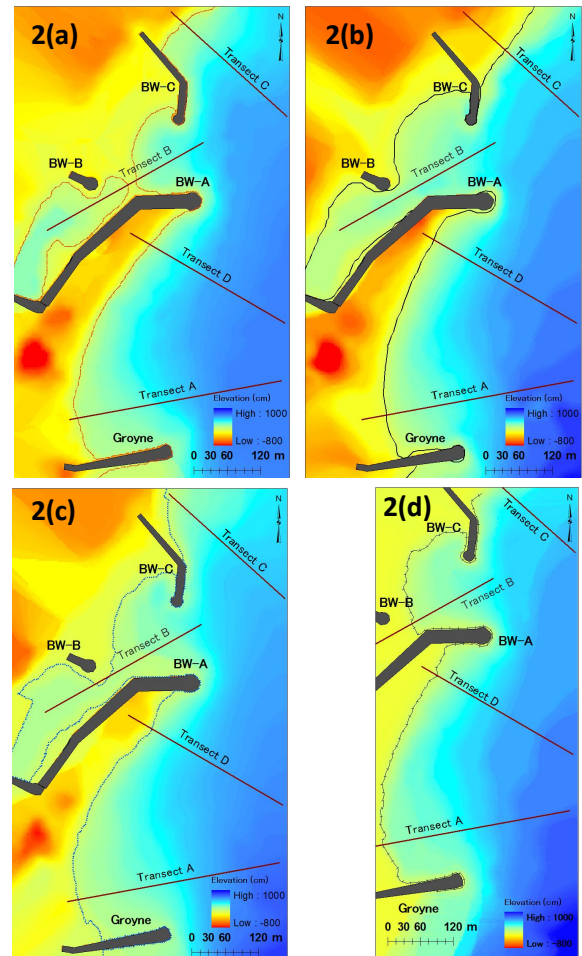
Figure 2: Bathymetry Data (2a: 2004Nov, 2b: 2005Feb, 2c: 2005Nov and 2d: 2006Feb)

**Review of the bathymetric changes:** 2004Nov bathymetry reveals that the complete blockage of the harbor mouth due to the siltation and huge sand accumulation along the BW-A (main) as well as between the BW-B and BW-C. However, by 2005 February, harbor entrance was totally eroded and some accumulation could

be seen in north of the BW-C (Goto et al., in press). The 2005Nov bathymetry shows the redeveloping of the siltation at the mouth, while eroding the accumulated sand above the BW-C (Goto et al., in press). Finally, all the activities of harbor were disturbed by 2006 February, as the result of completely close of harbor mouth.

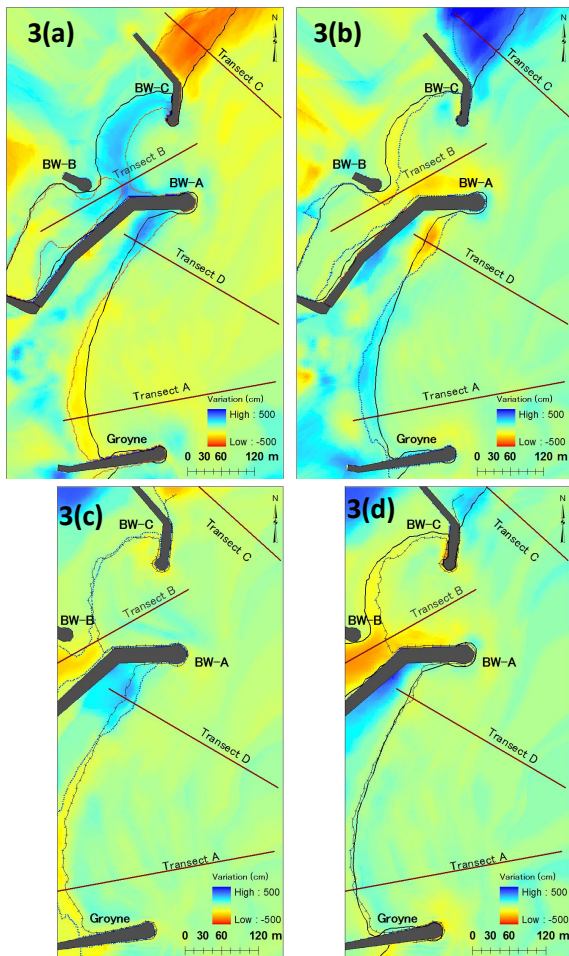
Figure 3: Bathymetry variation (3a: 2004Nov-2005Feb, 3b: 2005Feb-2005Nov, 3c: 2005Nov-2006Feb and 3d: 2005Feb-2006Feb

**Discussion:** The 2004 tsunami was able to wash the sand deposition at the harbor mouth as well as the sand which was along the BW-A. Furthermore, it could be seen that high deposition near the BW-C (Figure 3a), while some deposition in nearshore area as well (Goto et al., in press). During the south west monsoon season, nearshore bathymetry (4m to 7m below mean sea level) was getting somewhat deeper, indicating the significant erosion near the BW-C. However, the surrounding area at the harbor entrance was swallowed in the same period. There could be some influence by inter monsoon as well, since this period is covered March- November (Figure 2b). In NE monsoon period (Figure 3c), bathymetry change became as an opposite of that in SW monsoon in 2005 (Figure 3b).

However, in the harbor month still could be seen the increase of the sand deposition (Figure 3c). Influence of the normal waves is indicated by Figure 3d which shows the changes from 2005Feb-2006Feb. One year after 2005Feb, shore line back to the same position in between BW-A and the groyne. During this one year period, net deposition has occurred in the harbor whereas net erosion has occurred near the BW-C and, along the BW-A.

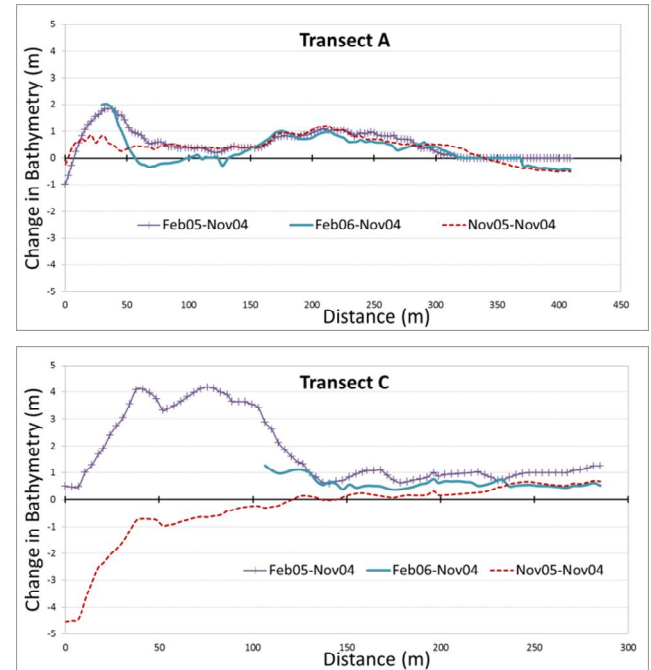
Figure 4: Variation along Transect A and C at 2 months, 1 year and 1  $\frac{1}{4}$  years after the tsunami

**Conclusion:** Tsunami has changed the Kirinda existing bathymetry instantly by eroding the harbor entrance and depositing the sediments in the harbor as well as the nearshore area. North sides of the BW-C and the groyne were eroded by south west monsoon waves while north east monsoon has created the accretion in the same area. Siltation at the harbor entrance has occurred in all over the year in more or less amount due to the normal wind waves. At the southern part of the harbor, shore lines were coincided in 2005 February and 2006 February, even though the shoreline has under gone some variation during the monsoon periods (Figure 3d). Normal wind waves were unable to recover the pre-tsunami condition even more than one year after the tsunami in some locations in nearshore area (Figure 4).
