Damage and reconstruction after the 2004 Indian Ocean tsunami and the 2011 Great East Japan tsunami

Anawat SUPPASRI*
Abdul MUHARI*
Prasanthi RANASINGHE*
Erick MAS*
Nobuo SHUTO*
Fumihiko IMAMURA*
Shunichi KOSHIMURA*

*International Research Institute of Disaster Science, Tohoku University, Japan

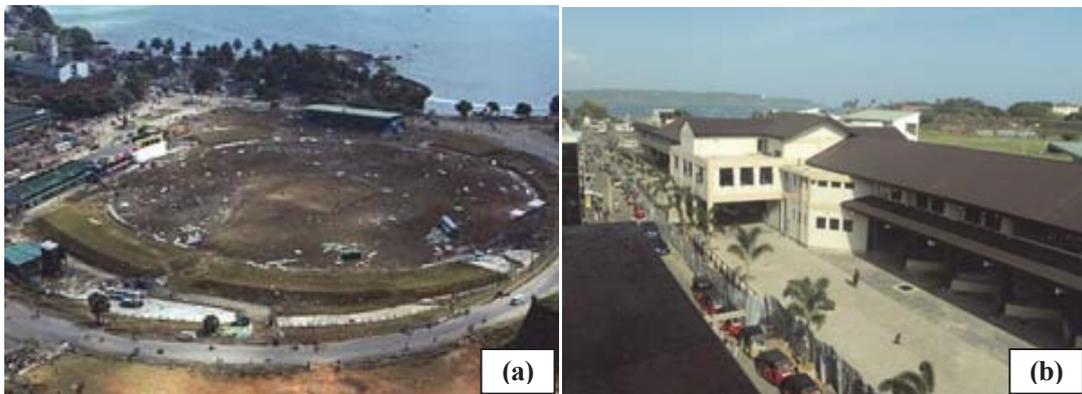
Figure 3. (a) Galle International Stadium (29/12/2004) and (b) Galle bus terminal (7/2011)

However, the most noteworthy damage was that near Peraliya, where the tsunami surge overturned and submerged a Galle-bound train, killing over one thousand people. Galle International Stadium, which is considered to be one of the most picturesque cricket grounds in the world, is situated near the Galle fort and surrounded on two sides by the Indian Ocean. The Stadium was destroyed (Fig. 3a) in the 2004 tsunami but was rebuilt and hosted international matches again in 2007. The Galle bus terminal was totally destroyed in the tsunami, claiming thousands of lives. A temporary bus stand was built after the calamity as a temporary measure, and work on a new modern bus stand commenced in October 2010 and was handed over to the public in July 2011 (Fig. 3b).

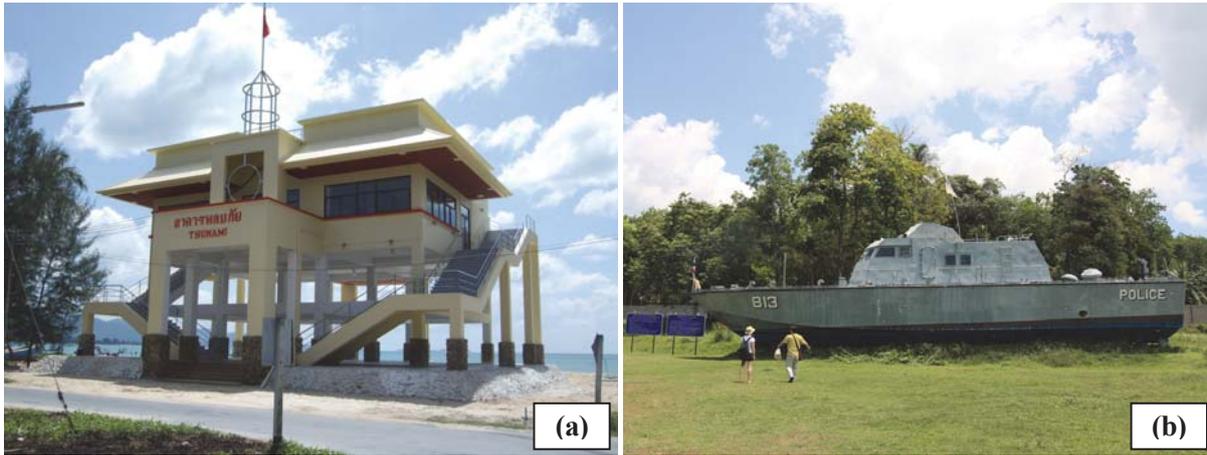
Figure 6. (a) Tsunami evacuation building in Phang Nga (5/11/2009) and (b) patrol boat from the 2004 tsunami in Phang Nga (19/3/2009)

In Pakarang Cape, Phang Nga, an evacuation shelter near the beach (Fig. 6a) was constructed in 2010 in accordance with shelter regulations stating that the distance to a safe zone must be greater than 1 km when there is no greenbelt to dissipate tsunami energy. In Khao Lak, the patrol boat that was in charge of protecting the royal family on their vacation was brought approximately 2 km inland by the tsunami (Fig. 6b). That boat was also kept in place as a symbol of the tsunami, and a small tsunami gallery was built nearby.

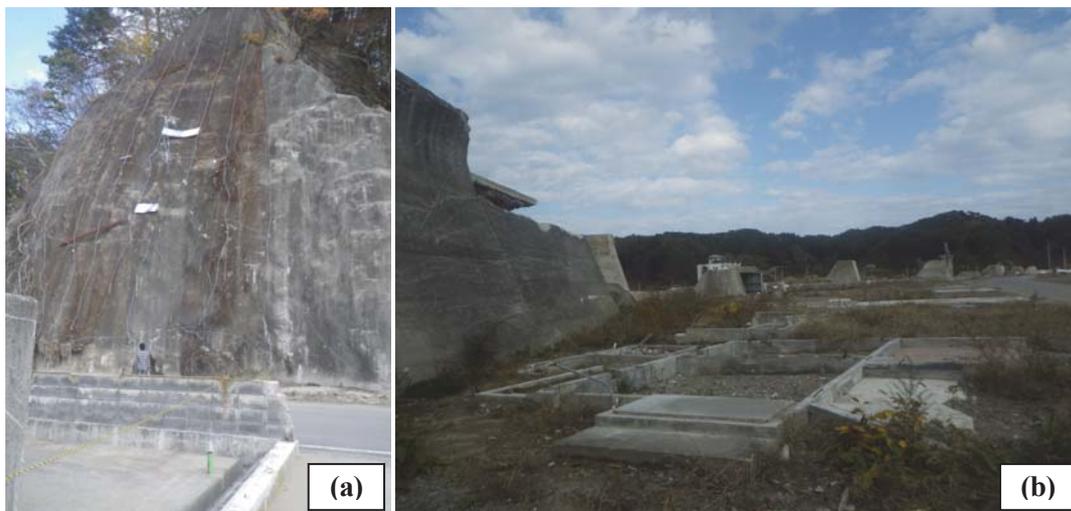
Figure 7. (a) Height records of historical tsunamis in 1896 (15 m) and 1933 (10 m) in Taro village (9/11/2011) and (b) destroyed seawalls (9/11/2011)

Taro is a typical example within the areas hit hardest by tsunamis in 1611, 1896 (15 m high) and 1933 (10 m high) (Fig. 7a). In 1934, the town constructed two lines of seawalls 10 m high above mean sea level with a total length of 2.4 km. In the 1970s, the village constructed another two lines of seawalls 10 m high to accommodate the increasing population. Both sets of walls were designed considering only the 1933 tsunami. The actual purpose of the seawalls was not to totally stop a tsunami similar to the event of 1896 but to mitigate such a tsunami. The population's tsunami awareness went down when the second line of seawalls was constructed because the inhabitants felt more secure behind the double construction.

The seawalls worked very well during the 1960 Chile tsunami, and the village became famous as the best tsunami disaster prevention area in Japan. However, the 2011 tsunami overtopped these two-line seawalls, and the eastern part of the new seawalls deteriorated (Fig. 7b). The main reasons why the seawalls were destroyed were that the two seawalls were crossed in an X shape, which concentrated the tsunami at the center of the seawalls; the foundations were weak and unstable because they were located near the river; and the seawalls were not maintained properly or adequately connected to one another (Suppasri et al., 2012c).

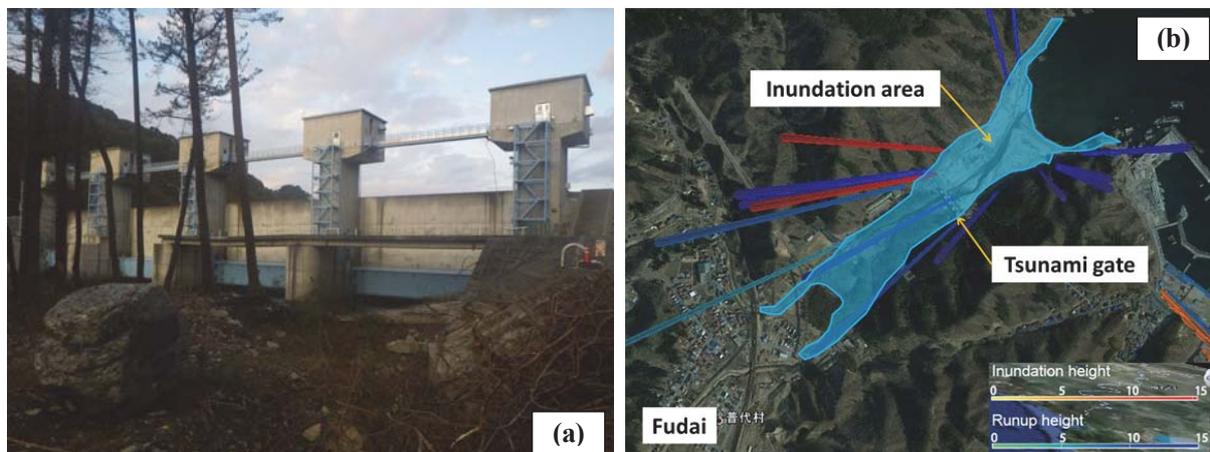
Figure 8 . (a) Tsunami disaster prevention memorial (rock on the lower left) behind the tsunami gate in Fudai village (9/11/2011) and (b) location of Fudai, its tsunami gate and tsunami inundation area

Fudai was developed along the Fudai River, and it suffered during the 1896 and 1993 tsunamis, which flooded this river. In 1984, tsunami gates 15.5 m high were constructed to close the river mouth in case of a tsunami. The 2011 tsunami was 17 m high at the gate and overtopped it but inundated only a few hundred meters of land behind the gate (Fig. 8a). The majority of Fudai village, including its evacuation shelters (located in primary and secondary schools), was protected and no loss of human life was reported (Fig. 8b).

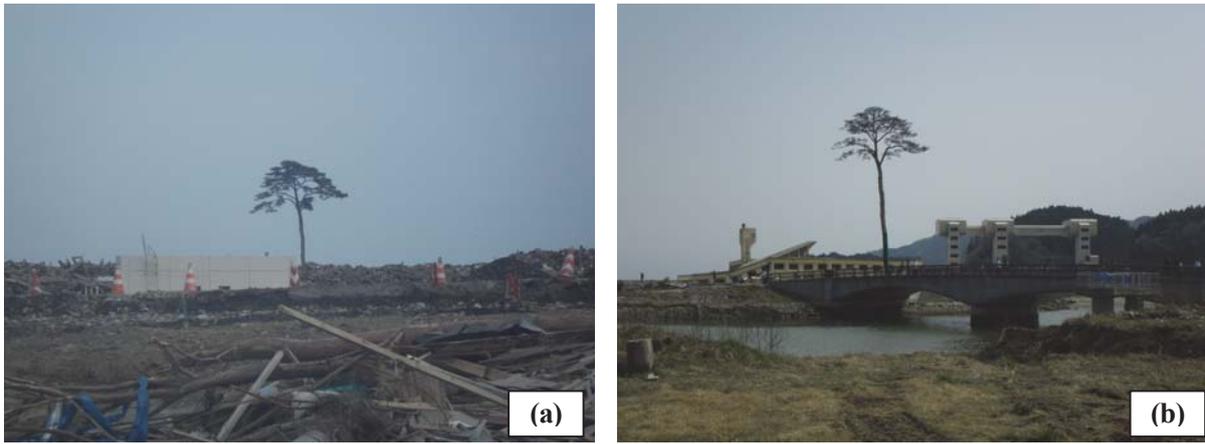
Figure 9 . (a) The only pine tree remaining of the 70,000 trees in Rikuzen-Takata (a) after three months (1/6/2011) and (b) after one year (29/4/2012)

This city is well known for its Takata-Matsubara region, a 2-km stretch of shoreline that was lined with approximately seventy thousand pine trees. In 1940, it became a designated cultural property of Japan. Such a control forest could withstand a tsunami up to 3-5 m, but the measured height of the 2011 tsunami was 19 m. As a result, only one tree, 10 m tall and two hundred years old, remained and the city behind the forest was completely destroyed (Fig. 9). This tree became the city's symbol of reconstruction.

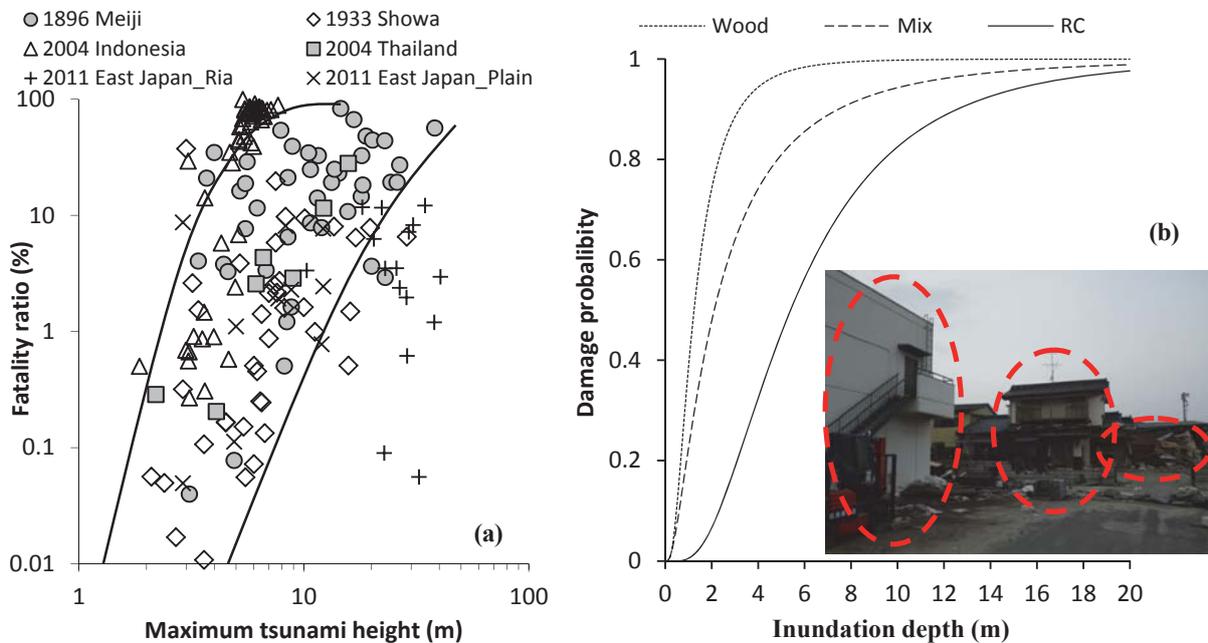
ings at this depth. In general, one good example of the impact of tsunamis on three different house types is shown in Ishinomaki city (Suppasri et al., 2012b). Although three houses were inundated at the same depth of 4 m, the damage to each house is totally different. The RC two-story office had broken windows but no structural damage. The two-story wooden house had damage to some walls and columns. The one-story wooden house totally collapsed. The tsunami fragility curve developed from previous tsunamis shows that

the possibility of damage at a 4-m inundation depth to an RC house, a mixed RC and wooden house and a wooden house is 0.3, 0.7 and 0.9, respectively, as shown in Fig. 10b (Suppasri et al., 2011).

Figure 10 . (a) Comparison between the tsunami fatality ratio from this event and from other historical events in Japan and the 2004 Indian Ocean tsunami and (b) damaged condition of an RC building, two-story wooden house and one-story wooden house under the same inundation depth of 4 m in Ishinomaki (26/4/2011)

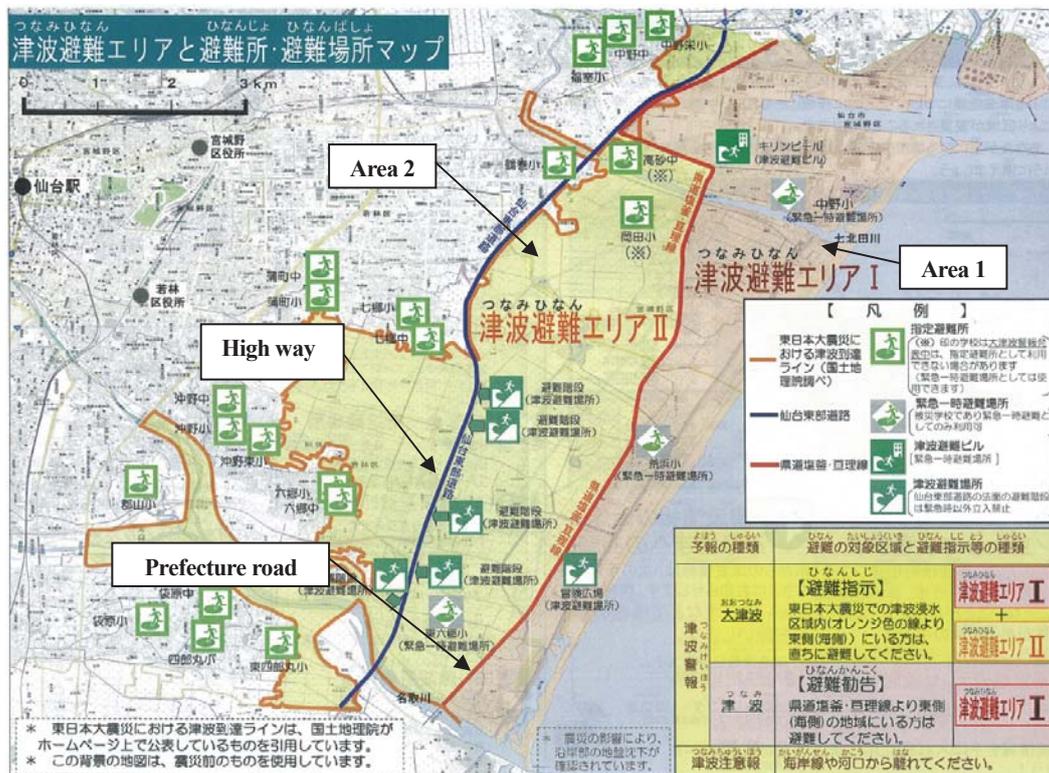
Figure 11. New tsunami hazard map in Sendai

ai city had high tsunami awareness due to the Miyagi earthquake, which had an estimated magnitude of approximately 7.5-8.0. Many tsunami countermeasures, such as evacuation drills and hazard maps, were implemented among coastal residents. Arahama primary school was the only tsunami evacuation building near the Sendai coast before the 2011 tsunami because the estimated tsunami inundation area was located only around the Tenzan canal, extending approximately 500 m inland. However, the 2011 tsunami generated by the M9.0 earthquake caused a larger tsunami height and wider inundation area than expected. The tsunami inundated an area reaching approximately 5 km inland, causing a wide range of damage to Sendai. The Sendai-East expressway helped to protect against the tsunami by chance in some areas because the expressway was situated perpendicular to the tsunami inundation direction. After the tsunami, the city created a new tsunami evacuation map separating the region into two areas (Fig. 11). The first area, situated from the coast to the prefecture road, is being raised to 6 m above ground level, and the second area extends over the inundation area of the 2011 tsunami (Sendai city, 2011). Sendai's new tsunami hazard map is shown in Fig. 11. The older tsunami hazard

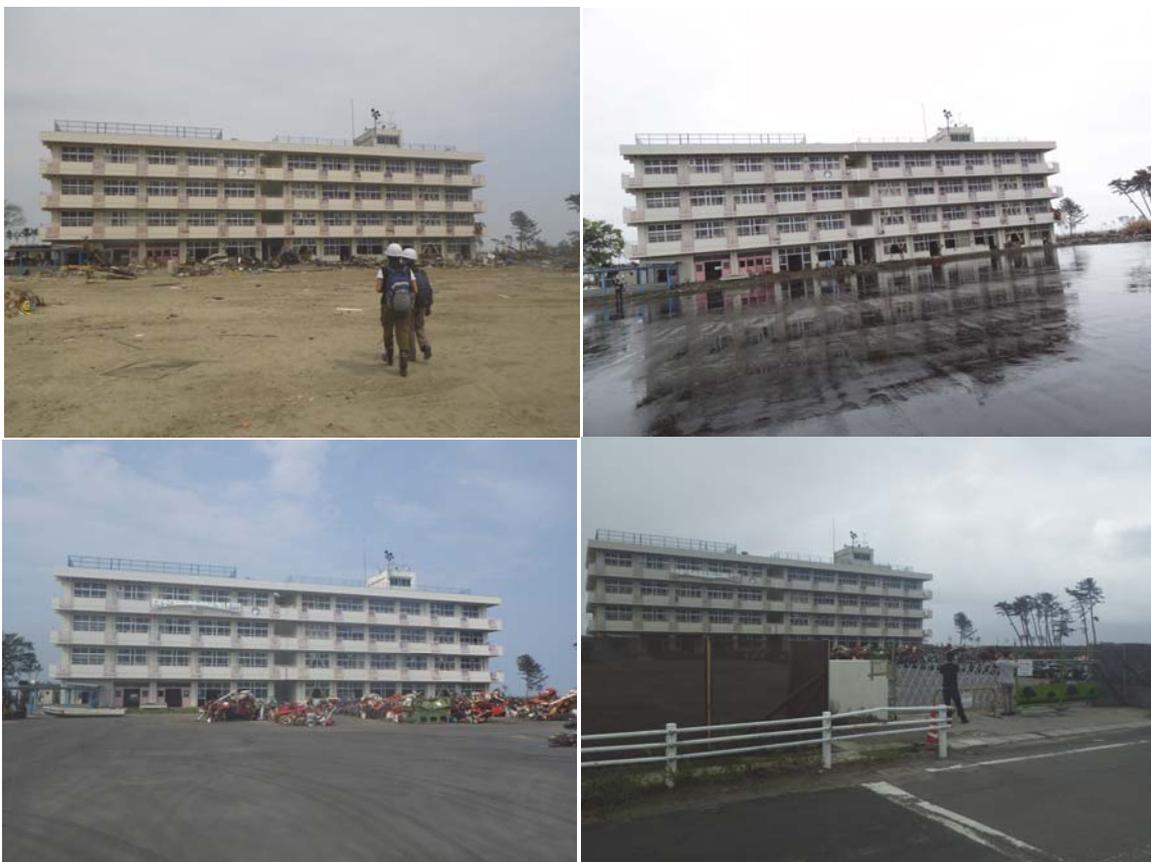
Figure 13. Arahama primary school on April 16th (upper-left), May 29th (upper-right), July 25th (lower-left), and September 2nd (lower-right)

The changes to the condition of Arahama primary school over several visits are shown in Fig. 13. The first visit to Arahama primary school was on April 16th, about one month after the tsunami. At that time, large amounts of debris were found below the second floor, including sandy soil from around the school. Small changes were observed during a visit on May 29th as the asphalt was revealed and some of the debris removed. On July 25th, most of the debris inside the school had been removed and the interior was being cleaned. Open space in front of the school was now being used as a temporary space for damaged motorcycles that the government could not demolish before obtaining permission from the motorcycles’ owners.

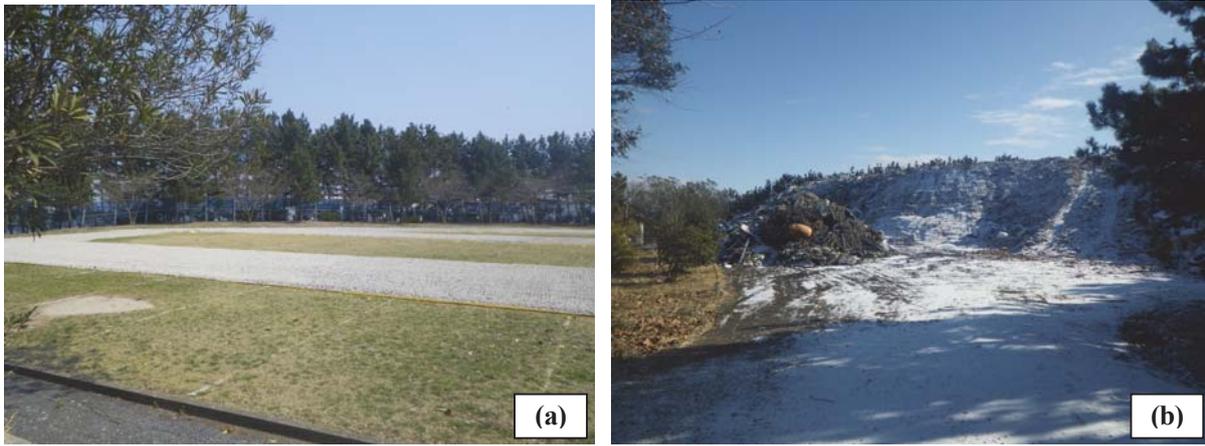
Figure 16. Condition of the elevated park at Sendai port (a) after one month (14/4/2011) and (b) after 10 months (25/1/2012)

15a). New electricity lines have been observed near the Sendai airport (Fig. 15b). A park in the Sendai port with an elevation of 10 m survived the 5-m-high tsunami. The park grounds were being used for the construction of temporary houses for disaster-affected residents during a visit in April 2011. However, the grounds were then covered in debris in January 2012 (Fig. 16). One of the reasons for this is that disaster-affected residents did not want to live near the sea and had transportation problems when living in this area. An example of an area affected by multiple disasters is Matsushima town (Fig. 17). The water mark from the 2011 Great East Japan tsunami in March was located approximately 0.4 m from ground level. Another water mark was found at the same location from the Roke typhoon (Typhoon No. 15) that attacked most prefectures in central and northeast Japan on September 22nd, 2011. Coastal residents evacuated

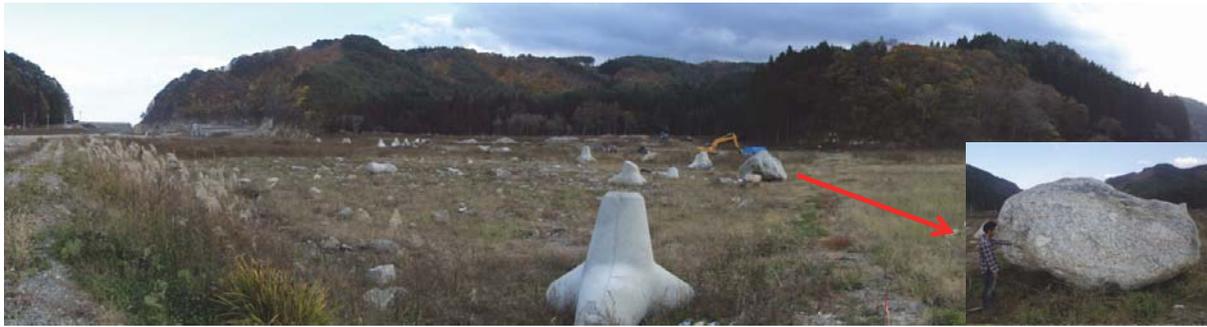
Figure 18. Massive boulder that was moved approximately 450 m by the tsunami in the Taro-Settai area (9/11/2011)

After the tsunami, a massive boulder was found approximately 750 m inland. A 28-m-high tsunami overtopped and destroyed a water gate near the sea

and transported numerous tetrapods inland, including the boulder mentioned (Fig. 18). This boulder is 3.5 m high, 6 m long, 4 m wide and weighs approximately 143 tons. According to the local news, the boulder, which was originally located near the water gate (approximately 300 m from sea), destroyed 6 out of 7 houses it hit and killed 3 out of the 6 people in its path (Iwate Nippo, 2011).

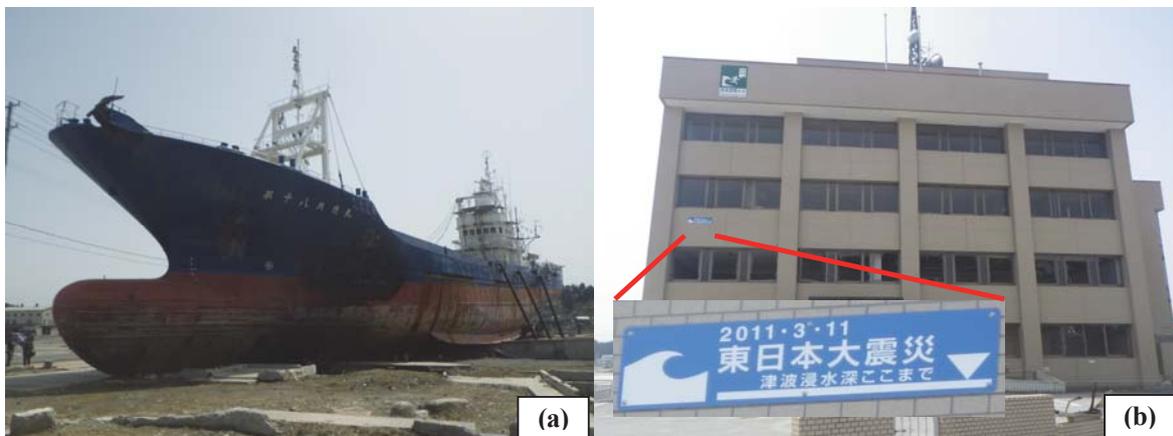
Figure 19. (a) Large fishing boat transported inland by the tsunami in 2011 (29/4/2012), and (b) 2011 tsunami inundation mark that was put in a damaged tsunami evacuation building (29/4/2012)

a plan to keep one large stranded fishing boat as a memorial of the 2011 event (Fig. 19a). The tsunami inundation mark was also recorded in the tsunami evacuation building one year later (Fig. 19b) next to the tsunami evacuation mark that had already been there before the 2011 event. The city’s fish market has already recovered after one year.

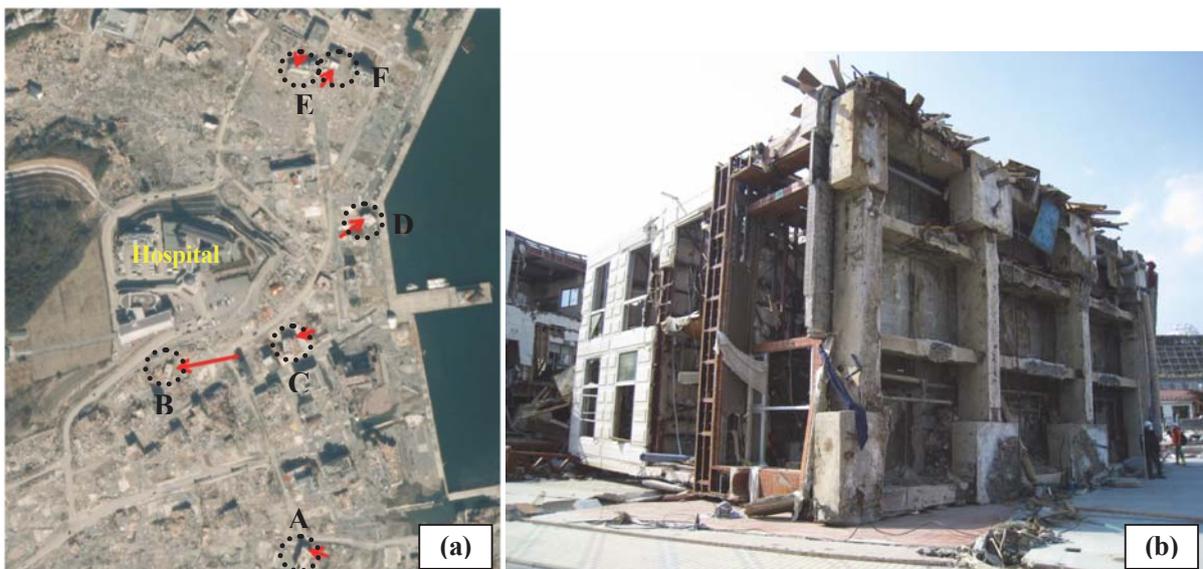
Figure 20. (a) Area map of Onagawa and location of its six overturned buildings A through F (6/4/2011), and (b) example of an overtopped building being saved for a memorial park (Building C) (29/3/2011)

Memorable damage from the 2011 tsunami included the overturned buildings in Onagawa. Six 2-4 story reinforced concrete (RC) buildings with pile foundations collapsed (Fig. 20). This type of structural damage is uncommon during tsunami events in such buildings, and has become a topic of study for the structural design of RC and/or evacuation buildings. The town would like to preserve some of those buildings as a memorial to educate people about a tsunami's power and its massive impact on the town (Onagawa town, 2011). At present, the town has decided to keep three buildings: the police station, a commercial building and an organization building. After one year, the tsunami inundation mark was recorded in front of the Onagawa hospital (Fig. 21a), and the fish market is now recovered (Fig. 21b).

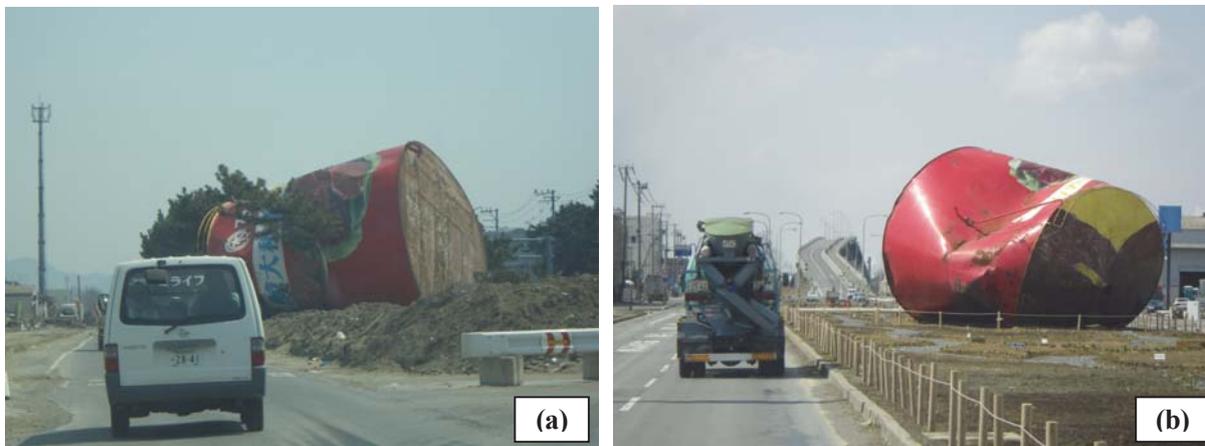
Figure 22. Large fish oil tank in Ishinomaki (a) after one month (15/4/2011) and (b) after one year (26/3/2012)

Unlike communities along the Sanriku coast, Ishinomaki had comparatively low tsunami damage from historical tsunamis. Thus, many factories located in Ishinomaki city did not have proper mitigation plans, and most of them were seriously affected by the tsunami. Among these, a giant fish oil storage tank 11 m high and 9 m in diameter was moved approximately 300 m from its original location by the tsunami (Yomiuri Shinbun, 2011), as shown in Fig. 22a. The tank can be clearly seen by people passing through the area, but it has been moved to a different place because it was blocking traffic. Some residents would like to preserve it as a monument to remind the community of the tsunami, and the city has a plan to make it a disaster memorial. In late March, it seemed that the city was planning to incorporate it in a memorial park (Fig. 22b), however apparently the idea was not fully supported by residents and finally the city decided to remove the tank.

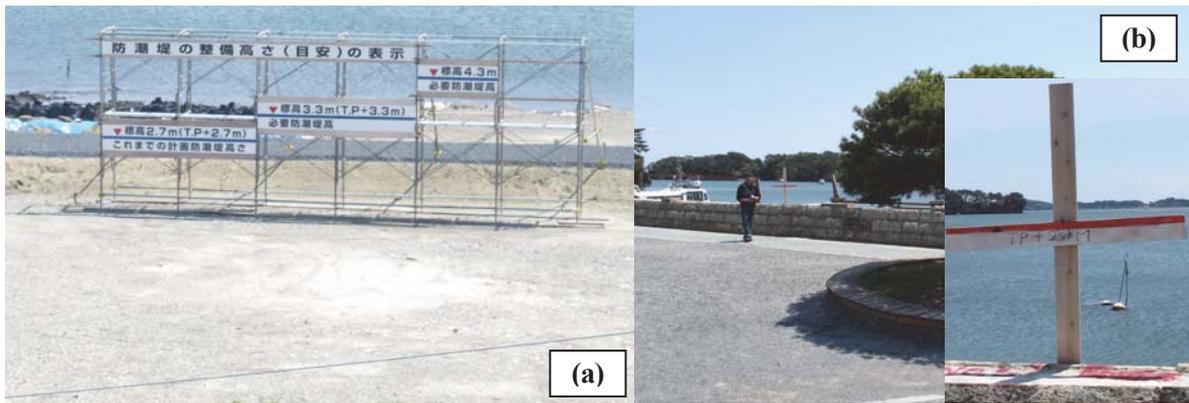
Figure 23. (a) Sign showing new seawall level to be constructed in Shiogama (12/5/2012) and (b) tsunami inundation mark in Matsushima (12/5/2012)

and Matsushima town are located inside a bay area and were protected by almost 300 small islands in the water. As a result, only 4-m and 2-m tsunamis were observed in the two locations. The sign in Fig. 23a on the left shows the planned height of 2.7 m for a new seawall in Shiogama. Markings at 3.3 m and 4.3 m are also shown to give citizens some idea of other tsunami heights. Matsushima is famous as a sightseeing area due to the above mentioned islands, and tsunami inundation marks at 2.1 m were built in some areas over the original 1-m-high seawall (Fig. 23b).

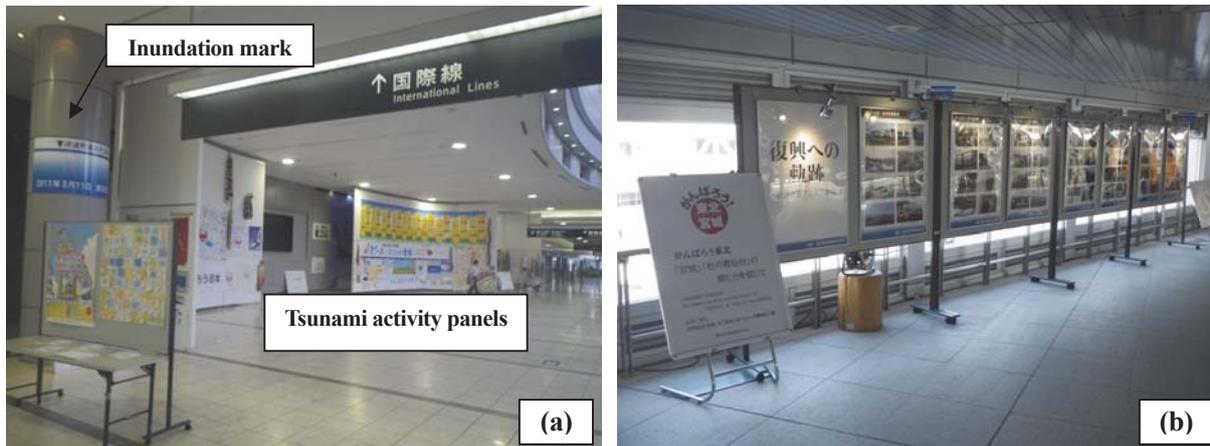
Figure 26. (a) Tsunami inundation mark in the Sendai airport and (b) display of tsunami damage in the Sendai airport train station (25/1/2012)

The Sendai airport covers area in Natori and Iwanuma cities and is located about one kilometer from the coast. Though the airport was protected by coastal seawalls and a 10-m-high control forest, these measures were insufficient and the tsunami inundated the first floor of the airport terminal. The airport was reopened one month after the tsunami for a limited number of domestic flights. There are two marks showing the inundation depth of the 2011 event on a first floor column, and some tsunami-related activities are on display near the arrival lobby (Fig. 26a). In addition, the Sendai airport train line reopened its service after seven months and used space near its entrance to present pictures of the earthquake and tsunami damage to the train lines and stations (Fig. 26b). Unfortunately, the displays were removed by late March.

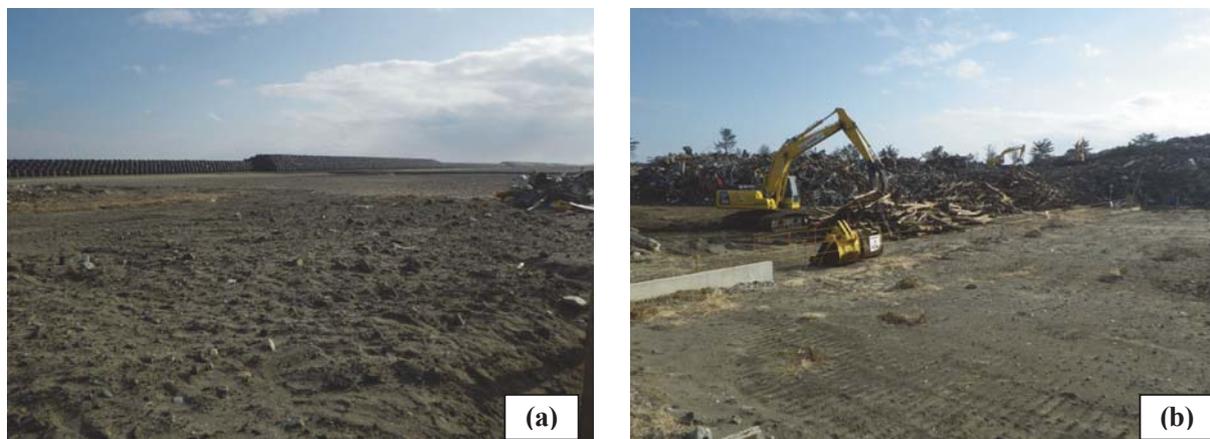
Figure 27. (a) Temporary seawall (25/1/2012) and (b) management of debris (25/1/2012)

Iwanuma was one of the cities with a coastal pine tree forest along its coast linked from the northern part of Miyagi prefecture. However, the greenbelt was heavily damaged, and the city has plans to replant it. Iwanuma's seawall was also severely damaged, and a temporary seawall was constructed using innumerable sand bags (Fig. 27a). The city has an idea to construct an artificial hill, the height of which varies from 10-15 m, using tsunami debris (Fig. 27b). The purpose of the hill, called the "Hill of thousand years hope," is to create a memorial park and evacuation site for future tsunamis (Iwanuma city, 2011). This hill will also help the new seawall to reduce a tsunami's energy before it reaches the populated area behind it. The town has plans to use solar energy on a large scale as part
