The 2011 Great East Japan Earthquake

Sendai Plain Field Guidebook

Field guidebook working group: International Research Institute of Disaster Science, Tohoku University

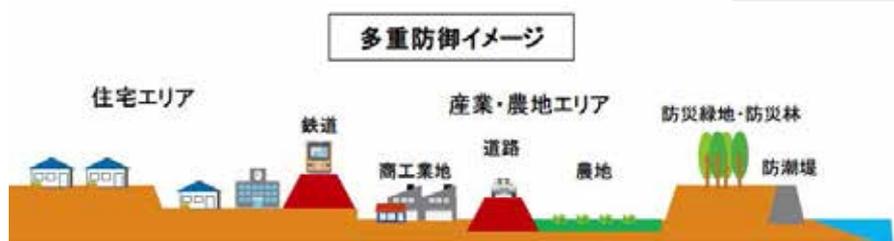
Figure 8: Image showing multiple defenses for tsunami countermeasures (Miyagi Prefecture, 2011a).

The 2011 Tohoku earthquake and tsunami caused severe damage to humans. Infrastructure was also severely damaged, including the airport, sewer treatment facilities, and agricultural fields. The 2011 Tohoku disaster underscores the fact that engineered coastal facilities such as control forests and coastal dikes are not always effective to protect people and property from a large-scale tsunami. After the 2011 disaster, both national and local governments came to advise multiple layers of protection, including elevation of roadways and railways, and building canals parallel to the shoreline to reduce the tsunami energy and consequent damage (Fig. 8).

The tsunami entered the inland side through the underpass and the part of the elevated way. The tsunami force was reduced considerably across the road, and the appearance of the damage differed greatly east and west of the highway (Fig. 26). Particularly, the effect of preventing the debris inflow was very large. The plan of relocation and raising of the road was adopted near the coast road (Shiogama-Watari line of country road No. 10) because of the good example of its unexpected effect as a breakwater (Fig. 8; Disaster Recovery Office, Sendai city, 2011).

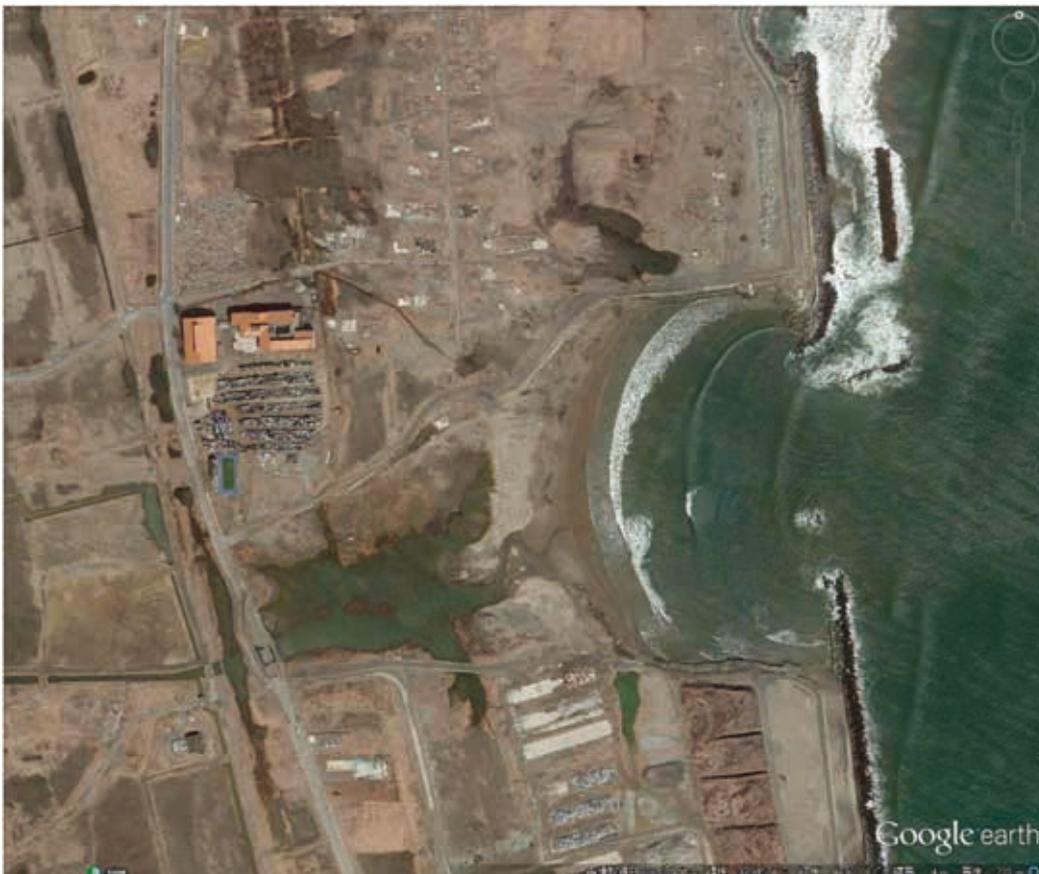
Figure 10: Overview of old Nakahama Elementary School of Yamamoto town (building with orange roof in left center side) and “Tsunami Bay (eroded arc-shaped coast in right center side).”

You might find the remnants of Nakahama Elementary School building and “Tsunami Bay” at this stop (Fig. 10). The tsunami rushed into the two-story elementary school building, which was made of reinforced concrete, through the windows in the east side. The waters reached up to the roof of the second floor. Nevertheless, not one of the 90 people in the building, including children, teachers and some local people, died. They all succeeded in evacuating to the roof terrace. The tsunami did not ultimately flood the terrace. Tsunami-damaged buildings have been disappearing as clearing and reconstruction work progresses. Few remain in southern Miyagi Prefecture. People have begun to devote attention to such buildings as tsunami memorials. Local governments are now considering the use of the damaged buildings as monuments.

“Tsunami Bay” is located 200–300 m east of the elementary school building. It is visible from the building terrace, from which one can reach the bay with a five-minute walk. The 2011 tsunami induced substantial sediment transport and created many erosional features all around the sandy beaches of southern Sendai Bay. Mechanisms and factors involved in the creation of tsunami bay are the retreat of the sandy beach because of long-term coastal erosion, the collapse of engineered dikes caused by the tsunami overwash and scouring, and formation of deep ditches in the lee side of the dike. The Tsunami Bay is a rare landscape showing interaction between the tsunami and anthropogenic coastal protection.

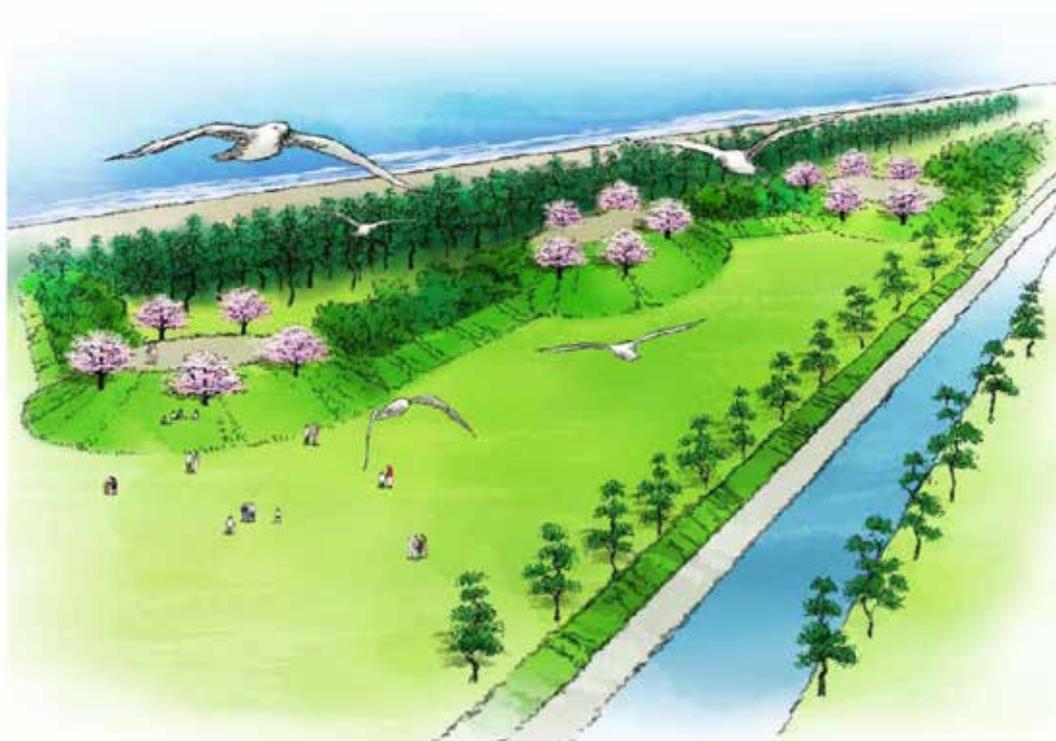
Figure 11: Schematic of "Hope Hill for a thousand year perspective" as a reconstruction plan in Iwanuma city.
http://www.city.iwanuma.miyagi.jp/kakuka/040700/documents/image_illustration.pdf

"Hill of millennium hope" is a reconstruction project planned for Iwanuma City. The coastal area of Iwanuma City was damaged by the tsunami, as were Sendai and Natori Cities. The tsunami debris will be used for construction of the hill (Fig. 11). The planned height of the hills is 8 m. The hill is designed to mitigate the effects of infrequent large-scale tsunamis such as the 2011 event, and to be tsunami-evacuation areas. The construction of a part of the hill was completed in June 2013. Work is expected to continue in the future.

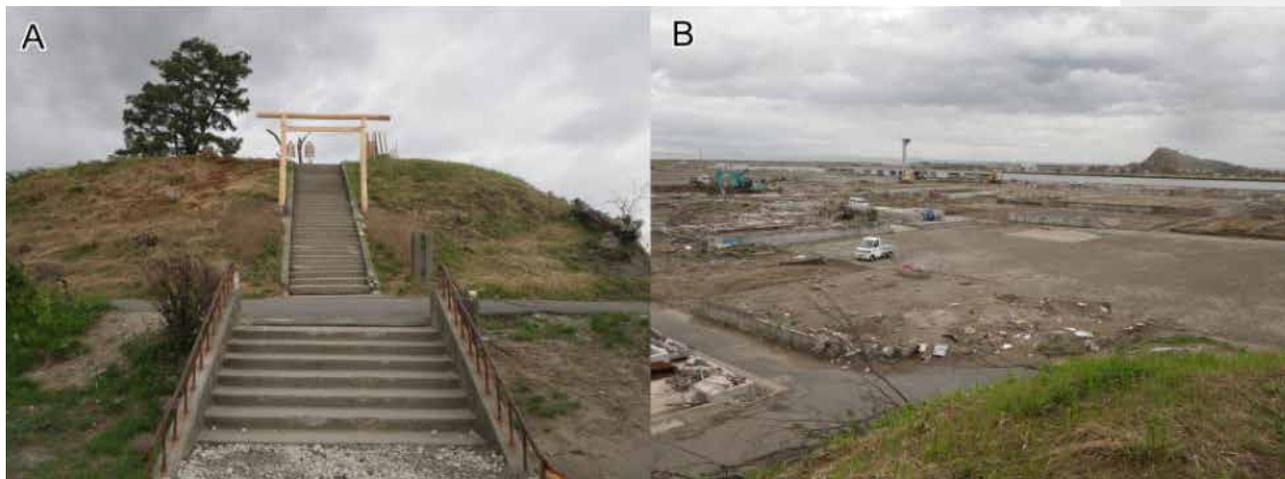
Figure 14: (A) Hiyoriyama Hill in the Yuriage area. (B) Damage to the Yuriage area in a photograph taken from the top of Hiyoriyama Hill (June 24, 2011).

Hiyoriyama is a small hill located about 800 m from the sea. The top of the hill offers a panoramic view of the area (Fig. 14). The 6.3-m-high hill was built using sediments dredged from the Teizan Canal. Wooden houses in the residential area within 1 km from the coastline were washed away completely by the tsunami. The Hiyoriyama hill is the only high ground in this area, but the tsunami overtopped the hill and washed out some stone monuments including a memorial of the 1933 Showa-Sanriku tsunami. The tsunami height measured on this hill was 7.9 m (Mori et al., 2012). The 911 casualties in Natori City include 40 missing, most of whom were reported from Yuriage (750 deaths out of 5,612 pre-disaster population in this area). At present, many people, including relatives of victims, volunteers

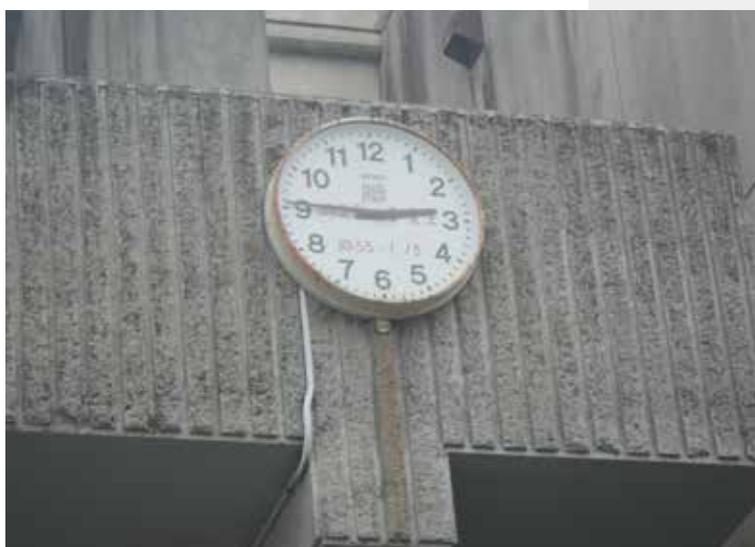
Figure 15: Stopped clock at Yuriage Elementary School.

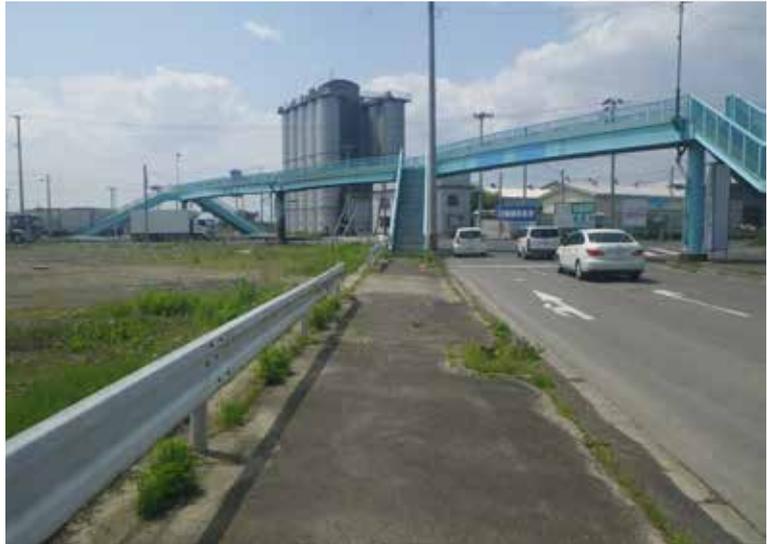
Yuriage Junior High School and Yuriage Elementary School are located, respectively, at 1.8 km and 2.1 km from the coastline. The measured tsunami height was about 4.4 m at these locations (Mori et al., 2012). Hundreds of people had evacuated to the buildings and survived the tsunami. A high water mark is still visible at the Yuriage Elementary School building together with a clock, which was stopped by the 2011 event (Fig. 15). A pedestrian bridge can be found at the crossing point of the Prefectural Road 10 and the City Road (Fig. 16). At the time the tsunami struck, some people climbed the stairs and survived on the top of the bridge.

A sign on the bridge's pillar shows the tsunami height. In October 2011, Natori City's government proposed a reconstruction plan for the Yuriage area, which includes leveling the ground to 3 m higher than it is currently and calling the local people to return to the area. The government produced a mock-up of the elevated land, together with a planned layout of new coastal dikes, to let people know how high the area will be and how safe the residents will be against large-scale tsunamis in the future. However, many people want to move away from Yuriage, or have already left and made new homes in other areas. Because three years have passed since 2011, the expected population of the new Yuriage community has been decreasing. The reconstruction plan has been revised many times.

Figure 16: Pedestrian bridge at the cross junction of the prefectural road no. 10 and the city road.

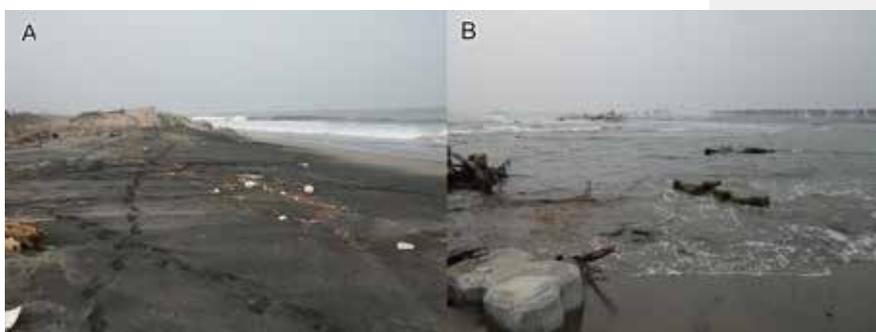
Figure 19: (A) Deposition of iron sand at Idoura; (B) view from the southern end of the sand bar remnant (based on Sugawara and Minoura, 2013).

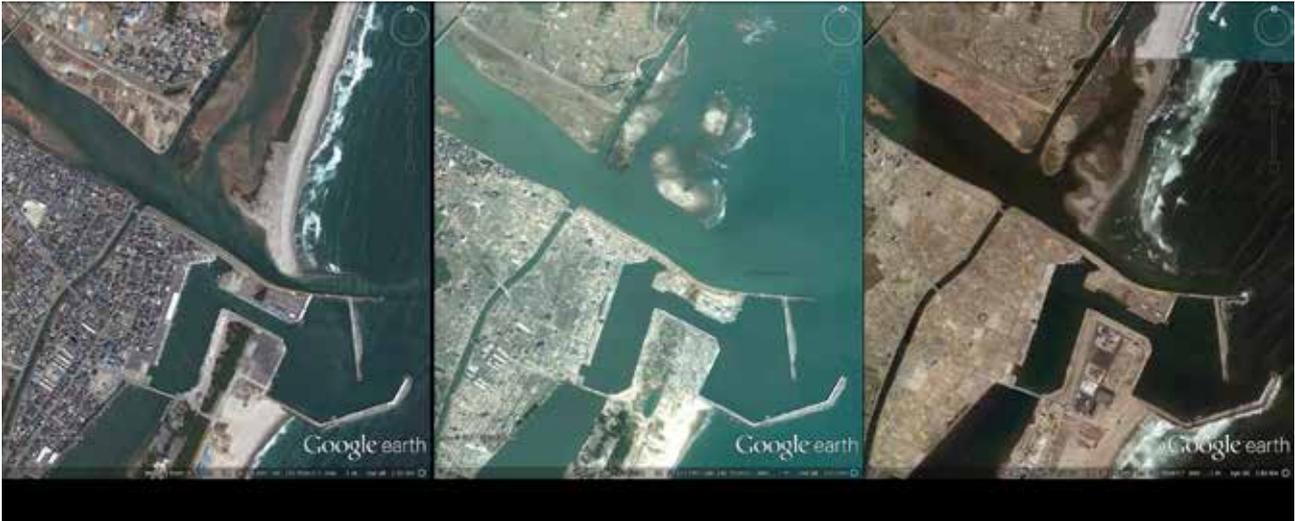
Figure 21: Google Earth images before and after the 2011 earthquake and tsunami at the Natori River mouth.

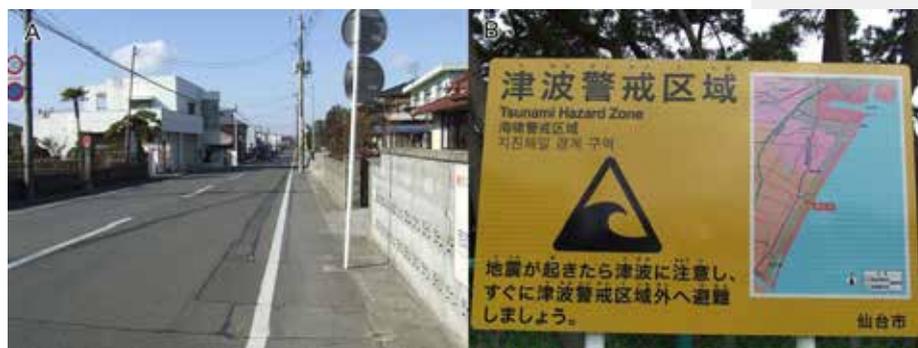
Figure 22: (A) Arahama area before the 2011 tsunami; (B) Tsunami hazard map located near the coastal forest (photograph taken on May 6, 2009) (Extracted from Sugawara and Minoura, 2013).

The tsunami height near the coastline was about 9–12 m (Mori et al., 2012). Figure 22B shows the tsunami hazard map published before the 2011 tsunami. As described earlier, the projected earthquake scenario in this area before the 2011 tsunami was the Miyagi-oki earthquake, which had 37.1 years of recurrence and typical magnitude of 7.3–7.5. The largest known Miyagi-oki earthquake occurred in 1793 (5th year of the Ansei period) with magnitude of 8.2. Considering the fault rupture in multiple segments, tsunami heights of 2–5 m were predicted along the Iwate and Miyagi coasts. Considering the migration of tsunami effects by the seawalls and coastal forests, the tsunami inundation area had been assumed to terminate within the coastal forest or the Teizan Canal, or at most around the building of Arahama Elementary School (Fig. 7).

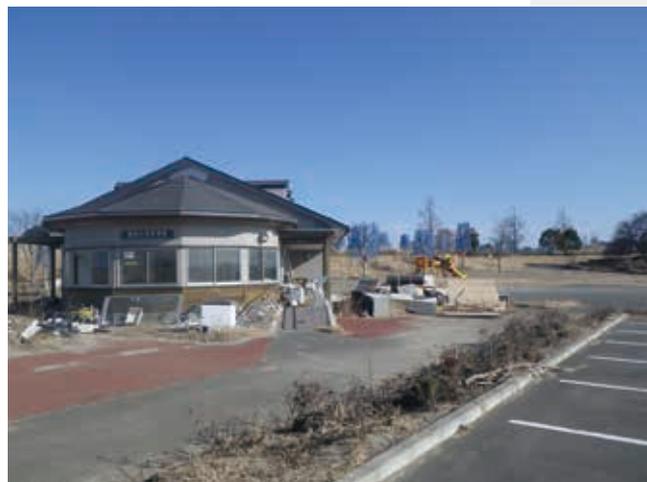
Figure 24 shows the coastal adventure park located 400 m from the coast. This place was once a pond, as presented in Fig. 23. The pond became filled by soil and an artificial hill had been constructed. Then the park was opened on it. The hill elevation was greater than 15 m, and the 2011 tsunami did not reach on the top. The tsunami near the coast, about 10 m high, inundated the first floor of the office located in the west side of the hill. Reportedly, five people survived on the hill.

Figure 24: Management office of the coastal adventure park.

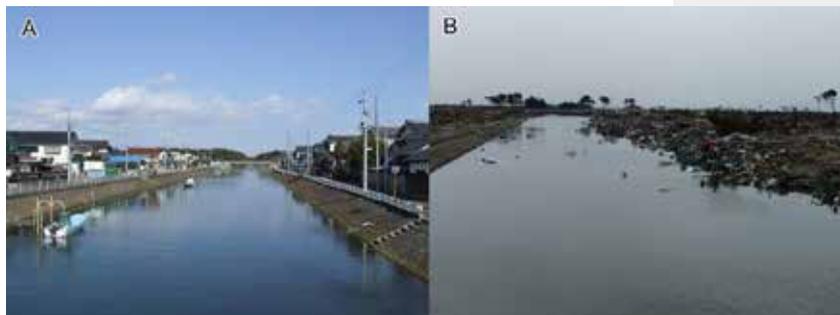
Figure 25: (A) Landscape of Teizan canal before the Tohoku Great Earthquake and Tsunami on January 29, 2010. (B) The disaster landscape of Teizan canal after the Tohoku Great Earthquake and Tsunami post-disaster, shot with same position and direction on March 17, 2011. (Reprinted from Sugawara and Minoura, 2013).

Because of the impact of the 2011 tsunami, the canal embankments collapsed. Most of the canal gates and bridges were washed away (Fig. 25). Nevertheless, a post-tsunami survey revealed that the tsunami height was reduced by about 3 m across the Tona canal in Higashimatsushima City, suggesting that the canal can reduce the impact of the tsunami waves (Goto, 2012).

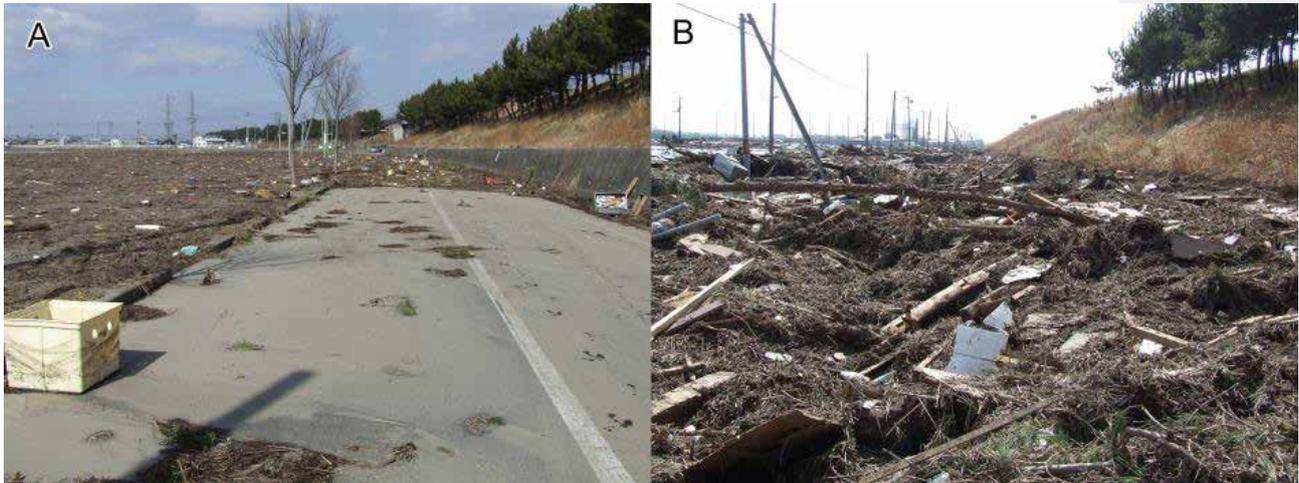
Figure 26: Landscape of contrasting disaster situation in Sendai eastern highway on March 12, 2011. (Reprinted from Sugawara and Minoura, 2013): (A) west side of the highway (land side); (B) east side of highway (sea side).

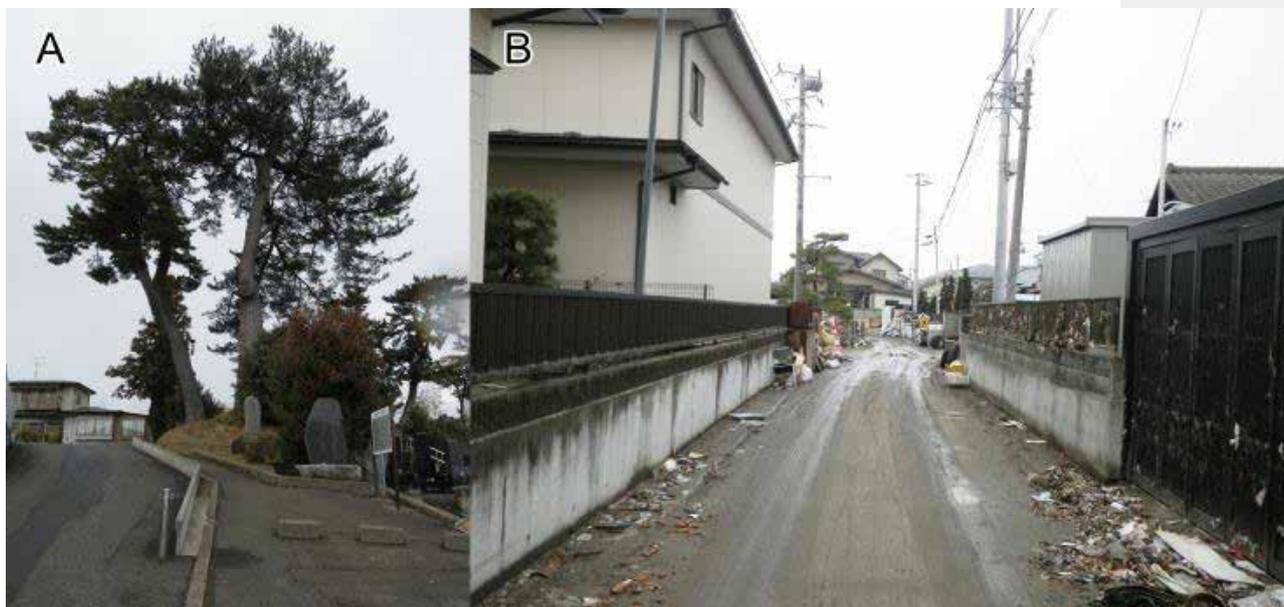
Figure 27: March 31, 2011: (A) landscape of *Sue-no-Matsuyama*; (B) landscape of damaged area immediately after the Great Tsunami near *Sue-no-Matsuyama* (tsunami depth about 2 m).
