# Minami-Sanriku town field trip (17 March 2013)

By Anawat Suppasri, Abdul Muhari, Fumihiko Imamura, IRIDeS, Tohoku University

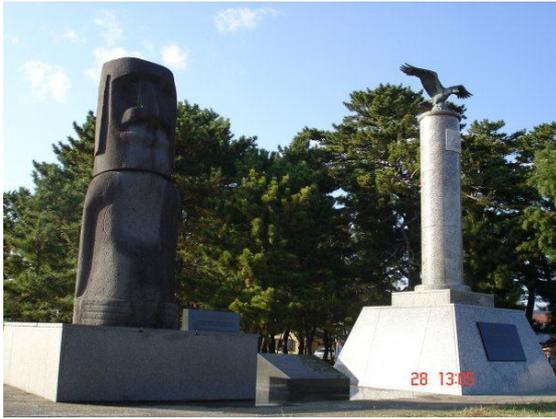
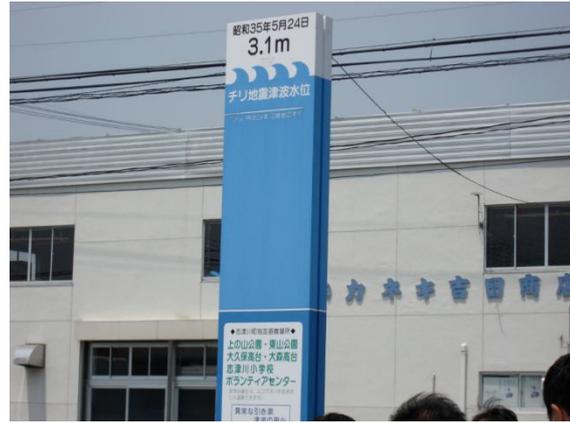
Fig. 3 Moai monument of the 1960 Chile tsunami (27/5/2008) and tsunami inundation mark of the Chile tsunami (27/5/2008)

Minami-Sanriku is a town with prosperous fisheries and a population of about 18,000. In Minami-Sanriku, the culture of a silver salmon, scallops, and oysters are prosperous. Because of their economic importance, tsunami-induced damage to these aqua-cultural facilities is a grave concern. The 1960 Chilean Tsunami caused great damage to Minami-Sanriku. On the occasion of the 30th anniversary of the 1960 Chilean Tsunami, a Moai monument was received as a symbol of friendship with Chile, which also had a stricken area. The Moai monument was installed in Matsubara Park (Fig. 3-left) where inundation signs (Fig. 3-right) were also installed. Tidal gate was installed near to the park and a private apartment nearby the park is designated as evacuation shelter (Fig. 4-right). The 1896 Meiji-Sanriku Tsunami height was 7 m here; 441 people were killed. The 1960 Chilean Tsunami height was 5.5 m. It washed away or destroyed 965 houses.

Tsunami memorial stone: Such as stone monuments, can be found in many areas along the Sanriku coast. In Minami-Sanriku town, there are monuments for the 1896 Meiji, the 1933 Showa and the 1960 Chile tsunamis. The message on the stone monument for the 1960 Chile tsunami reads “to be cautious of an abnormal receding wave”. However, these monuments, including a 2.6 m high monument for the 1960 Chile tsunami were destroyed by the 2011 Tohoku tsunami.

Tsunami inundation sign: Tsunami inundation signs of the 1960 Chile tsunami were put in many places in the Sanriku coast including the Minami-Sanriku town. Most of the heights of the 1960 event were lower than 5 m in general, however, greater than 10 m for the 2011 event. At present, Miyagi prefecture has already prepared and put the inundation sign for the 2011 event in many places such as survived buildings and structures. These signs are very important to maintain tsunami awareness and recall about tsunami hazard in each tsunami affected area.

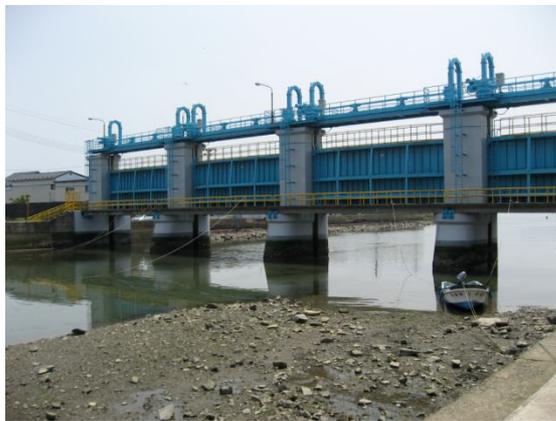
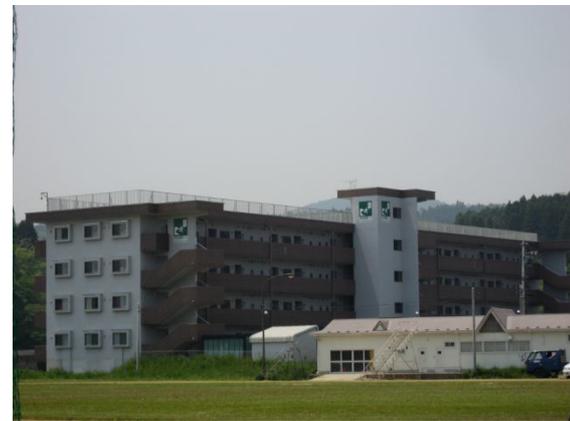
Fig. 4 Automatic tidal gate (27/5/2008) and evacuation building (27/5/2008)

In Minami-Sanriku, seawalls (+4.6 m) and tidal gates (+10 m) were constructed after the 1960 Chile tsunami. The town was fully protected from the tsunami generated in Tokachi Sea in the east coast of Hokkaido in 1968. However, these were not high enough for the 2011 tsunami which approximately greater than 10 m in every area. About 52% of the town area was inundated and destroyed 3,301 houses. The total reported death and missing is 695 from the approximated population inside inundation area of 14,389 (Total = 17,666). Total number of evacuee was 9,753 during the peak in 20<sup>th</sup> March 2011.

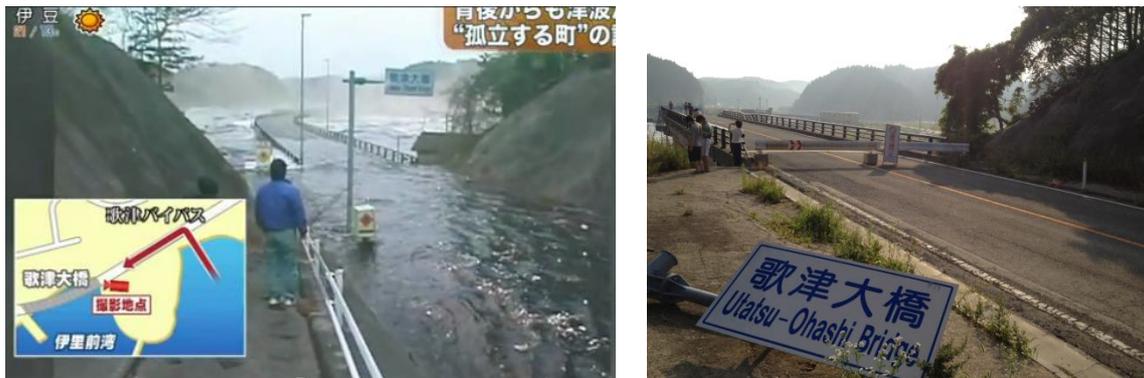
Fig. 5 Utatsu Ohashi Bridge (28/7/2012)

Utatsu Ohashi Bridge: VDO taken by survivors shows the moment of tsunami attacking Utatsu area and the Utatsu Ohashi Bridge (Fig. 5) and tsunami also came from the back side. The destroyed bridge is a typical example damage type of many bridges found in the 2011 event. Bridges were designed well enough against earthquake force but not for the hydrodynamic force including uplifting force by tsunami.

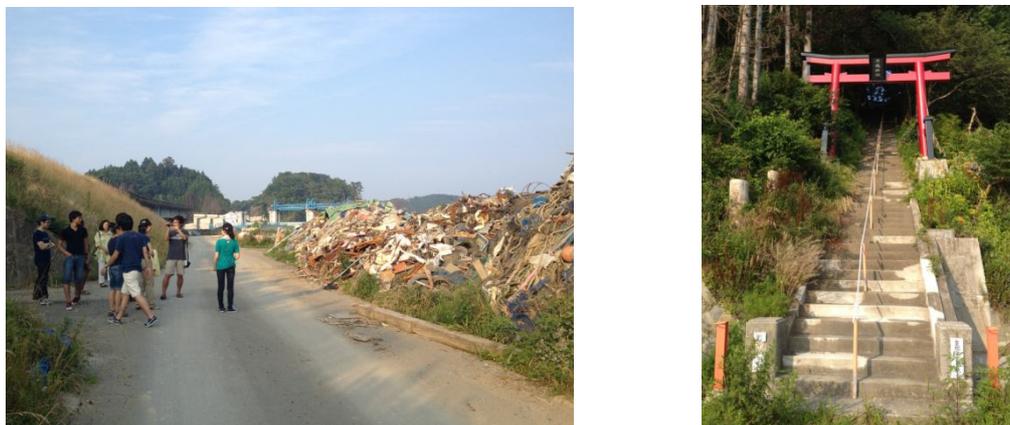
Fig. 6 Tsunami debris (28/7/2012) and Mishima Shrine (28/7/2012)

Mishima Shrine: A shrine called Mishima shrine (Fig. 6–right) that survived the 2011 tsunami located in a hill slope near to the bridge. There was large number of shrines that survived the tsunami. One of the main reasons is that experiences of historical tsunamis must be transferred as the shrines were built or re-built outside tsunami inundation zone of the historical events.

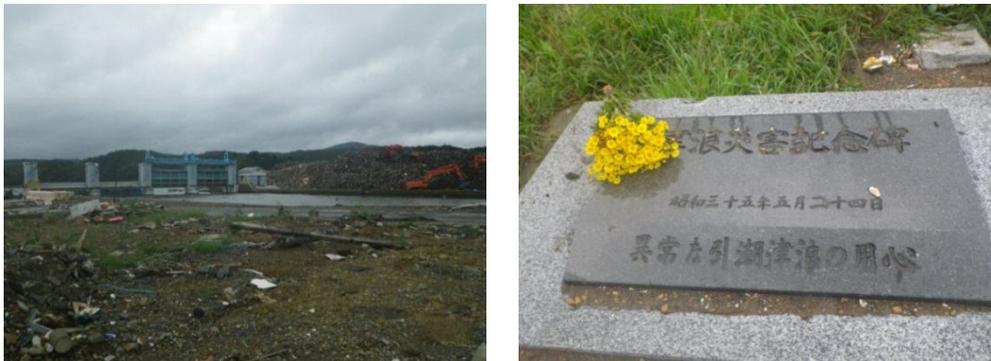
Fig. 7 Tsunami gate (3/9/2011) and tsunami memorial stone (3/9/2011)

Tidal gate: Tidal gates were installed in some places in Minami-Sanriku town similar to other areas in the Sanriku coast as to protect and reduce tsunami damage. However, all of the tidal gates in Minami-Sanriku could not help to protect the town. Fig. 7-left shows an example of four gates with 4.5 m height and 11.0 m in total span length. On the other hand, there was one place that the gate could fully help to protect the village called Fudai as the number of casualty was zero.

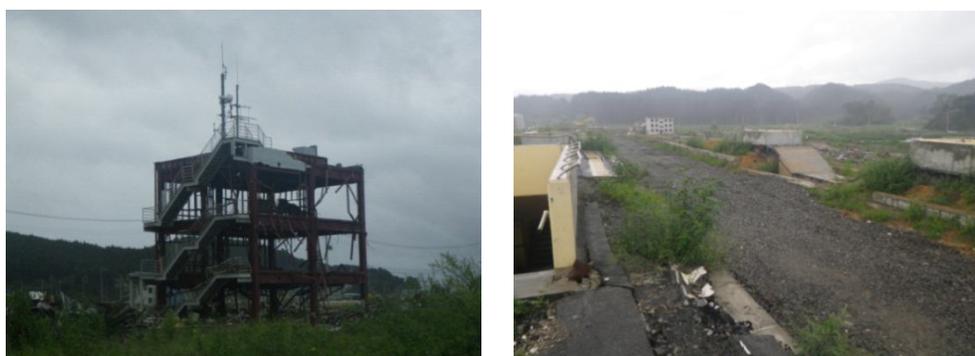
Fig. 8 Disaster prevention building (3/9/2011) and JR train station (3/9/2011)

Disaster prevention building: Similar to other areas officers and staff members that were stationed at the disaster prevention building (Fig. 8-left) in Minami-Sanriku Only 10 people of the 130 employee of the town hall (including the Mayor of Minami-Sanriku town were survived by reaching the top floor of this building). The remaining damaged building is considered as one of 37 structures in Miyagi prefecture proposed to be preserved as memorials of the 2011 event and to maintain tsunami awareness. During the 2011 tsunami, Miki Endo (遠藤未希), a 25 year old employed by the town's Crisis Management Department sacrificed her life to continue broadcast disaster advisories and warnings over the community loudspeaker system, located in the Crisis Management Department's building, as the tsunami overwhelmed it.

JR train station: Many train lines and train stations operated by the Japan Railway company (JR) were damaged or destroyed. There are seven main lines, Hachinohe, Yamada, Ofunato, Kesenuma, Ishinomaki, Senseki and Joban line. JR reported that there were 48 stations damaged or washed away and 99 stations were inspected and repaired. Total damage to the train line was 1,780 places covering the total length of 325 km. Shizugawa station (Fig. 8-right) belongs to the Kesenuma line. The station was washed away and the train line was totally destroyed. Most typical damage to the train is that the train was derailed or overturned.

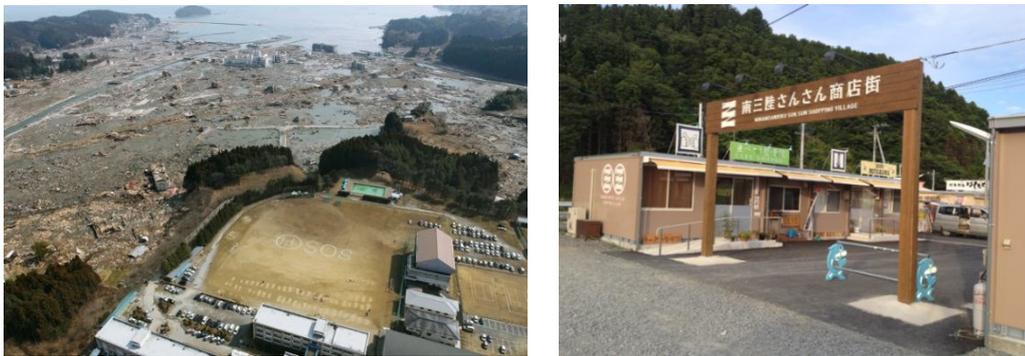
Fig. 9 Shizugawa Elementary School and shopping village (28/7/2012)

Shizugawa Elementary School: This school was used by tsunami evacuee for several weeks, and in the first week they wrote ‘SOS’ sign in the field to attract the rescue. The school was an example of a shelter that survived the tsunami. However, there were many example of an unfortunate result from the unexpected tsunami such as Okawa primary school which located near the mouth of the Kitakami River in Ishinomaki city where the tsunami claimed 74 out of a total of 108 children and 10 staff.

Minami-Sanriku Sun Sun shopping village: The shopping village was opened in Feb 2012 using the pre-fabricated structure similar to a typical temporary house for tsunami affected residents. The area comprises of 30 shops including fresh aqua-agricultural products and various kind of restaurant using ingredients from Minami-Sanriku town. There was also some event took place here to promote the town’s reconstruction.
