# Field Guide of tsunami damage and reconstruction site visit in Miyagi prefecture

Onagawa – Ishinomaki – Sendai – Natori – Iwanuma

11 May 2013

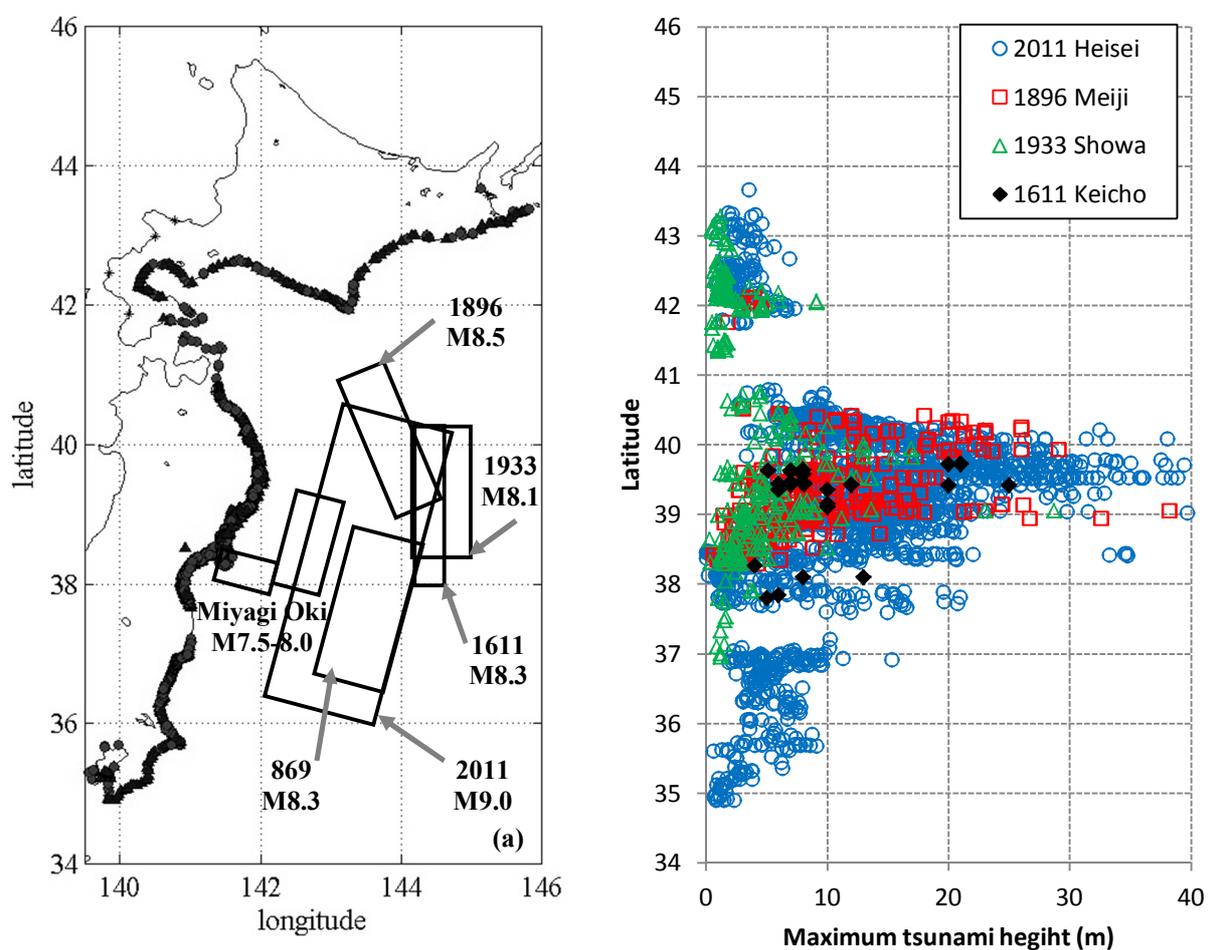
Figure 2 **Left**: Major historical tsunamis and the expected Miyagi-Oki earthquake and location of the main shock; **Right**: tsunami height distribution of the 2011 Great East Japan tsunami (Coastal Engineering Committee, 2011 and The 2011 Tohoku Earthquake Tsunami Joint Survey Group, 2011) and of the historical 1611 Keicho-Sanriku, 1933 Showa-Sanriku and 1896 Meiji-Sanriku tsunamis (Tsunami Engineering Laboratory, 2011b)

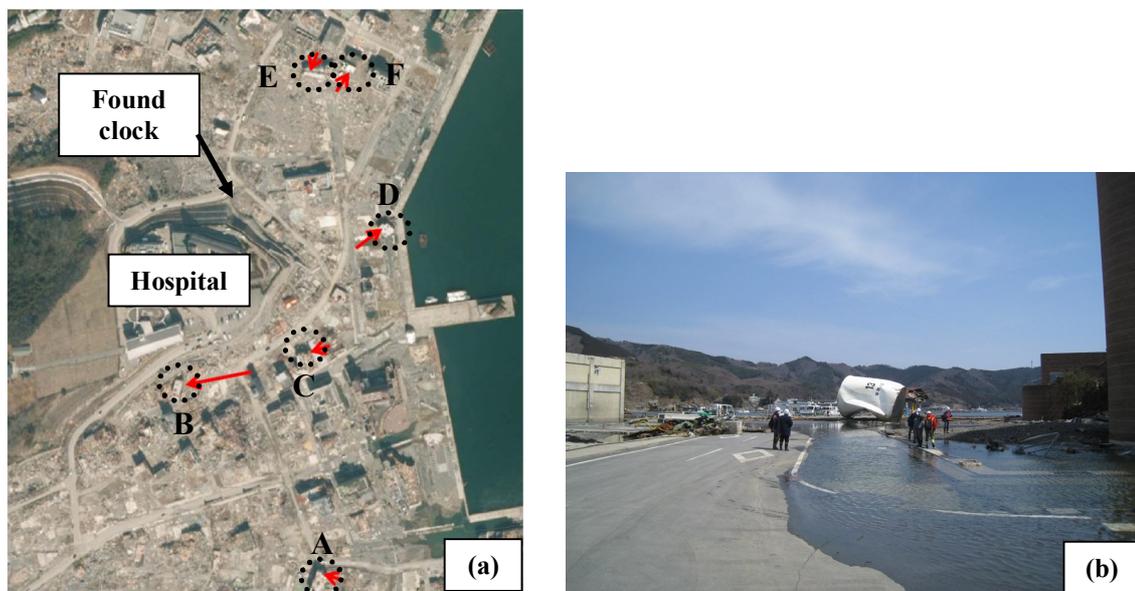
Figure 3 (a) Area map of Onagawa town and location of six overturned buildings A to F (6/4/2011) and (b) Land subsidence causing submerged land by sea water (29/3/2011)

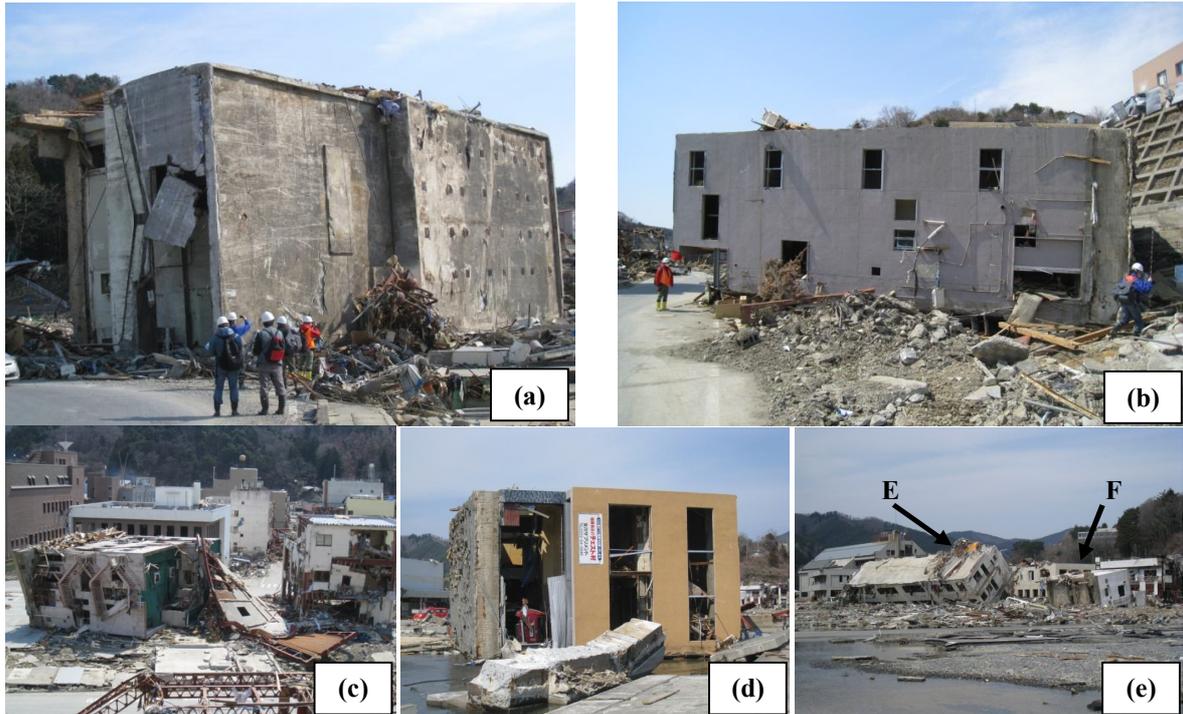
Figure 4 Overturned buildings in Onagawa namely A, B, C, D, E and F which some were moved up to 70 m (29/3/2011)

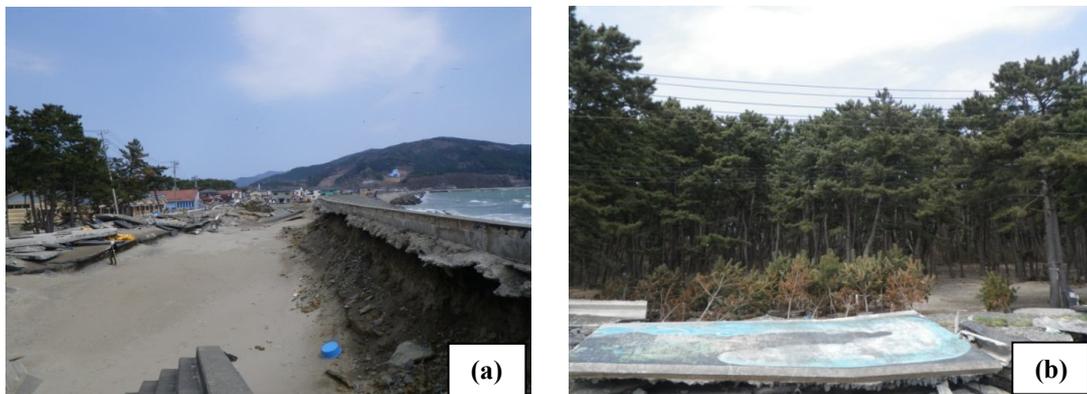
Figure 6 (a) Damaged seawall foundation (26/4/2011) and (b) Survival of most pine trees after the tsunami in Ishinomaki city (26/4/2011)

Ishinomaki city was protected by breakwaters, seawalls and control forests. Based on a visual inspection from satellite images, washed-away building probability in the zone outside breakwaters was as high as 88.4% whereas it was of only 42.8% inside breakwaters zone. Although the damage to breakwaters was not large, the seawalls were seriously damaged by erosion on their back side. However, these structures were able to protect the control forests behind them (Fig. 6). The tsunami height measured around the control forests was 7-8 m. The populated residential area behind the control forest was generally less damaged on the outside. This shows a reduction effect of the control forest. Figure 7(a)-(d) presents a very good example during the survey of the fragility of each structural type under the same tsunami inundation depth of 4 m. Only broken windows were found for the RC building in Fig. 7(b) and some walls and columns were destroyed in the 2-story wooden house in Fig. 7(c); however, the 1-story wooden house was completely collapsed in Fig. 7(d). Tsunami also caused fire in wide areas on Ishinomaki. One of them is the fire at Kadonowaki elementary school (Fig.8(a)). The fire was first occurred by electrical short in a car battery. Then the car was flown as debris to the school enlarging the fire area. However, all teachers and children had already evacuated to the hill behind the school via their evacuation route before the tsunami arrived. Fig. 8(b) shows example of tsunami inundation mark in Ishinomaki city.

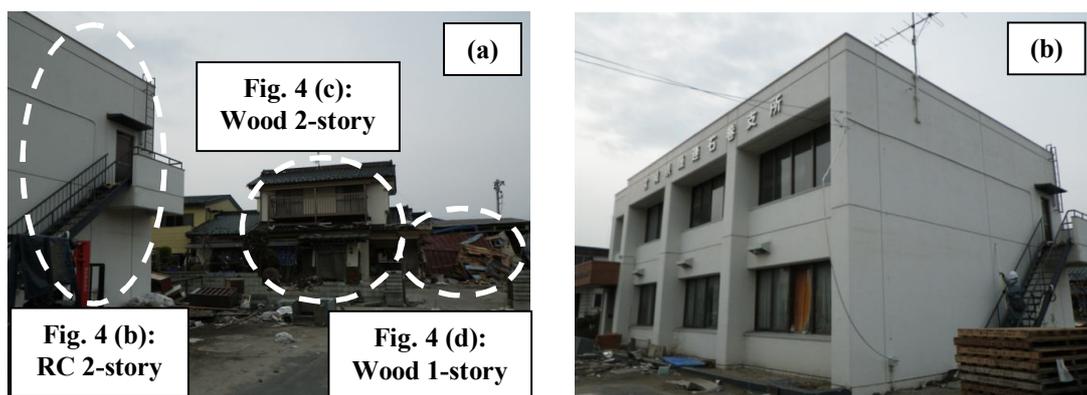
Figure 7 (a) Damage condition of a RC building, 2-story wooden house and 1-story wooden house under the same inundation depth of 4 m in Ishinomaki city and (b) RC building

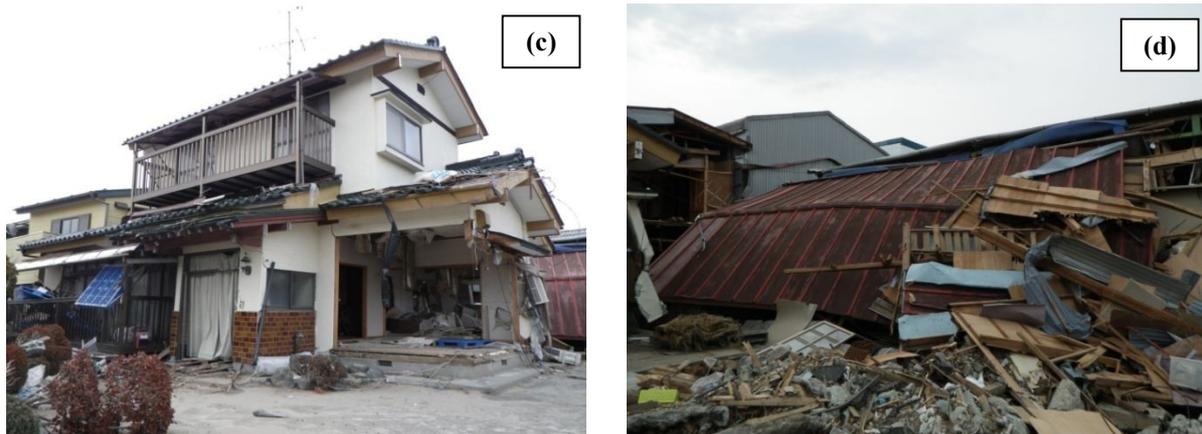
Figure 7 (c) Damage conditions of a 2-story wooden house and (d) 1-story wooden house

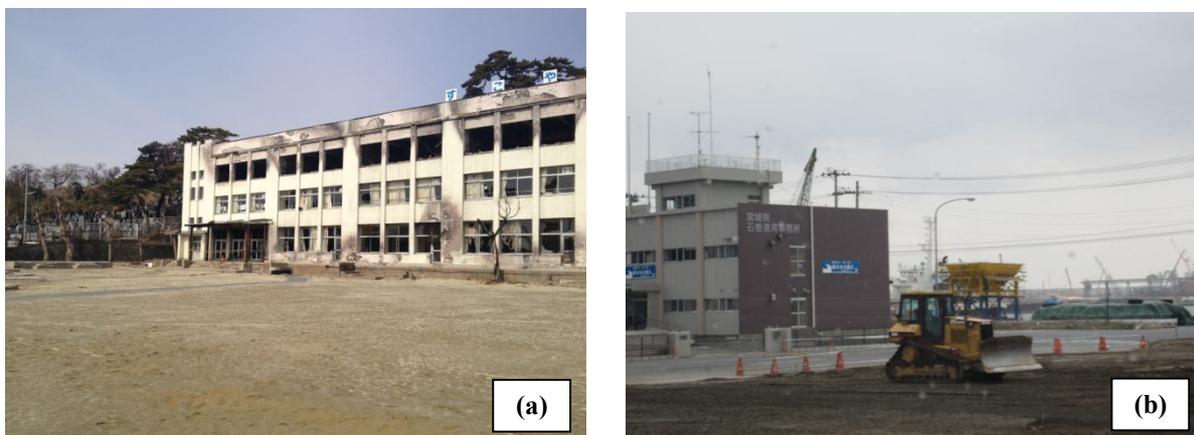
Figure 8 (a) Kadonowaki elementary school (16/3/2012) and (b) Tsunami inundation mark (26/3/2012)

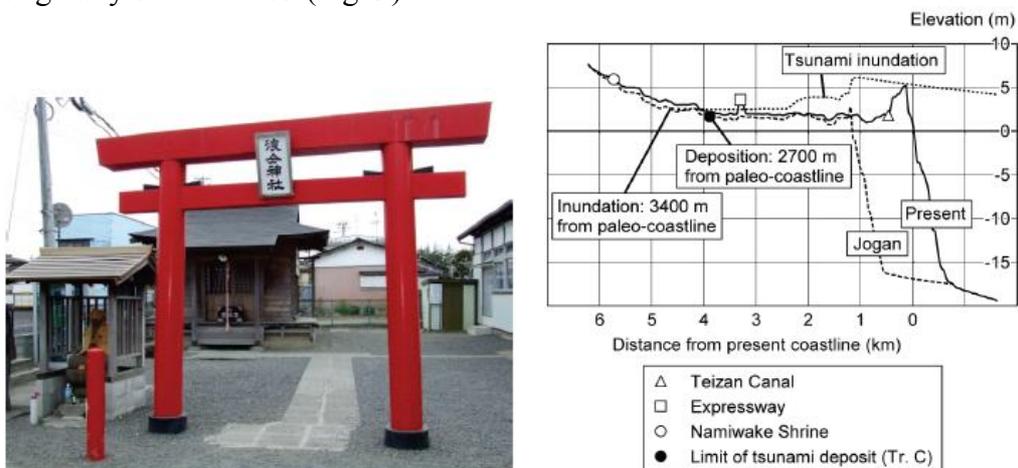
Figure 9 (a) Namiwake shrine and (b) Topographic profile of the Sendai plain and inundation by the Jogan tsunami (Sugawara et al., 2010)

The Namiwake shrine is a monument in the Sendai area. It is located approximately 5.5 km from the sea in a low-lying area in the Wakabayashi ward of Sendai city. Namiwake was originally built in 1703 (Fig. 9).

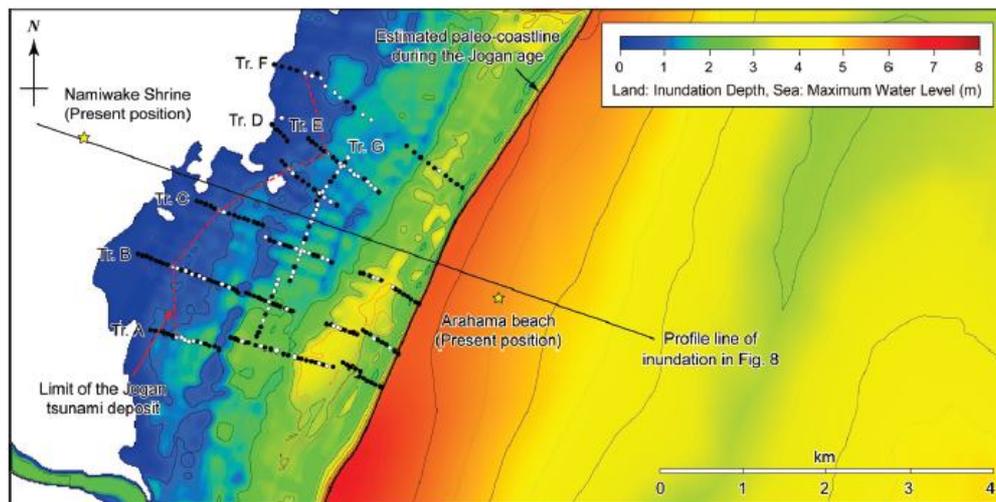
Figure 10 Locations of excavation sites and distribution of the Jogan tsunami deposit

Many flood and tsunami disasters have occurred in this area in the past. In the 1611 Keicho event, the tsunami inundated the shrine's original site, and approximately 1,700 people were killed. At one site, the tsunami wave, which approached from the East, was split in the North-South direction; at that time, people believed that the tsunami was created by the God of the sea. In 1835, the shrine was moved to the actual site to protect it from the next tsunami; it was given the name "Namiwake" ("Nami" means wave and "Wake" means separate) and is viewed as a symbol of tsunami prevention. In fact, also deposits from the 869 Jogan tsunami were found 200-300 m from the front of the shrine (Fig. 10).

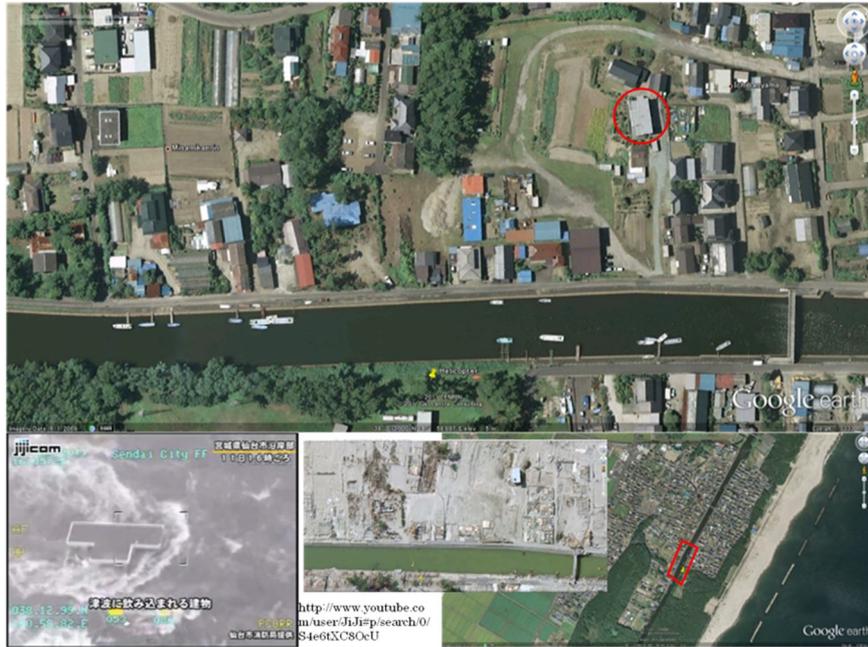
Figure 12 Videos show inundation heights and RC buildings standing tsunami force

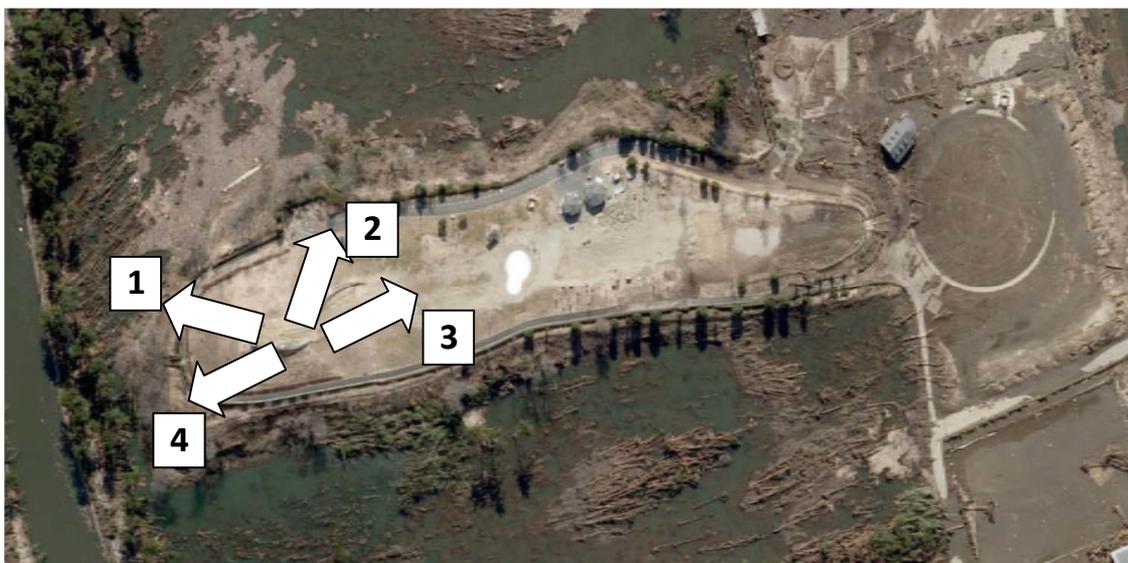
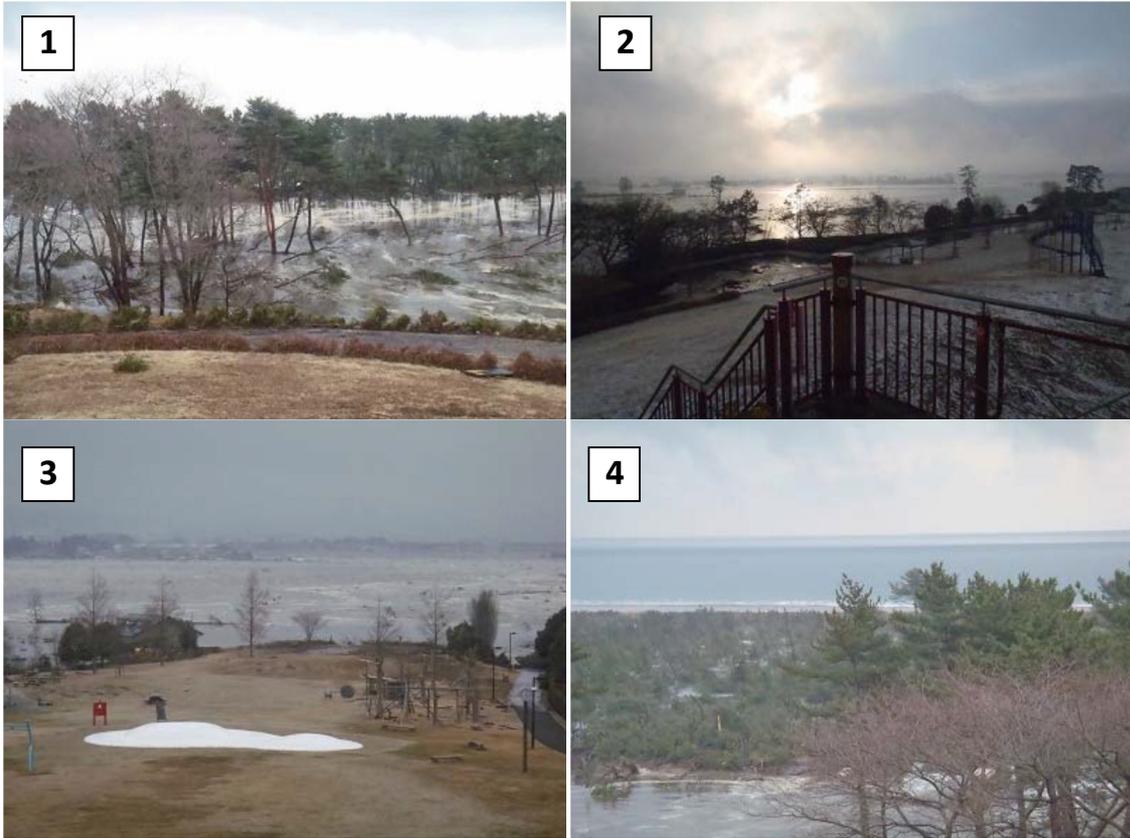
Figure 13 Adventure Park in Arahama. 400m from shoreline. Tsunami did not overtop this area and continue until 4km inland. 5 persons evacuated here (2 staff members and 3 locals). Tsunami height was around 10m.

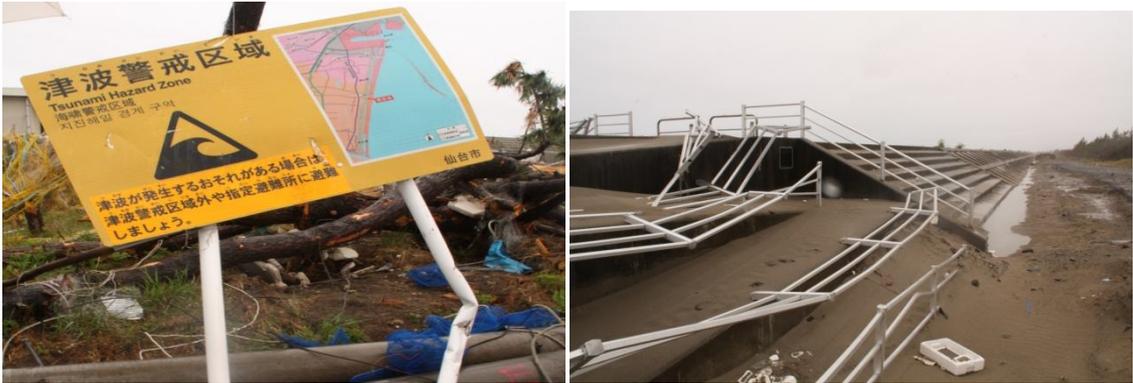
Figure 16 **Left:** Hazard Map; **Right:** Seawall

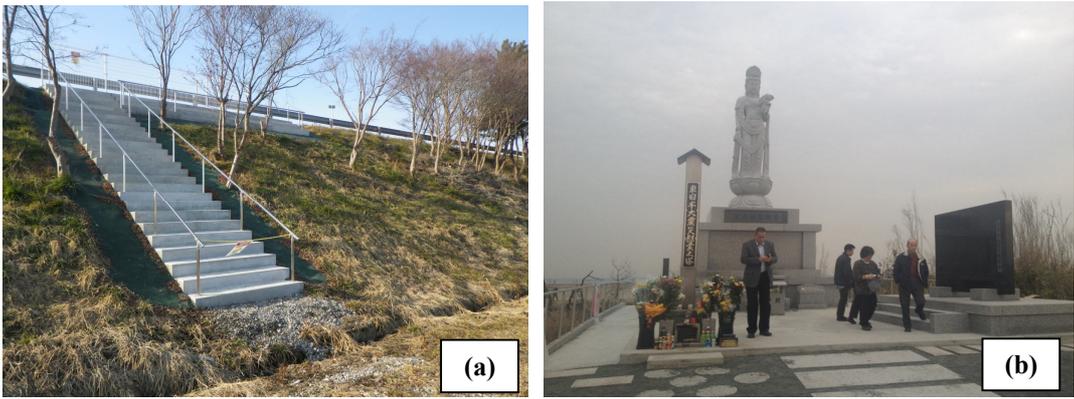
Figure 17 (a) Staircase built for access to the surface of the Sendai-East expressway and (b) New tsunami memorial (13/3/2013)

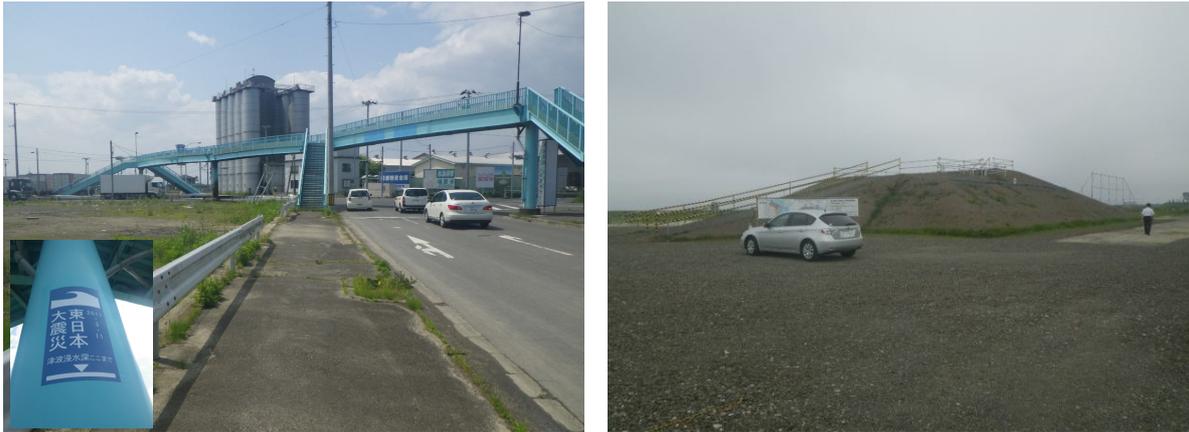
Figure 24 **Left:** Tsunami inundation mark on the pedestrian bridge that saved many lives in Yuriage (30/5/2012); **Right:** About 3 m land elevation in Yuriage will be increased as shown in the model

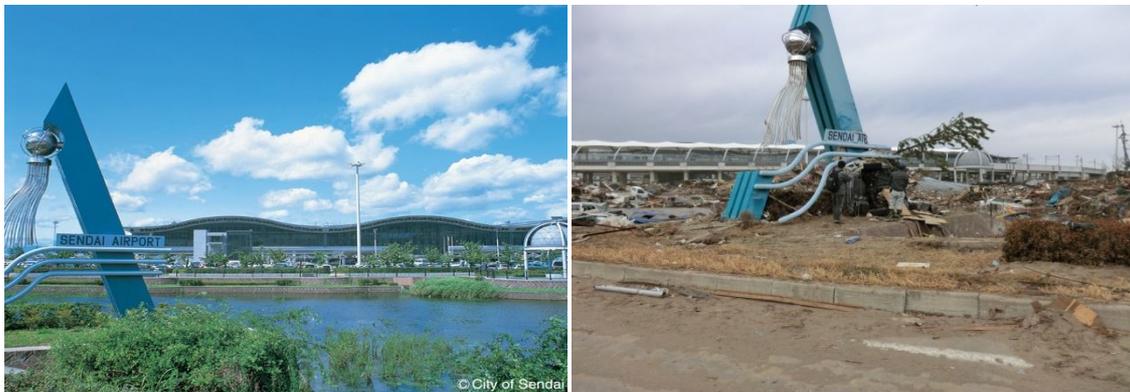
Figure 25 Damages to Sendai Airport (**Left:** before [[www.japan-i.jp](http://www.japan-i.jp)]; **Right:** after)

Sendai Airport is located 13.6 km southeast of Sendai city in Natori, Miyagi. It was built in 1940 by the Imperial Japanese Army, turned into national airport in 1957 and then upgraded to international airport in 1990. In 2011, the airport was first damaged by the earthquake and tsunami. Inundation reached up to some areas of the 2<sup>nd</sup> level of passenger terminal (3.5m). All services were stopped at the moment and 1,300 people stranded in the terminal until March 13<sup>th</sup>. It was reopened only for tsunami response flights on March 17<sup>th</sup>. The US Air Force and Japan Self-Defense forces removed debris until the airport reopened to limited commercial traffic on April 13<sup>th</sup>. Regular domestic flights resumed on July 25<sup>th</sup> and most international flights on October 2011.

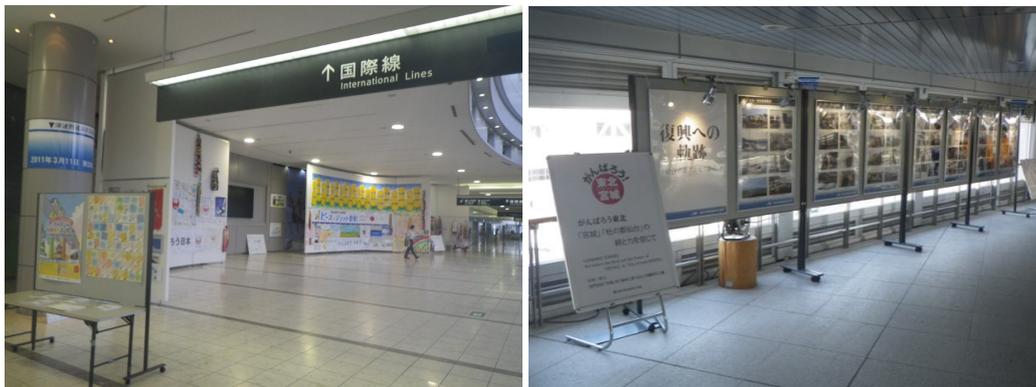
Figure 28 **Left:** Tsunami inundation mark in the Sendai airport (25/1/2012); **Right:** display of tsunami damage in the Sendai airport train station (25/1/2012)

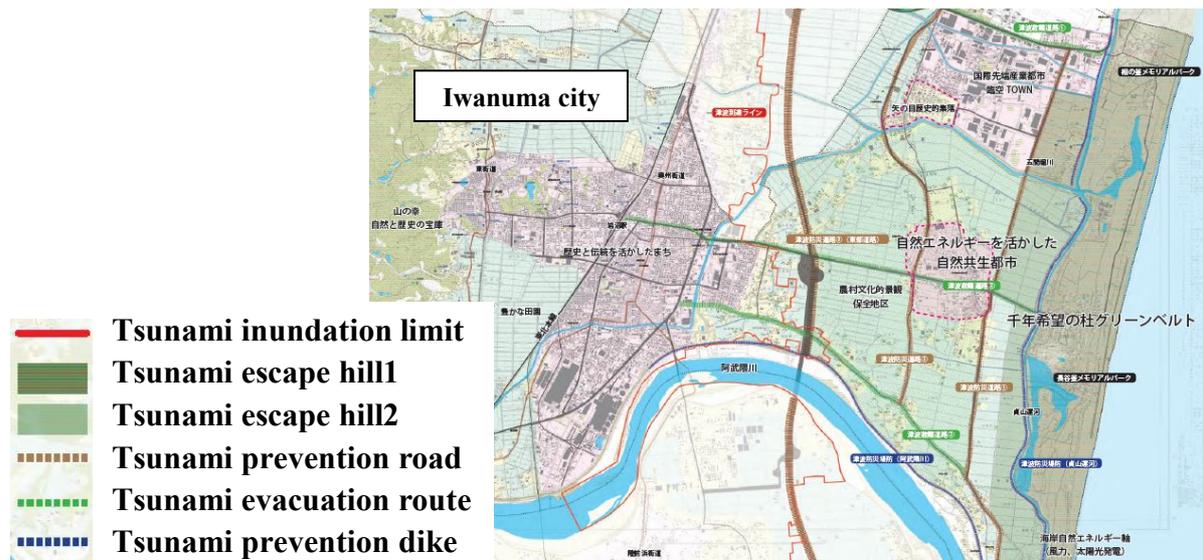
Figure 29 Reconstruction plan of Iwanuma city

Iwanuma city was one of the cities that had a coastal pine tree forest along their coast linked from the northern part of Miyagi prefecture. However, the greenbelt was heavily damaged and the city has a plan to replant it again. Besides, they have an idea to construct an artificial hill which height varies from 10-15 m using tsunami debris. The purpose of the hill is to use as a memorial park and evacuation place as an escape hill for a future tsunami called “Hill of thousand years hope” (Iwanuma city, 2011). This hill will also help with new seawall to reduce tsunami energy for the new populated area behind it. The town has a plan to use solar energy in a large scale to build an eco-compact city project.

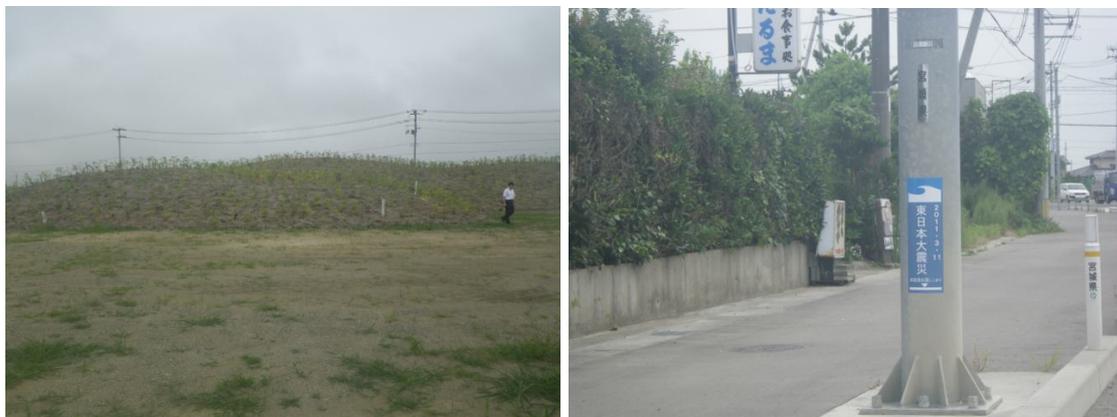
Figure 31 **Left:** Experiment model of the thousand years hope hill (3/8/2012); **Right:** Tsunami inundation mark in Iwanuma city area (3/8/2012)

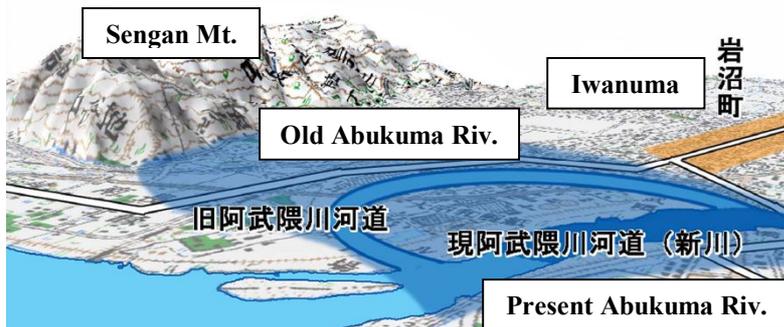
Figure 33: Historical map in Sengan Mountain area showing location of the old Abukuma River and estimated inundation area by the 1611 tsunami is shown in blue (Ebina, 2011)

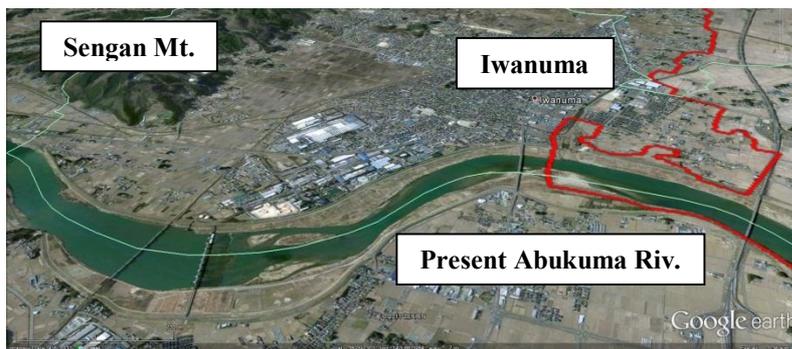
Figure 34: Present map in Sengan Mountain area where the old Abukuma River was disappeared (Red line shows tsunami inundation limit of the 2011 tsunami). It can be noted that coast line at the time of 1611 tsunami was about 400 m more inland
