Joint Report for Tsunami Field Survey for the Solomon Islands Earthquake of April 1, 2007

PARI Tsunami Survey Team

International Tsunami Survey Team

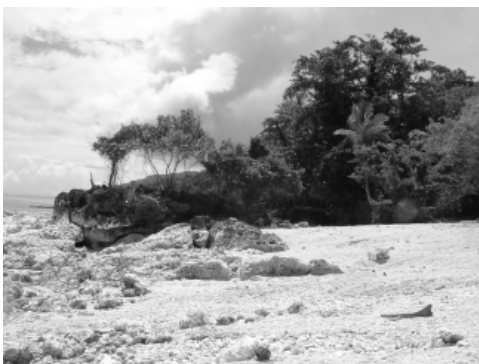
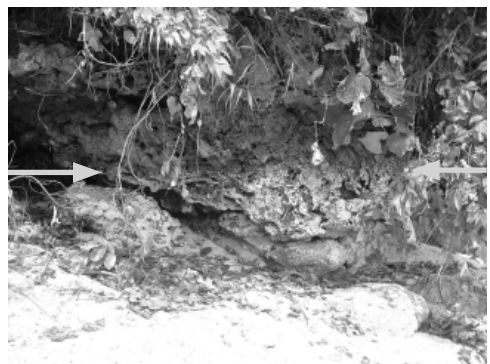
The amount of vertical crustal deformation was roughly estimated from the white lines (Fig. 2.5) showing the mean tide level before the earthquake, the top of dead corals, or eyewitnesses testimony of the pre-earthquake high tide or mean tide level (Appendix 2). Fig. 2.3 shows the observed vertical deformation at the survey points

Fig.2.5 The white line showing the mean tide level before the 2007 Solomon earthquake

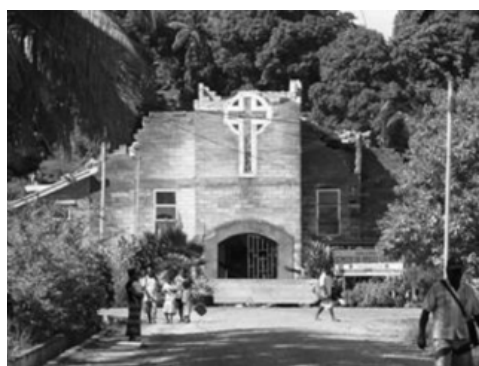
Photo 3.1.1.1 Structural destruction in Gizo Town of Ghizo Island

The earthquake also caused strong ground shaking on the island. The Modified Mercalli Intensity scale was VIII which meant the shaking was destructive. Photo 3.1.1.1 shows the destruction of a church in Gizo Town which is located on the eastern coast of the island. Gizo Town is the second biggest town in the Solomon Islands (the biggest one is the capital city, Honiara.).

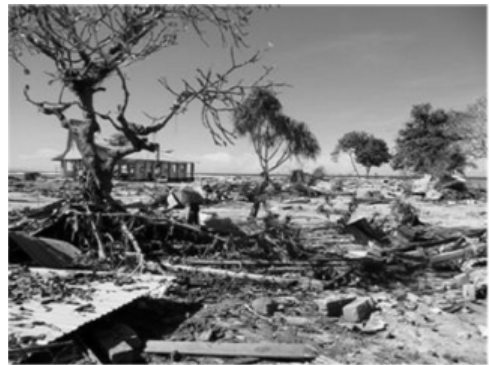
The tsunami caused severe damage in Titiana. As shown in Photo 3.1.2.2, most houses were swept and destroyed by the tsunami. A church was damaged but remained intact as shown in Photo 3.1.2.3. The front and back walls facing the tsunami flow direction were completely de-

Photo 3.1.2.2 Destructive situation in Titiana

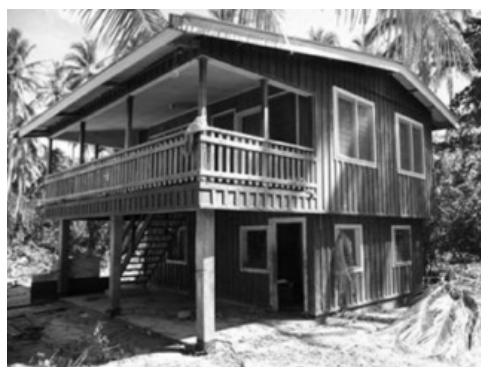
If the location of building was slightly different, the situation of tsunami damage was greatly different in the east side of the bridge in Fig. 3.1.3.2. A house remained as shown in Photo 3.1.3.1 and a nearby house was completely destroyed as shown in Photo 3.1.3.2.

Photo 3.1.3.1 House that withstood 2 m of tsunami inundation

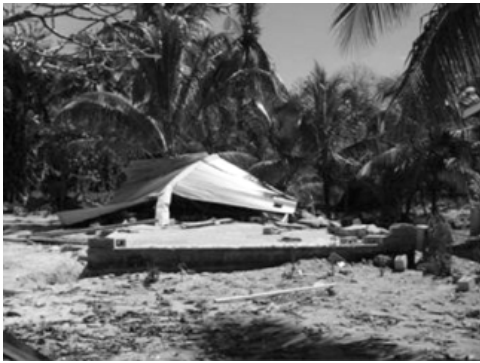
Photo 3.1.3.2 Destroyed house neighboring the house in Photo 3.1.3.1

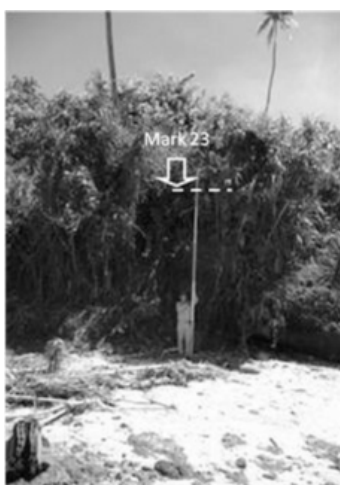
Photo 3.1.4.2 Mark 23

Fig. 3.1.4.1 shows the measurement points of Marks 23, 24 and 25. Their transects are shown in Figs. 3.1.4.2 – 3.1.4.4. Mark 23 was on the west edge of the village, where the limit of inundation was indicated by a border of discolored vegetation. The runup height was 5.59 m. A resident also reported that the tsunami stopped there.

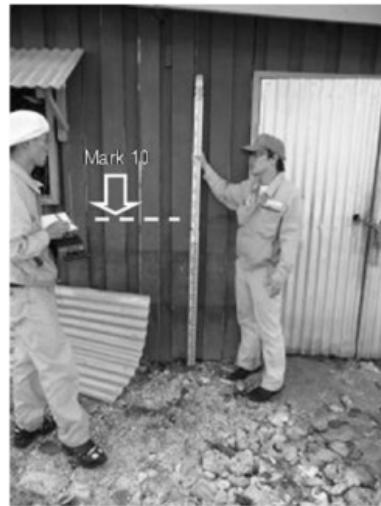
Less damage occurred in the downtown area than nearby. Tsunami traces were measured in Gizo. For example, Marks 11 and 10 were measured at the point shown in Fig. 3.1.6.1 and at the point marked "S" in Photo 3.1.4.1, respectively. Transects of Mark 11 and Mark 10 are shown in Figs. 3.1.6.2 and 3.1.6.3, respectively. Mark 11 is an inundation mark on a leg supporting a high-floored house. The inundation depth was 0.89 m on the ground whose height level was 0.93 m and the resultant inundation height was 1.82 m. Mark 10 was also an inundation mark on an outside wall of a warehouse. The inundation depth was 0.53 m and inundation height was 1.75 m.

Photo 3.1.6.1 Inundation level of Mark 10

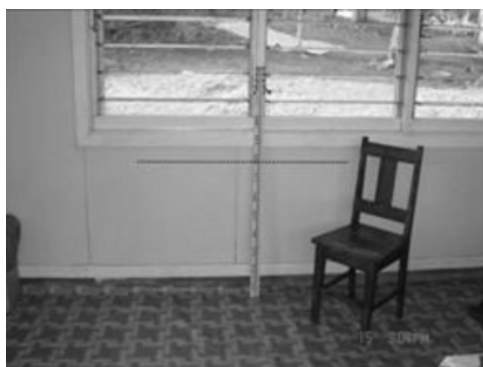
Photo 3.1.7 Inundation level at Logha village (Mark48)

There is a church on the west coast in Logha island (Mark48 in Fig. 3.1.7.1). The tsunami rose up and the church was inundated. The watermark remained, which was estimated as 2.08 m (Photo 3.1.7.1).

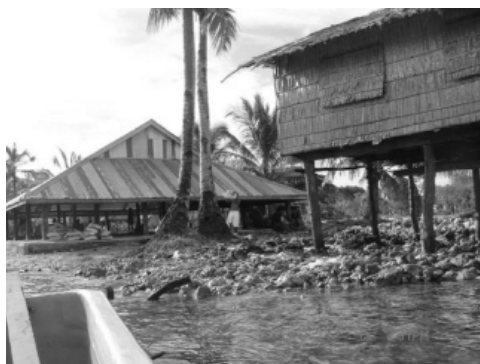
Photo 3.1.9.1 Warehouse of grain at Nusambaraku

Nusambaraku village is about 1 km northwest of Gizo town. In this village, there is a large warehouse of grain shown in Photo 3.1.9.1. According to the inhabitants' eyewitness accounts, the tsunami rose up to the roof of the warehouse (Mark 47, Fig. 3.1.9.1). The watermark was clearly remained inside the roof. The height was measured as 3.27 m. In this village, nine people

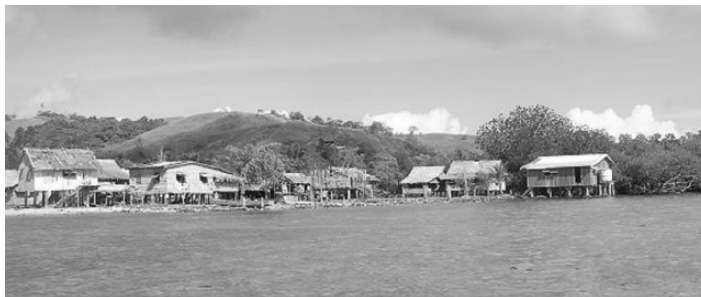
Photo 3.1.10.1 Distant view of the fishing village from the sea

Fishing Village is located 0.7 km north-north-east of Nusambaraku village (see Figs. 3.1.1.2 and 3.1.9.1). Photo 3.1.10.1 shows a distant view of the village from the sea. The village is on a low-lying flat land and is defenseless. A tsunami inundation trace was found on the wall of a church. The height was 1.4 m above the sea level at the time of tsunami attack. As seen from the photo, most houses are high-floor-type and withstood the earthquake and tsunami.

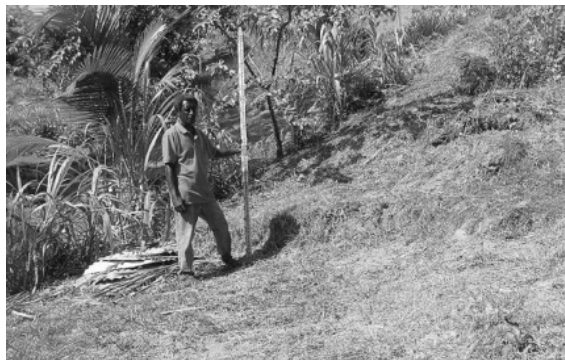
Photo 3.1.10.2 Tsunami measured point decided on the basis of eyewitness accounts of inhabitants

the coast 0.4 km northwest of Fishing Village (see Fig. 3.1.1.2). The coast was protected by a small mangrove forest and the run-up point shown in Photo 3.1.10.2 was decided on the basis of eyewitness accounts by inhabitants. As houses were high-floor-type and located on a slope of hill, no houses were damaged by the tsunami.

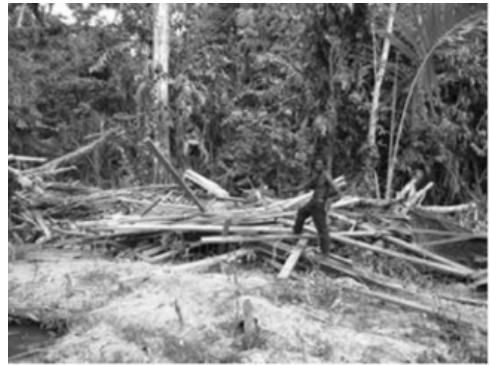
Photo 3.1.12.1 Situation at the runup limit in Sagheraghi

Mark 7 indicated the location of runup limitation determined by residents' accounts. The tsunami reached up to 128 m inland from the coast. At the runup limit much debris was piled up among trees, as shown in Photo 3.1.12.1.

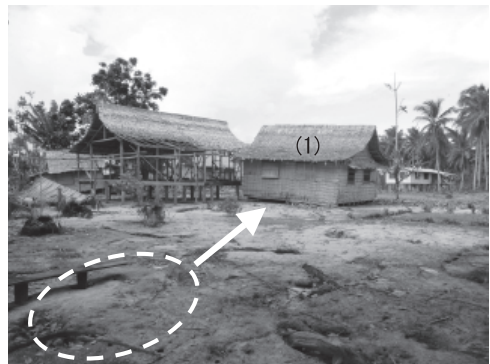
Photo 3.1.12.2 High-floored house swept by the tsunami

Although no one was killed in this village, 43 houses suffered damage. Some high-floored houses were swept by the tsunami. For example,

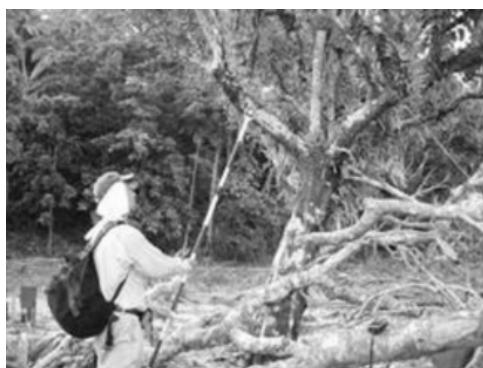
Photo 3.1.13.1 Scratch remaining on a tree in Vorivori village.

Vorivori village is located along the western coast of Ghizo island. Its population is more than 100. Nobody was killed by the tsunami. Because many people had watched an educational video about tsunami disasters given by an NGO, they knew to run away from the tsunami just after the earthquake. The sea level receded at first, and then the land was inundated for about 10 minutes. Because of the inundation, houses floated, moved, and were broken. In the village, much debris remained in trees, and scratches remained on trees (Mark 51 in Fig. 3.1.13.1 and Photo 3.1.13.1).

The height was measured as 4.46 m. At the other point, Mark 52, there were a lot of rubble and houses moved inland by the tsunami, and the height was estimated as 1.75 m. Mark 52 is about 60 m behind Mark 51.

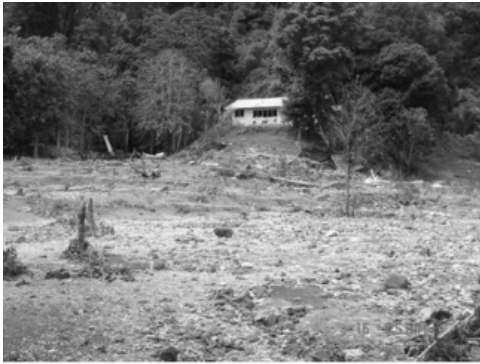
Photo 3.2.2.1 The building of the church in Tapurai. This church and one shed were survived.

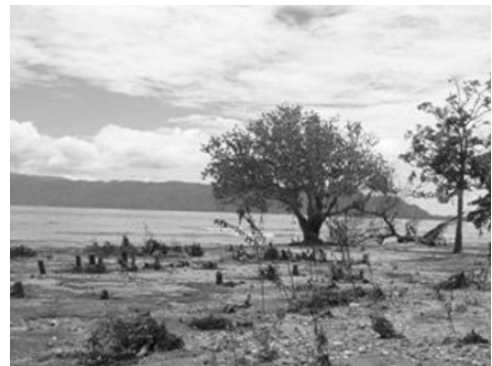
Photo 3.2.2.2 Coastal region in Tapurai. There had been four buildings of the primary school here, but all of them were entirely swept away due to the tsunami.

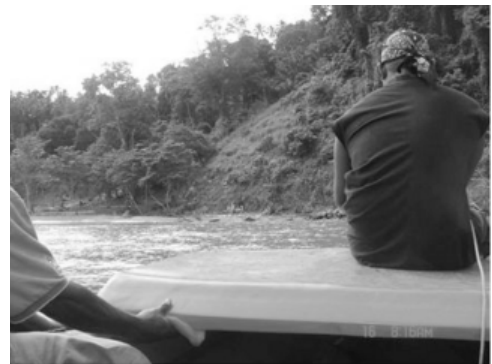
At Marks 59 and 3, seawater rose up to the cliff (Photo.3.2.2.3), and the border line between living and dead grass can be seen easily, which was corroborated by the eyewitness accounts of the inhabitants. The height of 8.5 m at Mark 59 and 9.0 m at Mark 3 (after correction of the astronomical tide) were measured. At Mark 116, the height was determined by a debris line on the hill. At the other points, we measured the tsunami heights in similar fashion. According to Fig.3.2.2.1, we found the tsunami height to be larger in the west than in the east. As the witnesses said, the tsunami came from the northeast. Therefore the tsunami ran up on the ground from northeast to southwest, and it bumped against the southwestern cliff around Marks 3, 59, 60 and

Photo 3.2.2.3 Tsunami runup limit at the Mark 59 in Tapurai, Simbo Is. We could easily recognize the inundation limit as the green and brown color boundary.

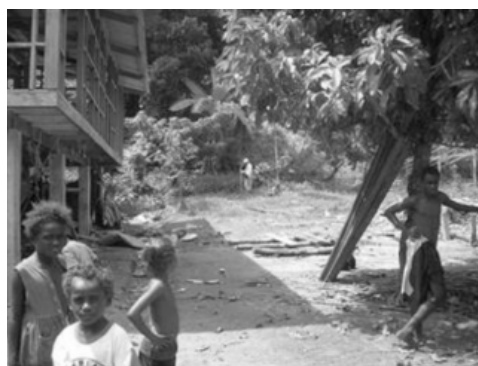
Photo 3.2.5.1 The runup point at Mengge

At this site, two kitchen-cottages near the coastline were washed away by the tsunami. In addition, one house was washed away. This house was already damaged by the earthquake, and floated and washed away by the tsunami. The runup height was measured, whose trace was the debris on the ground.

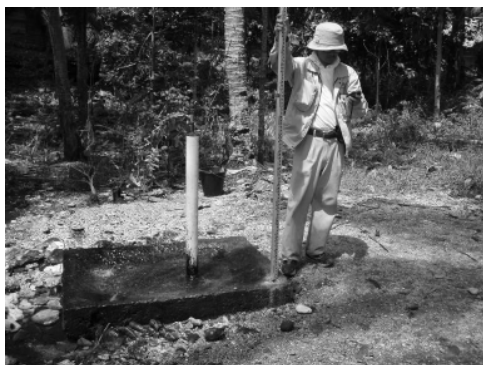
Photo 3.3.2.2 Bench mark of Bench 1 at Lale
The reference point is at the intersection point between the staff and concrete base.

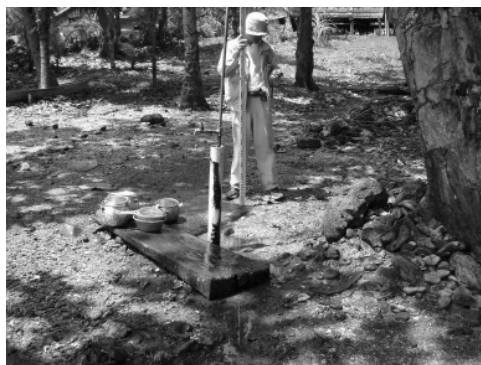
at the top of the base in the different water supplies shown in Photo 3.3.2.3 (Bench 2). The height of the top is measured as 5.750 m above Mean Sea Level. We recommend future survey team to measure the heights of the benchmarks and compare them to the above values.

Photo 3.3.2.3 Bench mark of Bench 2 at Lale
The reference point is at the intersection point between the staff and concrete base.

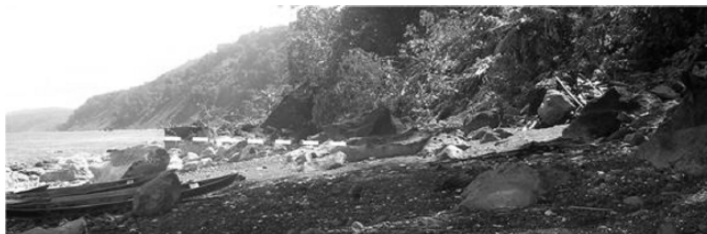
Photo 3.3.5.1 Clear upper limit line of coral bleaching after the earthquake at Kundu village

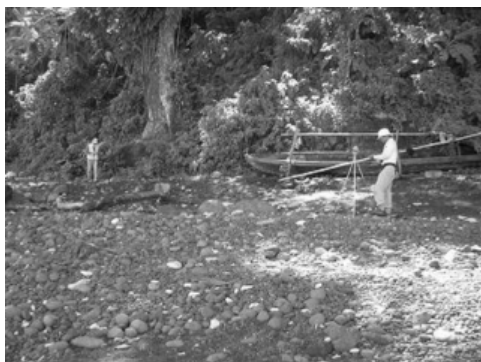
Photo 3.3.5.2 Tsunami measured point at Kundu village

The tsunami run-up height reached 3.5 m. The run-up point was located on the beach and decided on the basis of eyewitness accounts of inhabitants (Photo 3.3.5.2). Residential area is located on a cliff. Therefore, there was no damage from the tsunami.

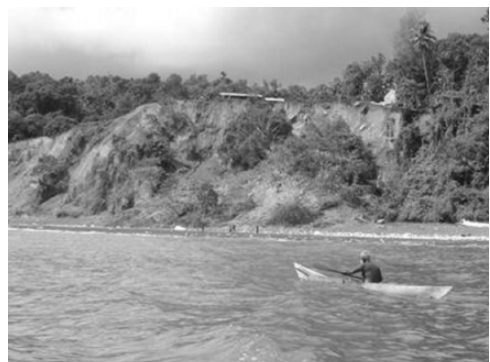
3.3.6.1 Landslide in Mondo village

There was no damage from the tsunami, but a landslide, shown in Photo 3.3.6.1, killed two people.

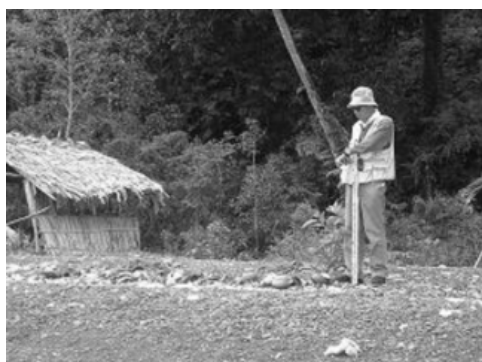
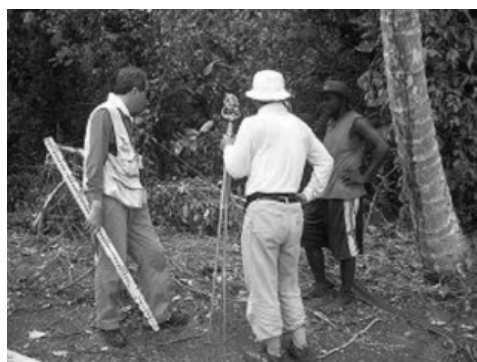
Photo 3.3.7.1 Tsunami measured points at Vori village (left) and Vori Point (right)

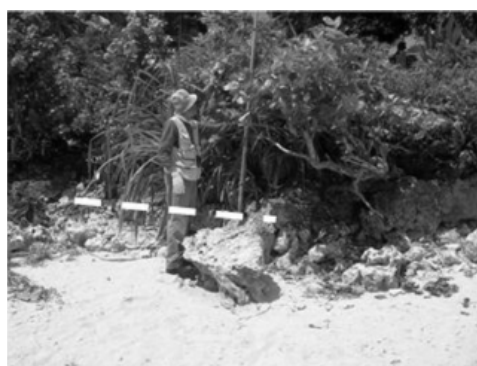
in the northern part of the island. The height of uplift was estimated around 1.9 m. Photo 3.3.8.1 shows a clear upper limit line of coral bleaching after the earthquake.

Photo 3.3.8.1 Clear upper limit line of coral bleaching after the earthquake at Koriovuku village

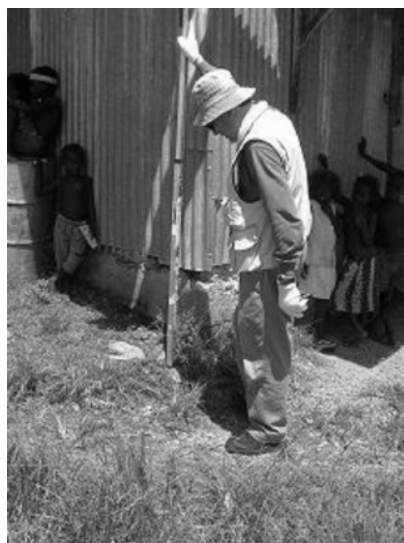
The tsunami run-up height reached 1.9 ~ 2.1 m. The measured point was decided on the basis of eyewitness accounts of inhabitants (Photo 3.3.8.2). As the tsunami height was small and the residential area was located on a hill, damage from the tsunami was not recognized at all.

Photo 3.3.8.2 Tsunami measured point at Koriovuku village

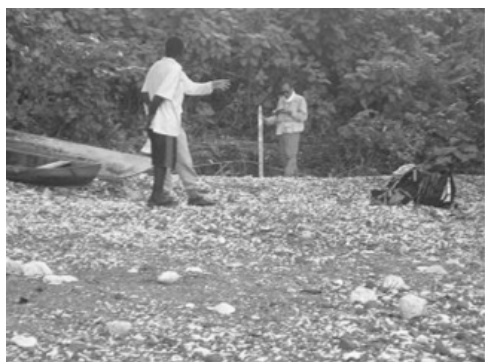
The tsunami run-up height reached nearly 3.3 m. The measured point was located on the beach and determined from eyewitness accounts of inhabitants (Photo 3.3.10.2). There was no damage except that caused by the earthquake. Although water tanks were destroyed by the earthquake, new ones had been already supplied by Solomon Islands' government.

Photo 3.3.10.2 Tsunami measured point at Suava village

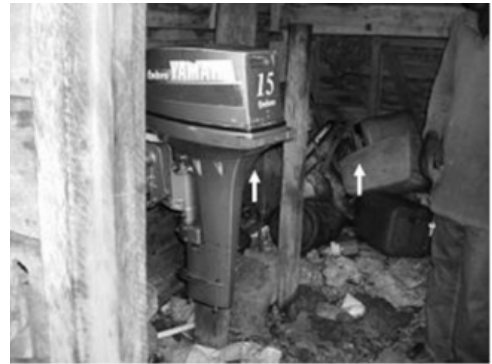
Tsunami trace heights were measured at two points, Marks 18 (1) and 18 (2), as shown in Fig. 3.4.3.2. Their transects are shown in Figs. 3.4.3.3. Mark 18 (1) was an inundation mark on a seaward-facing wall of a high-floored house with stilts. The inundation height was 1.09 m. Mark 18 (2) was also an inundation mark on an out-board engine of boat in a storage house along the coast, as shown in Photo 3.4.3.1. The inundation

Photo 3.4.3.1 Inundation mark of Mark 18 (2)

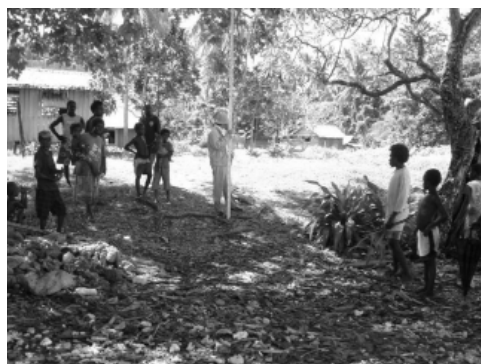
Photo 3.4.5.1 Tsunami inundation at Mark 86 in Niarovai, Vella Lavella Is.

We measured tsunami heights at two points in Niarovai (Fig.3.4.5.1) judged by the debris. At Mark 86, tsunami ran up to the limit of dead leaves (Photo 3.4.5.1), which was corroborated by the inhabitants. The height of 1.1 m was measured. At Mark 91, we could measure the tsunami

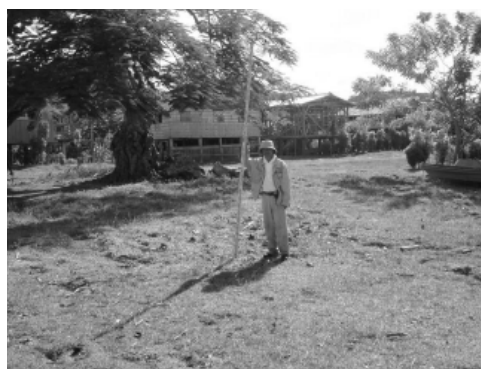
We measured the tsunami heights at two points in Lambu-Lambu (Fig.3.4.6.1) judged by the debris. At Mark 87, the tsunami ran up to the limit of dead leaves (Photo.3.4.6.1), which was also corroborated by the inhabitants. The height of 0.3 m (after correction of the astronomical tide) was measured. At Mark 92, we measured the tsunami height in the same way, and almost same the height was measured as 0.5 m.

Photo 3.4.6.1 Tsunami inundation at the Mark 87 in Lambu-Lambu, Vella Lavella Is.

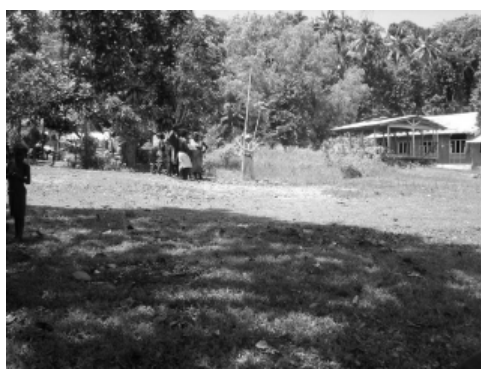
We measured the tsunami heights at two points in Varese (Fig.3.4.7.1) judged by the trace of dead weeds on the ground. At Mark 84, sea water inundated up to the boundary of the area marked by dead weeds where the person stands in the Photo.3.4.7.1, which was also corroborated by the inhabitants. We measured the inundation height at 2.4 m (after compensation for the astronomical tide). At Mark 90, we measured the tsunami height in the same way, and almost same value (2.5 m) was obtained.

Photo 3.4.7.1 Tsunami inundation at Mark 84 in Varese, Vella Lavella Is.

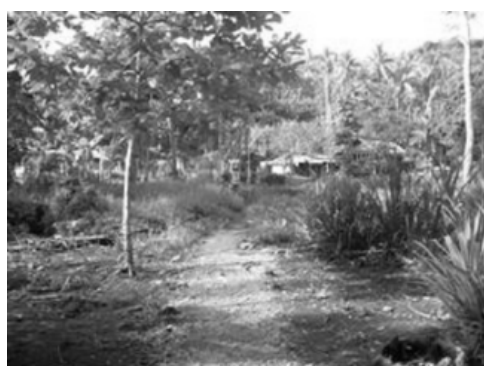
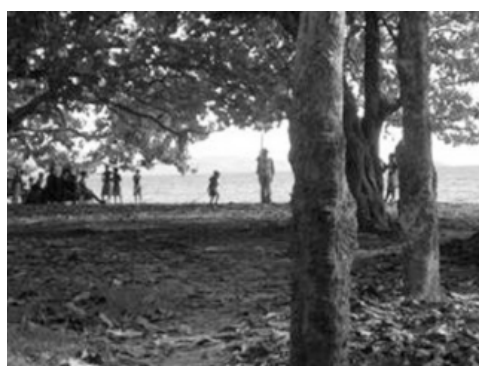
The inundation limit was determined by eye-witness account (left photo of Photo 3.4.8.1). The height of the location was 1.0 m above sea level

at the tsunami event. However, that ground elevation was lower than the dune near the coastline (right photo of Photo 3.4.8.1). Thus, we measured also the height of the dune, 1.4 m. Unfortunately, we could not know the inundation depth on the dune. The actual water elevation was higher than 1.4 m at the dune.

Photo 3.4.8.1 Survey points in Supato (left: inundation limitation, right: top of dune)

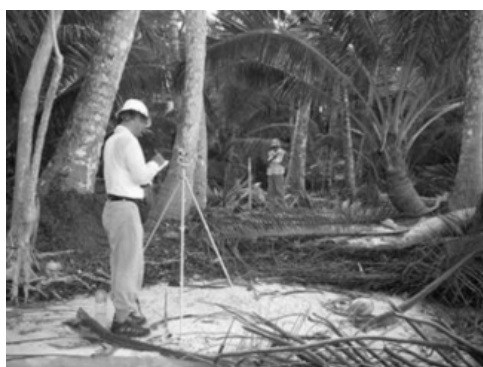
On the east coast of the island, we found some debris near the coastline. The tsunami might have inundated beyond this line, however; the limit of inundation was not clear. Thus, we measured the height of debris, 1.3 m. It is possible that the actual height was higher than 1.3 m.

Photo 3.4.9.1 Debris at the east coast of Baga Island

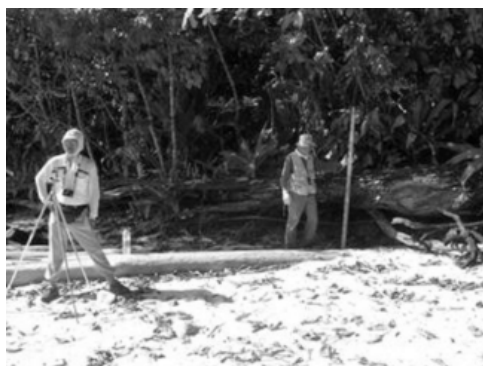
On the west coast of Baga Island, we could not find clear tsunami-traces. The fallen big tree in Photo 3.4.9.2 was not a tsunami trace. However,

Photo 3.4.9.2 Big tree at the west coast of Baga Island (It is thought that this tree is not the trace of tsunami.)

it was thought that the tsunami could not have exceeded the location of the tree, considering the arrangement of debris and dead vegetation. The height of that place was 1.7 m, thus the runup height was lower than 1.7 m. The runup height of ordinary waves was estimated as 0.7 m, considering the debris on the beach. Thus, the runup height of the tsunami seemed to be higher than 0.7 m and lower than 1.7 m.

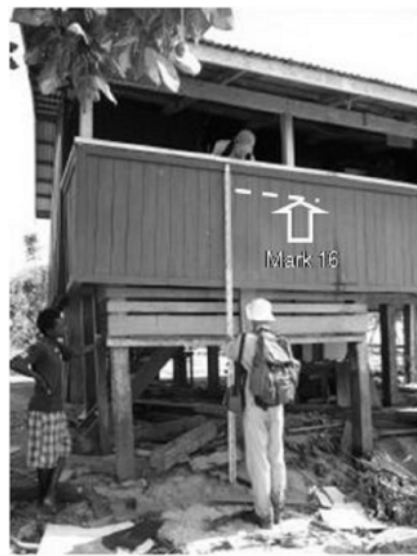
Two tsunami traces were measured in Iringgila: Marks 16 and 17, as shown in Fig. 3.4.10.2. Their transects are shown in Figs. 3.4.10.3 and 3.4.10.4. Mark 16 is an inundation mark on a side wall of a high-floored house located behind a small island, as shown in Photo 3.4.10.1. The inundation height was 4.37 m and inundation depth on the ground level was 2.90 m. Mark 17 is also an inundation mark on a facing-to-sea front door of a clinic located in the southwest edge of the village. The inundation height was 1.86 and inundation depth was 0.77 m.

Photo 3.4.10.1 Inundation level of Mark 16

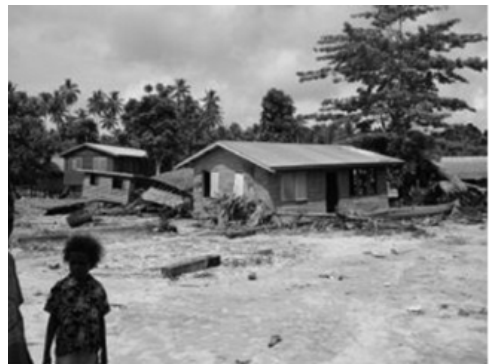
east side of the village were swept and destroyed as shown in Photo 3.4.10.2, even though houses on the west side suffered less destruction.

The local change of tsunami height is probably attributed to the complicated bathymetry, geometry and topography around Iringgila. Especially, very-shallow water area in front of the village may converge energy of tsunami, resulting in high local tsunami height. The converged tsunami was also watched by residents as described later. Such characteristics can be calculated easily if bathymetric and geometric data are available.

Photo 3.4.10.2 House swept inland by tsunami in the east part of Iringgila

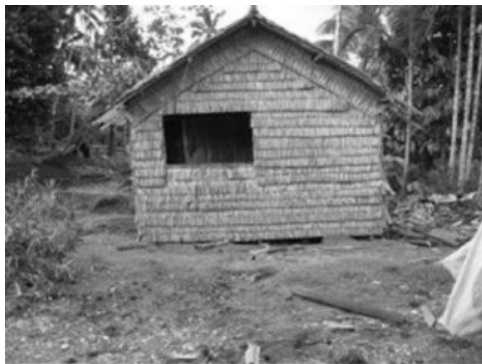
in Fig. 3.4.11.2, as shown in Photo 3.4.11.1, was moved 9.5 m from the original position. The schoolhouse was also swept 50 m from its original position.

Photo 3.4.11.1 High-floored house in Fig. 3.4.11.2 moved by the tsunami

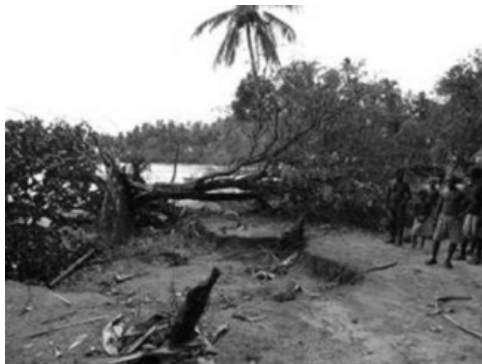
Photo 3.4.11.2 Eroded beach and fallen trees in Reona

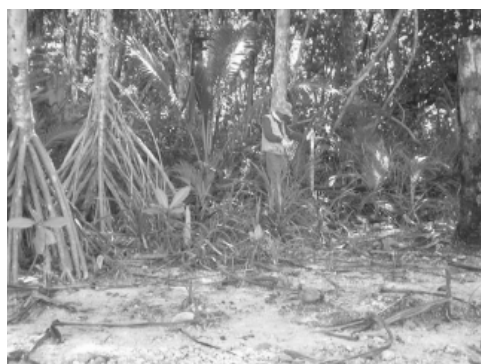
vulani, which is one of the chain of islands on the extending coral reef. Because no one lived in this island, there was no damage to structures here. Debris was found on the slope as shown in Photo 3.5.2.1. However, the debris seemed to have stopped there by being caught on vegetation. Thus, there is a possibility that the actual runup height was slightly higher than this measurement data.

Photo 3.5.2.1 Runup point at Ndivulani

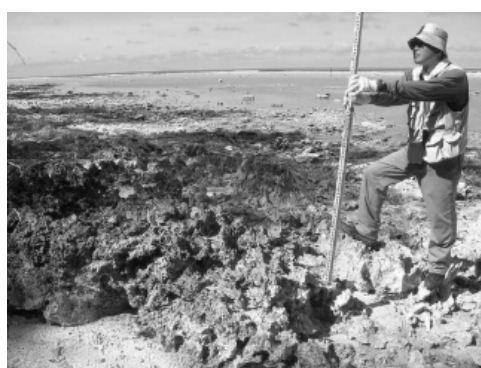
Uplift was clearly observed in this island, e.g. the coral reef was cropped out from the sea surface. The uplift of the ground was estimated as about 1m. The surveying staff in Photo 3.5.2.2 marks the location of the pre-earthquake shoreline, shown as a sharp line from gray to white on the coral rubble.

Photo 3.5.2.2 Exposed coral reef at Ndivulani

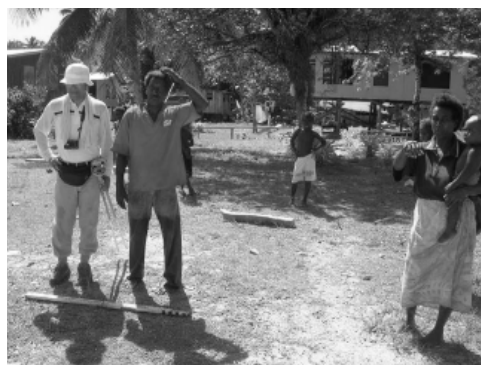
The runup height of 1.3 m was measured at Rarumana, the village on the main island of Parara. The runup point was determined by eyewitness accounts of the tsunami. The place of the staff in Photo 3.5.2.3 shows the runup point. In addition, the residents told us that the first tsunami motion was rundown and the low-tide level before the earthquake was near the white line in Photo 3.5.2.4. The uplift of this location was estimated as 0.8 m. This village suffered no damage, because the coast is sheltered by the extending reef and the ground was uplifted by the earthquake.

Photo 3.5.2.3 Runup point at Rarumana

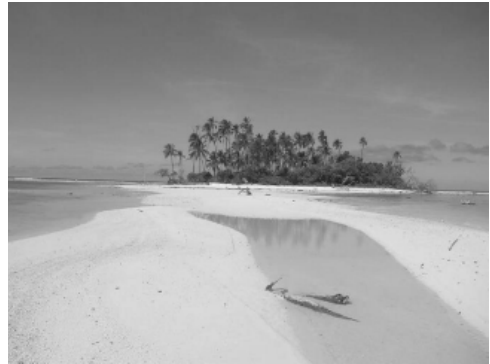
The record of 1.7 m was measured at an unidentified small island (Photo 3.5.2.5) near the end of the keys. The tsunami might intrude the whole island, because the debris was found in every place of the island. While the height of the debris shown in Photo 3.5.2.6 was measured, it is possible that the water level of the overflow on

Photo 3.5.2.5 Surveyed island near the end of the chain of keys

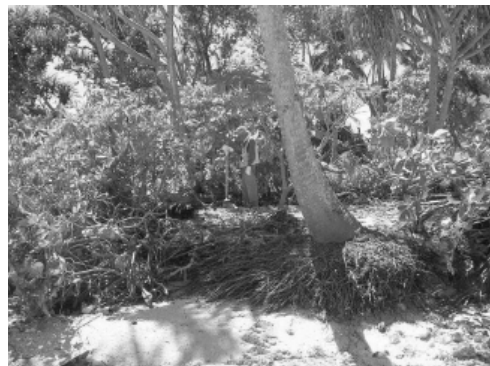
Photo 3.5.2.6 Tsunami trace at the surveyed island

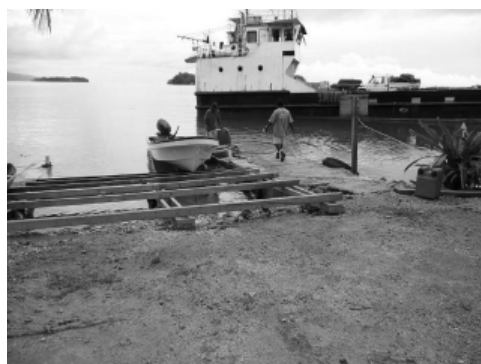
Fig. 3.5.3.2 shows the coastline and reef edges around Munda. Reefs have developed 800 m and 3000 m offshore along the south Munda coast; these reefs act as natural breakwaters. The survey points were in low-lying areas close to the sea surface as shown Photo 3.5.3.1. However, no severe damages were caused there, because the striking tsunami was approximately 1 m high as described later. The reason why the tsunami was not so high could be caused by tsunami reduction by reefs.

Photo 3.5.3.1 Survey location in low-lying area in Munda

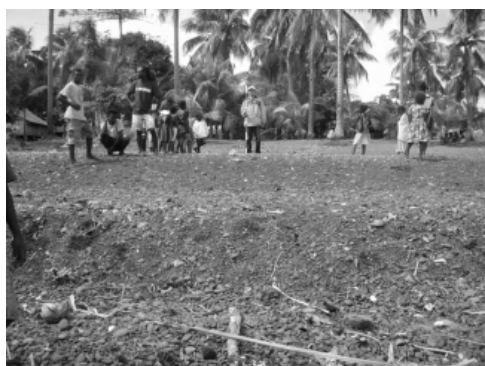
Photo 3.5.5.1.1 Uplifted beach in Hoppongo, Rendova Island.

tide. By comparing the original and present high tide lines we estimated the uplift to be 50 cm. Based on eyewitness accounts the tsunami came from the north. Before the tsunami attack, they observed the sea retreating for about 10 minutes. The tsunami did not damage houses. Inundation limit of the tsunami was inferred by a line of pumice that were carried up by the tsunami and re-deposited on the ground surface. The pumice probably originated from the submarine volcano off this island and composed the beach. The estimated tsunami runup height is 2.0 m (Photo 3.5.5.1.1).

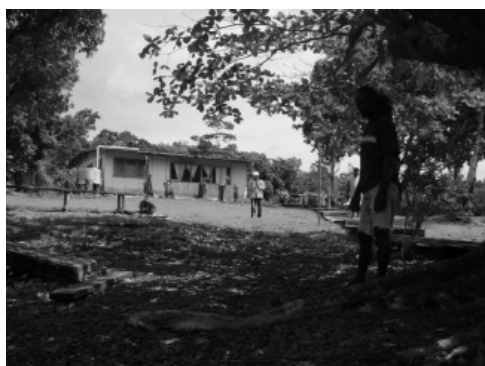
Photo 3.5.5.2.1 Measuring the tsunami inundation boundary in Kenero, Rendova Island.

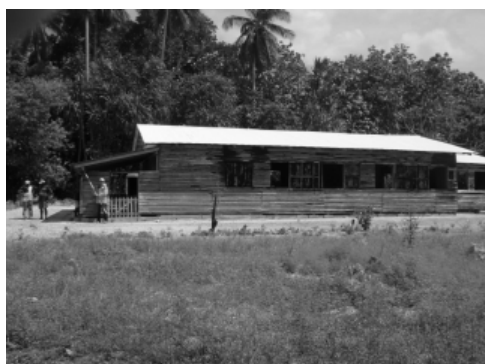
We visited Mendali point, Randuvu, at the north western coast of the island. There is a village with more than 100 people. The village suffered significant damage from the tsunami. Local people say that the tsunami came from the east about five minutes after strong shaking. Before the tsunami attack, they observed the sea retreating. Some people were caught by the tsunami wave but escaped to the roof of the church. They showed the water level on the church wall and we measured the height from the sea level (Photo 3.5.5.3.1). The tsunami height there was about 3 m. Most of the people escaped inland to the bush and were safe. They showed the inundation boundary of the tsunami at about 200 m inland, and we measured the runup height of 1.2 m there (Photo 3.5.5.3.2). Based on eyewitness accounts, we estimated the ground subsidence as 41 cm.

Photo 3.5.5.3.1 Measuring the tsunami flow height on the wall of a church in Randuvu, Rendova Island.

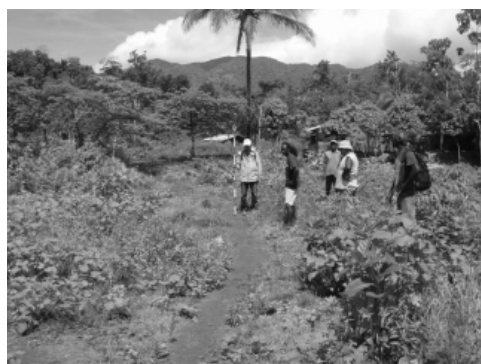
Photo 3.5.5.3.2 Measuring the tsunami inundation boundary in Randuvu, Rendova Island.
