Great Eastern Japan Earthquake 2011

Natori – Sendai Airport (24.03.2011)

Minami Sanriku (25.03.2011)

Onagawa (29.03.2011)

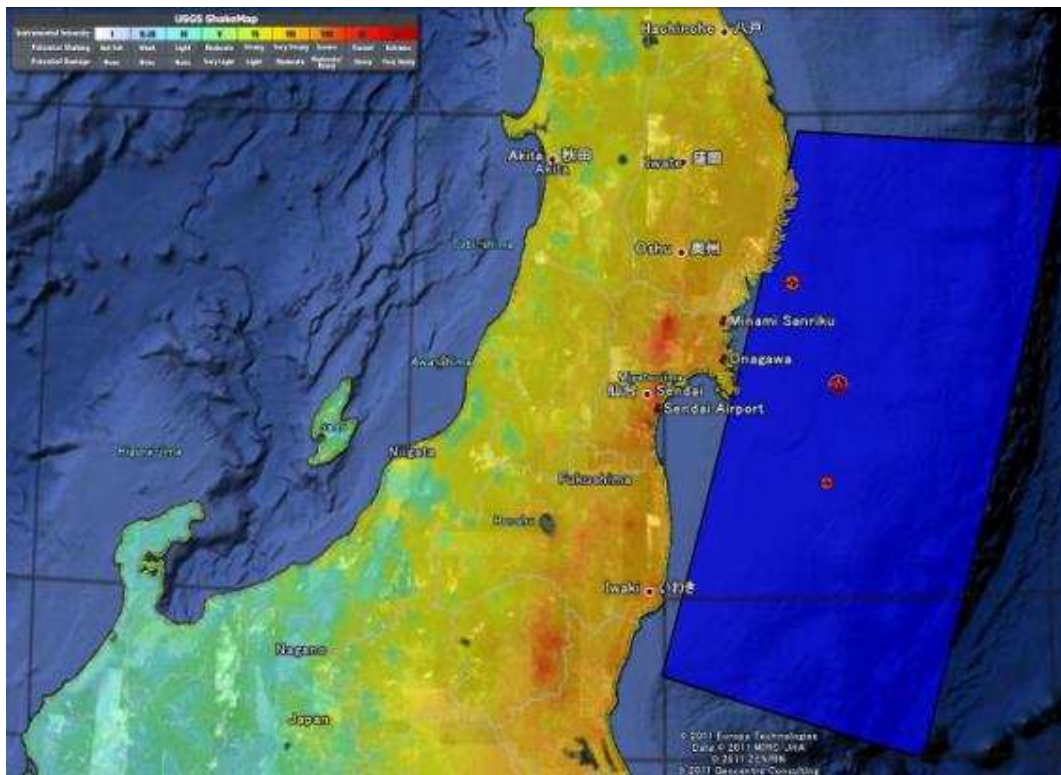
Figure 1. Tsunami Field Survey points for Tohoku Offshore Earthquake & Tsunami. (Shake Map – USGS / Location – Google Earth)
