6/4/ 2011 (Wed)

Field survey in Shinchi town, Yamamoto town and Watari town

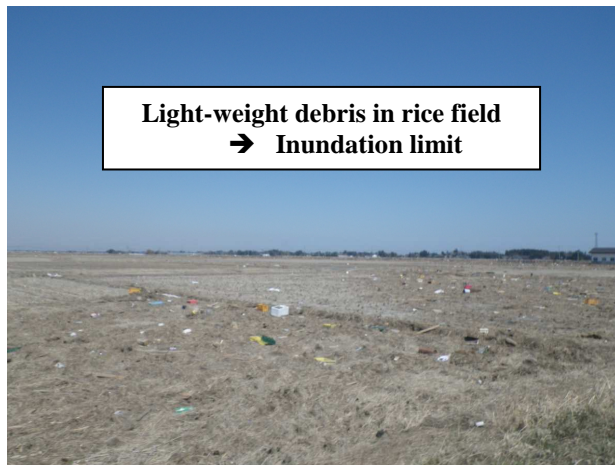
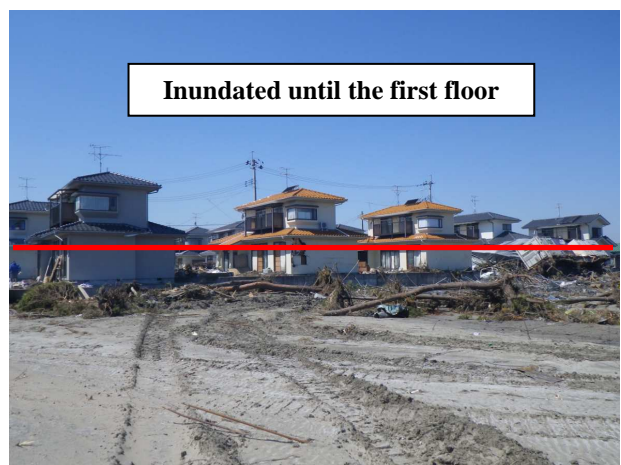
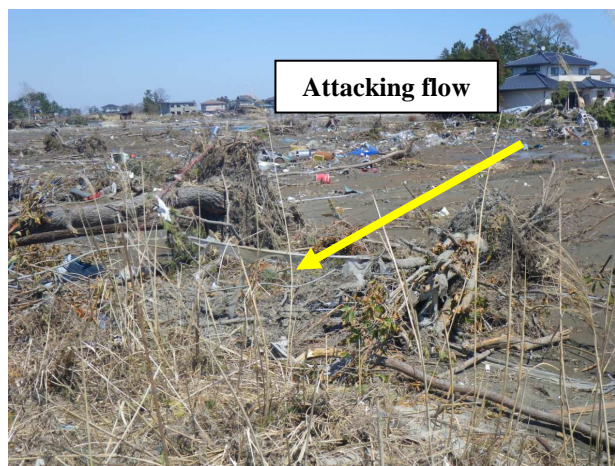
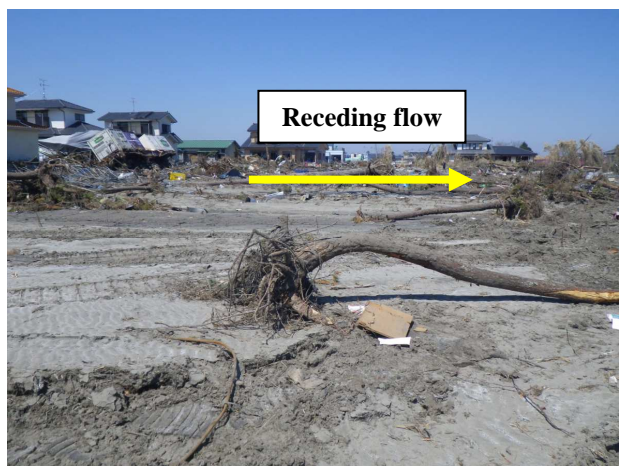
Type: two-story wood frame
 Function: residence house
 Flow depth: 1.94 m
 Damage: no structural damage
 Location: Latitude = 37.983961 and Longitude = 140.893869
