## 津波強度と被害

首藤伸夫\*

\*東北大学工学部災害制御研究センター  
津波工学研究分野

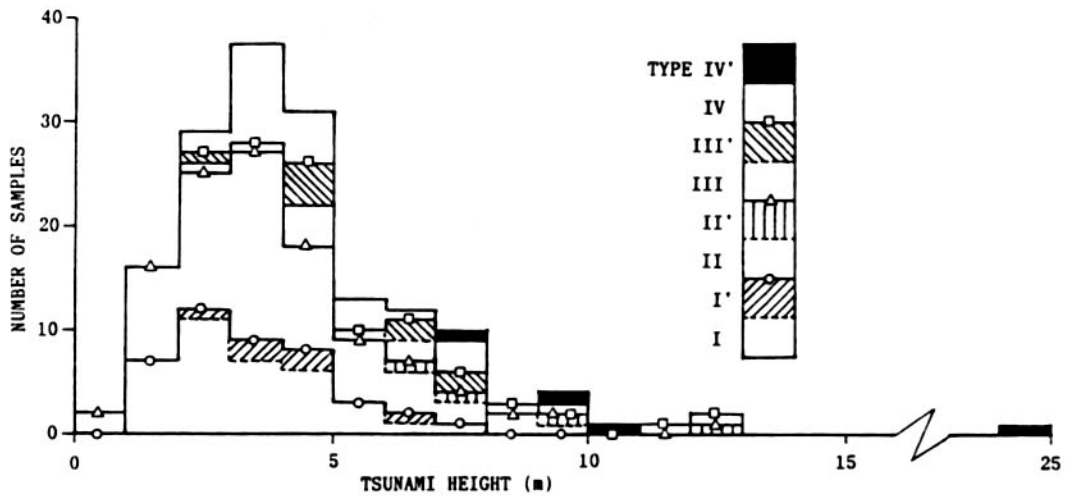
図-1 昭和三陸大津波の沿岸での形態毎の発生度数。全資料数160。形式-Iは潮汐に類似のもの、形式-IIは沖では認められない津波が岸近くで急に大きくなるもの、形式-IIIは沖において既に海の壁として認められるもの、形式-IVは巻き波砕波となるもの。

全体は四つの型式に大別され、各々の型式は更に一つの副型式を含むこととなる。図-1 は津波高に関して、形式分類の出現回数を示すものである。

形式-I は、潮汐に類似しているとされるものである。「水面は潮汐のようにゆっくりと上昇した」、「津波は速い潮のようである」、「津波は岸に向かって静かに進み、防波堤の所で急に盛り上がった」などと表現される。そのいくつかは、先端に「畦のように」波打つ短周期波を持っていた。その短周期波が砕波したものもあり、これを形式-I' とした。この形式-I は、比較的急勾配の海岸に比較的波形勾配の緩やかな津波が襲来したときに発生するものであって、160 例中 42 例がこの形式であり、そのうち 7 例が、前面での砕波する短周期波を伴っていた。図-1 において、丸印のついた所までがこの形式に対応しており、更にその中で左下がりの斜線を施した部分が、砕波する短周期波を伴った例である。

岸にきて急に大きくなる」という表現で特徴付けられる。これは、海岸は比較的急勾配であり、津波は形式-Iにくらべ波形勾配が大きくなっていることを示唆している。全体で70例あった。この形式の津波は、「岸で急にふくれあがった」、「水が底からふくれあがった」、或は「短い波が次々と追いついてきて、前の波に重なるようにして水面が上がった」などと表現されている。図-1において、丸印と三角印の間の面積がこの形式に属する。縦線で示したもの(4例)は、峰のところが崩れ砕波となっていた。どちらかというときの高さの高いものである。これを形式-II'とした。

形式-IIIには22例があり、「沖でも既に認められていた津波が、岸近くで更に急に成長する」と表現される。比較的緩やかな海底勾配を有する場所での津波である。「堤防の土手のよう」、「幕を引いたよう」、「壁の頂が沖でもしぶきをあげていた」と形容される。図-1で、三角印と四角印とで囲まれた面積がこの形式-IIIである。その内の半分は、それほど津波の背が高くないにもかかわらず、崩れ砕波を伴っていた。これをIII'とする。図中、右下がりの斜線を施した部分がこれである。

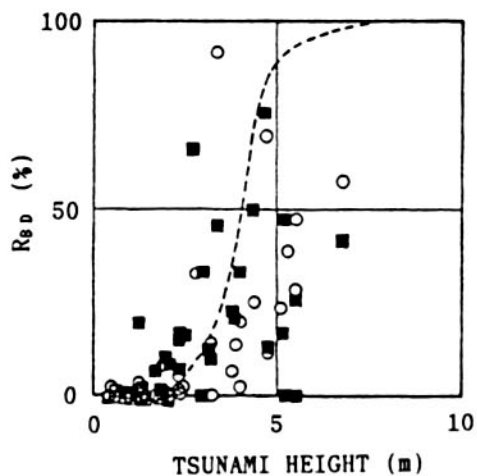
図-9 日本海中部地震津波による漁船被害率。白丸印は小型船舶，黒四角印は大型船舶。点線は船舶種別を考慮せずに引いた平均的な被害率曲線。横軸は平均水面上の津波高。

図-9が結果である(Shuto, 1991)。被害の出始める水位は前二者と殆ど変わらない。ところが、大型船と小型船との被害の出方が昭和三陸大津波の場合とかなり異なる結果となった。全体として、明かに大型船の方が被害を受けやすいのである。これは漁港の整備に原因する所が大きい。漁港が防波堤で囲まれ、港内には係船岸が増え、自然海浜が無くなった結果、津波来襲時に港内に複雑な流れが生じ、しかも狭いため、大型船ほど操船が難しくなり、衝突の機会が増えたものと考えられる。

図-9に引いた点線は、船の寸法に関わらず、平均的な被害率を示すものである。

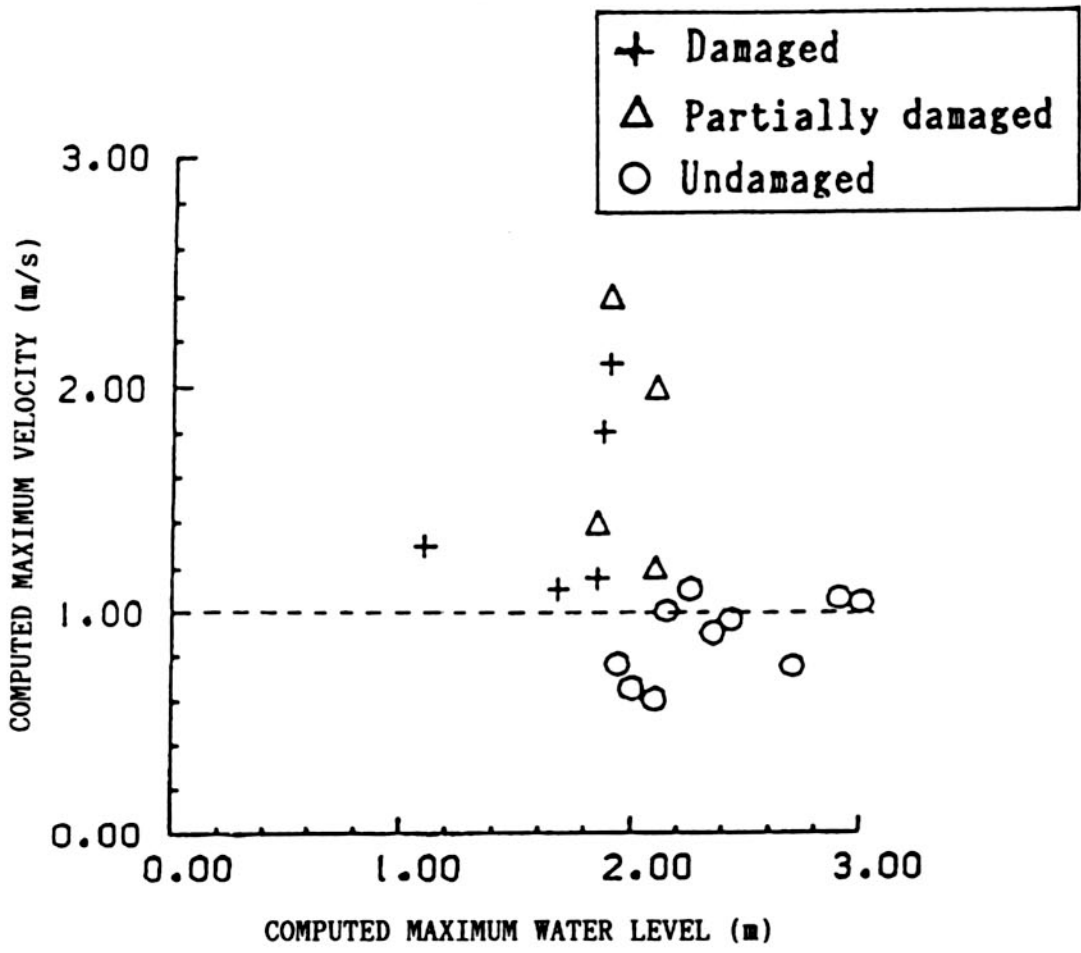
図-10 チリ津波による養殖筏の被害。白丸印は無被害，三角印は部分的被害，十字は全壊。水位，流速とも，数値計算値を使用している。

筏の被害には津波による流れの強弱が影響すると予想されるが、津波時の流速を測定したものは存在しない。チリ津波に対する的矢湾内の数値計算結果から、計算流速と計算水位の関数として図-10のように表現した(Nagano, Imamura and Shuto, 1991)。これを見ると最高水位が3mであっても被害の生じない例があるのに比べ、流速が1m/sを越えると被害が出始めている。狭い水道や浅い湾では最高水位1mで流速が1m/sを越えることもあり、被害が出ることになる。

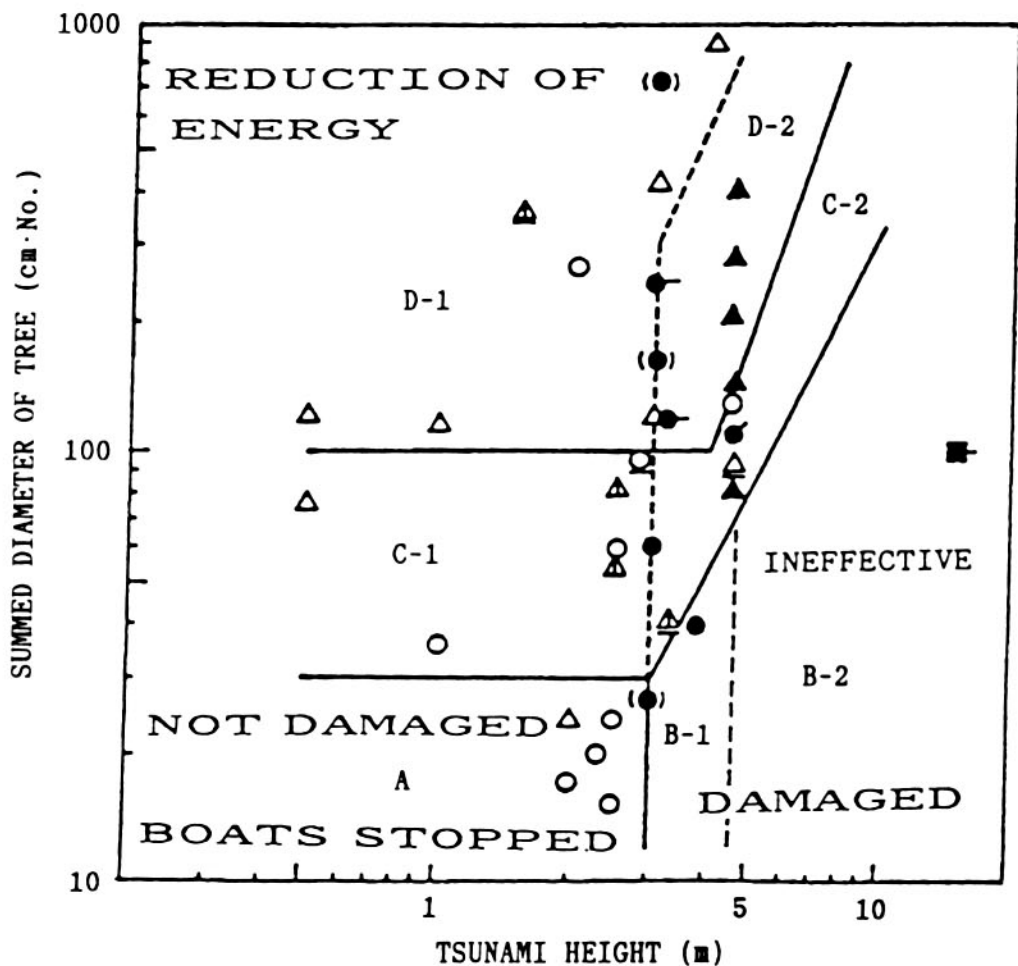
図-11 防潮林の効果。白丸印は主樹木は健全で漂流物を阻止，黒丸印は倒木被害はあるものの漂流物阻止も可能，黒四角印は主樹木折損のため全く無効果，白三角印は流勢を緩和し林帯無被害，黒三角印は流勢を緩和しうるものの林帯にも表土洗掘などの被害，縦線の入った白三角印は流勢を緩和したものの林帯被害については無記述，下線は下生え密生，括弧は林縁部等，横棒は津波高がもっと大きかったと想定されること，斜線は強力な漂流物が集中したこと，等を示す。

図-11に見られるように、効果と防潮林の被害とによって、4つの主領域に分かれ、更に3つの副領域に分割される。
