# A case report of Sato's Hill, a tsunami evacuation site utilized in the 2011 Great East Japan Earthquake, and a literature review on its effectiveness

In Great East Japan Earthquake, the damage caused by the tsunami was extensive, especially in the coastal lowlands. We report a case of Sato's Hill, a private tsunami shelter that saved residents of Higashi-Matsushima. According to an internet archive search and Mr. Yoshifumi Sato, the hill provided shelter to 70 people. A literature search reveals that the tsunami height reached up to about 17 m in coastal areas and 40 m inland. Google Maps and inundation record data verified the safety of Sato's Hill at that time. This report is useful in the development of future tsunami countermeasures.

Keywords : tsunami evacuation shelter, Great East Japan Earthquake, Sato's Hill

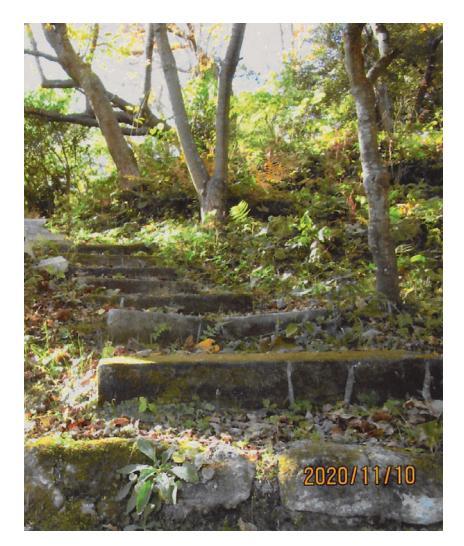
Fig 4: A photograph of stairs maintained to allow climbing to the top of the hill.

Sato's Hill is about 700 m from the coast and about 30 m above sea level(8,10-14). Steps are maintained so that foot traffic can reach the hill's summit(Fig. 4). Sato's Hill is currently participating in a fieldwork program with a disaster education facility based in a closed elementary school(KIBOTCHA)(14, 15).

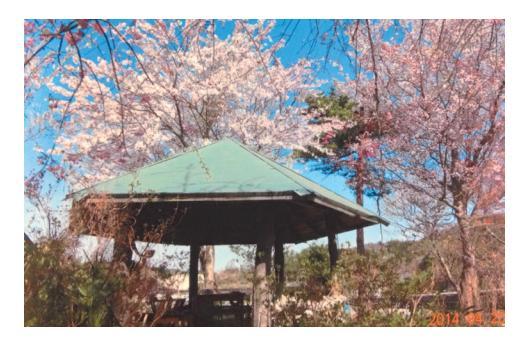
Fig 6: A photograph of the shelter at the top of the hill, which includes structures to keep out rain and wind and to stockpile evacuation supplies.

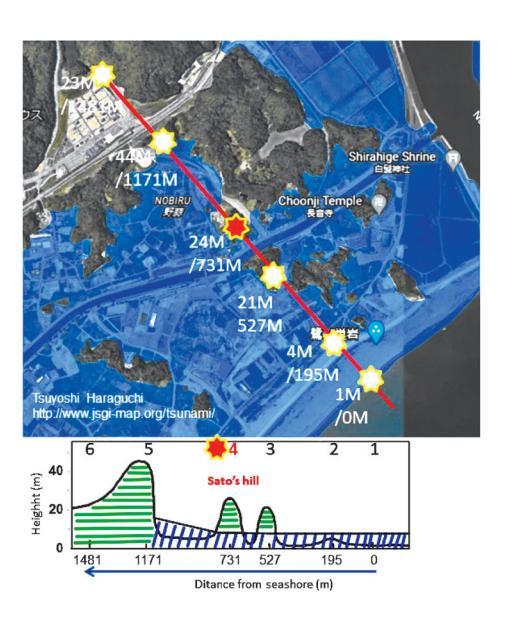
Fig 7: Tsunami inundation data superimposed on Google Maps data for the vicinity of Sato's Hill. The area recorded inundations of 6-7m, but Sato's Hill, which is more than 30 m above sea level, was not submerged.

We determined the inundation situation around Sato's Hill at the time of the earthquake and evaluated its safety by using Google Maps and inundation record data (http://www.jsgi-map.org/ tsunami/)(9).

The academic literature search returned 180 articles on J-STAGE and 374 articles on Pro-Quest with details of the tsunami height and evacuation shelter height. Examining the article titles and contents related to the tsunami height in the area around Sato's Hill, we found no articles on J-STAGE and one on ProQuest, which indicated that the tsunami height reached about 17 m in the coastal area and about 40 m in the inland area(17). The height of the tsunami differed with time, so it is difficult to accurately determine. The maximum tsunami height planned for in tsunami evacuation guidelines is the expected tsunami height plus a safety margin of 2 stories(about 6 m); in this way, the maximum height was estimated as 23 m in coastal areas and 46 m in inland areas(17, 18). We used Google Maps to extract a map around Sato's Hill from inundation data and created a schematic regional map describing a straight line passing from the coast to Sato's Hill(Fig. 7 and Table 1). The tsunami height around Sato's Hill was about 6-7 m, and the maximum height was about 13 m, which is less than that of Sato's Hill.

Sato's Hill is located near the coast, and verification by Google Maps showed that its elevation of about 30 m places it in a safe area. However, there is a possibility of an unprecedented earthquake or that tsunami height forecasts do not apply to all areas. It is practically difficult to prepare tsunami evacuation facilities with elevations of about 50 m in all locations. Although there are regional indicators such as elevations of 17 m or more in coastal areas and 40 m or more in inland areas, simulations for the specific topology of each area are indispensable. In other words, the specific height and location of Sato's Hill is not a universal standard for tsunami shelters.
